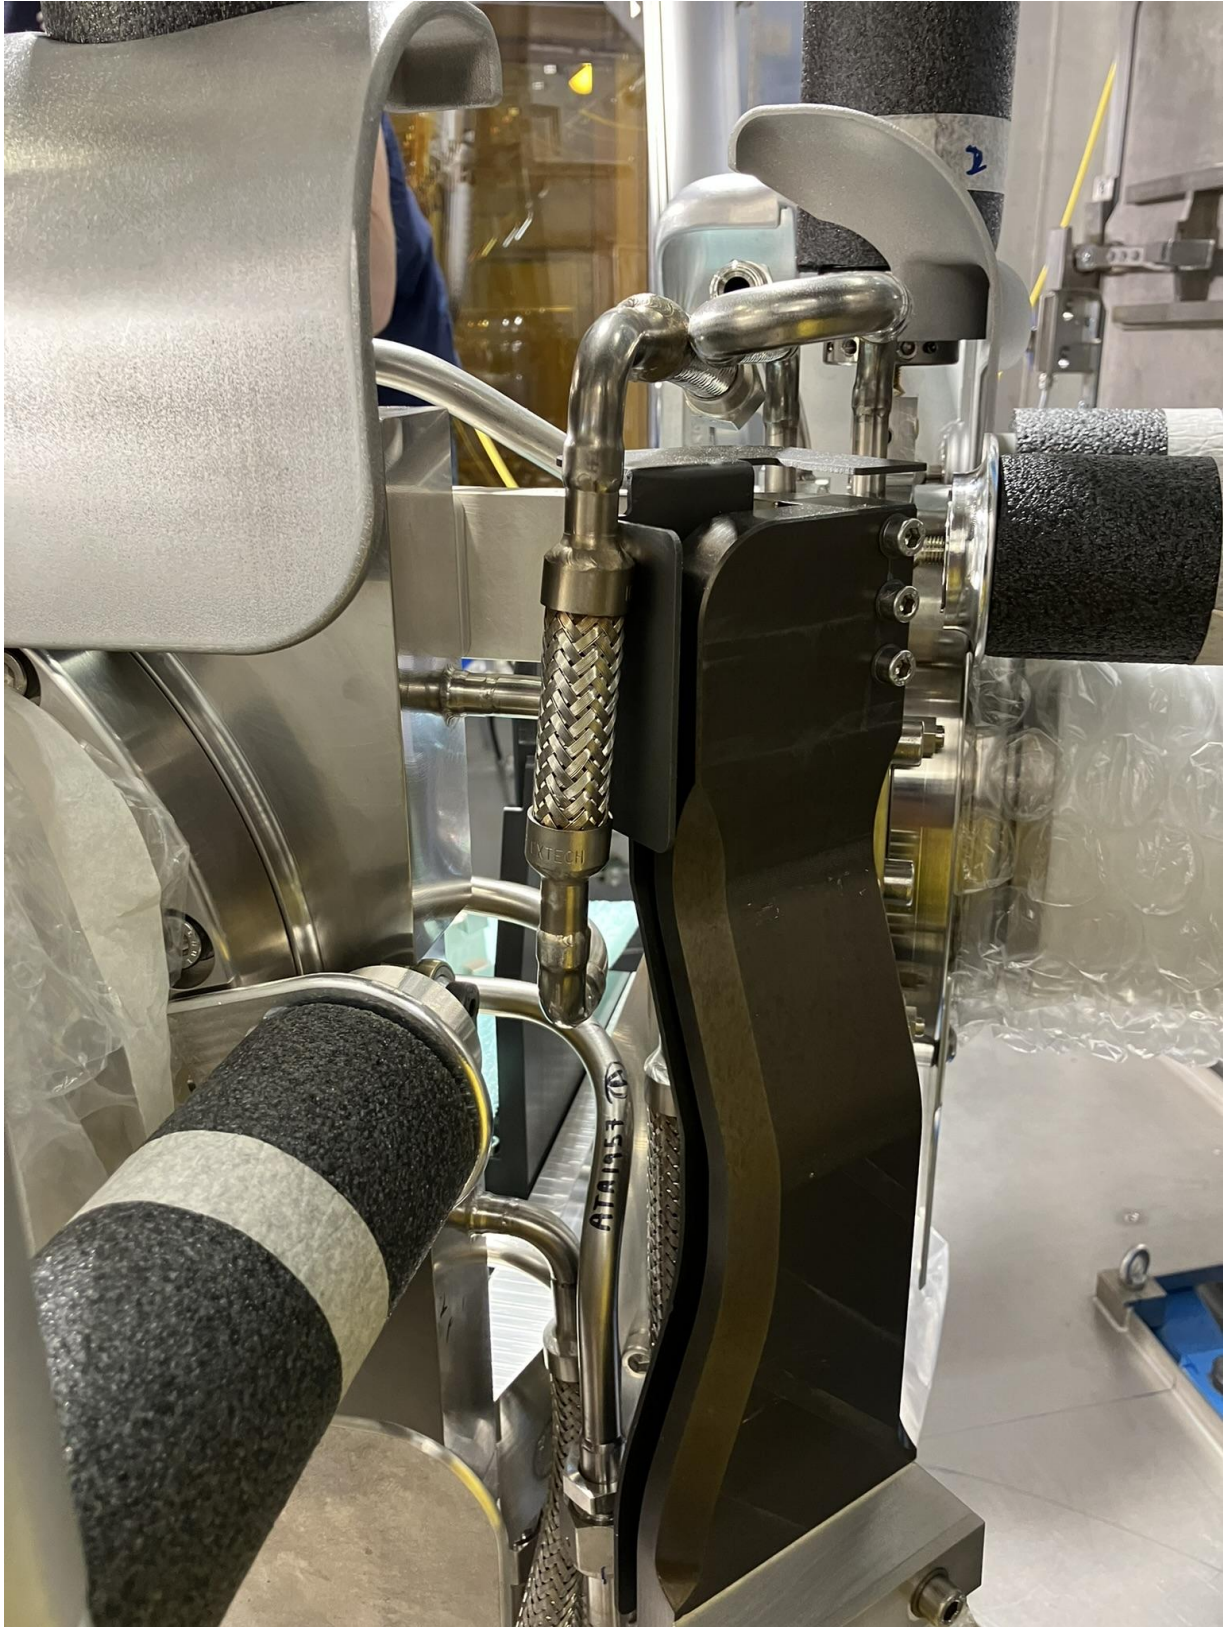
Interference of second top most line against busbar, prevents exchange.

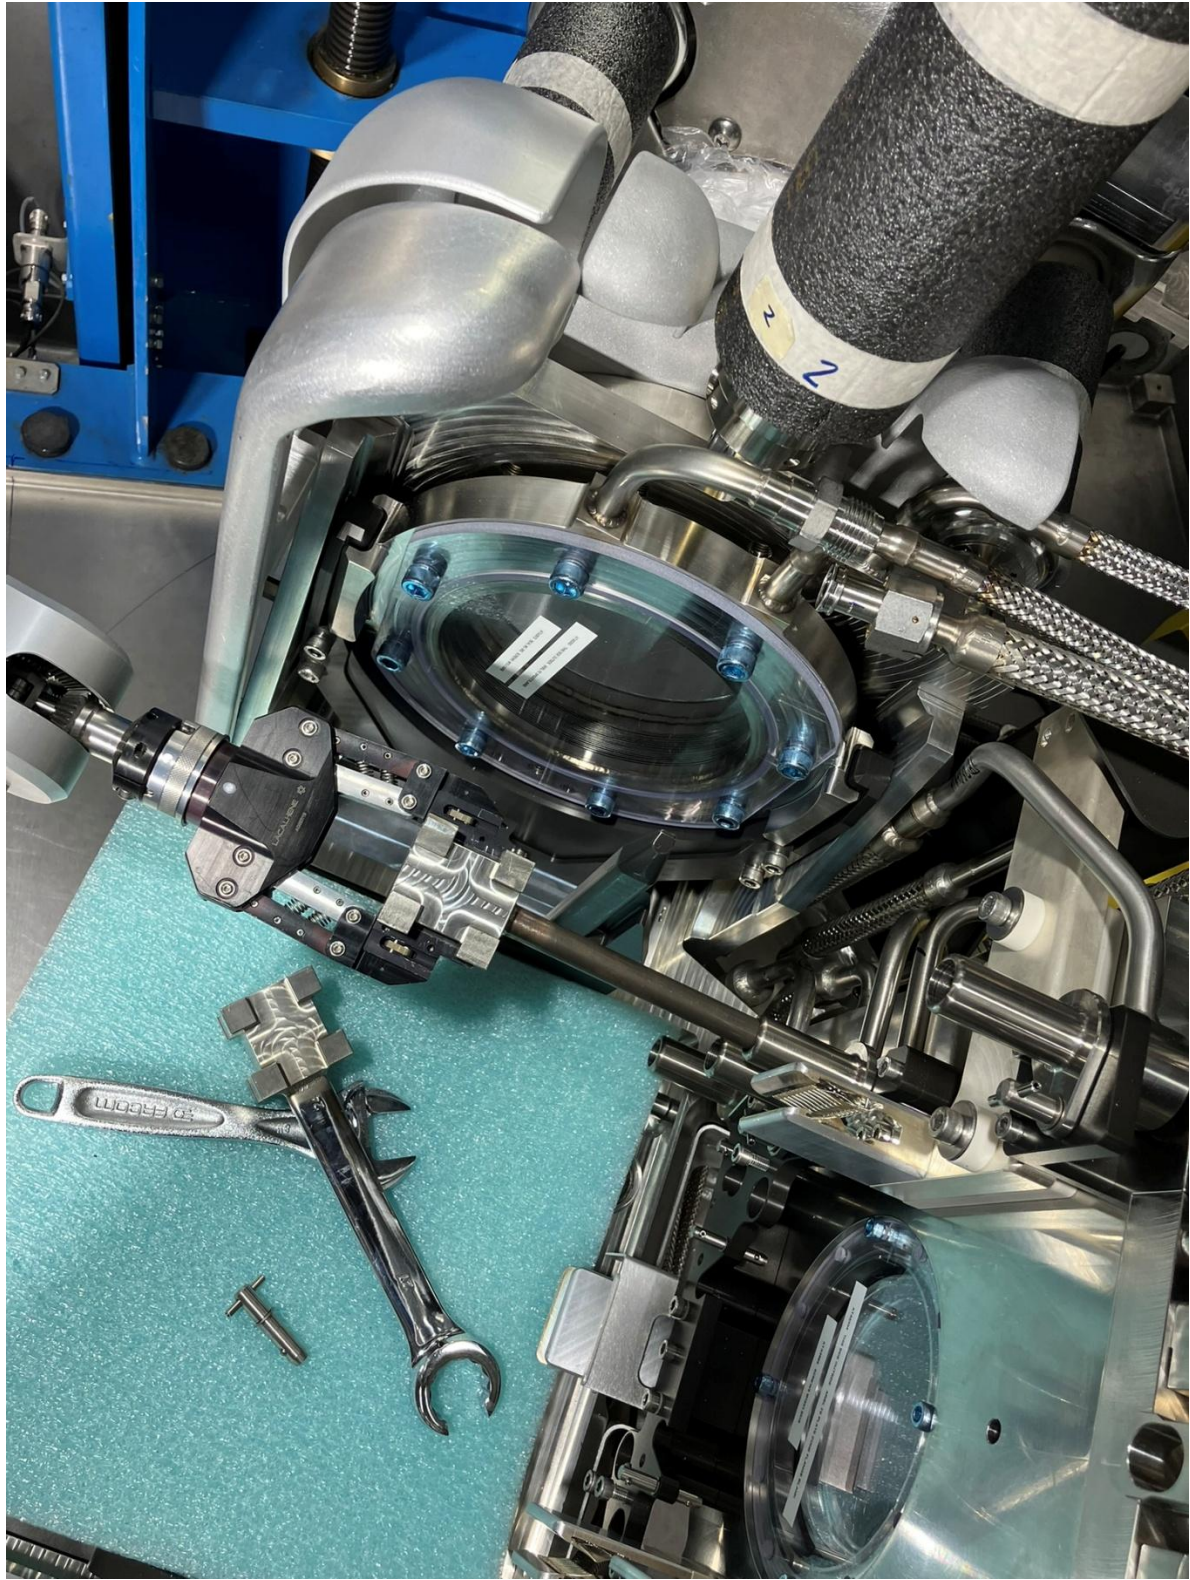
Use of pi detent tool to manipulate the water line without scratching the sealing face.

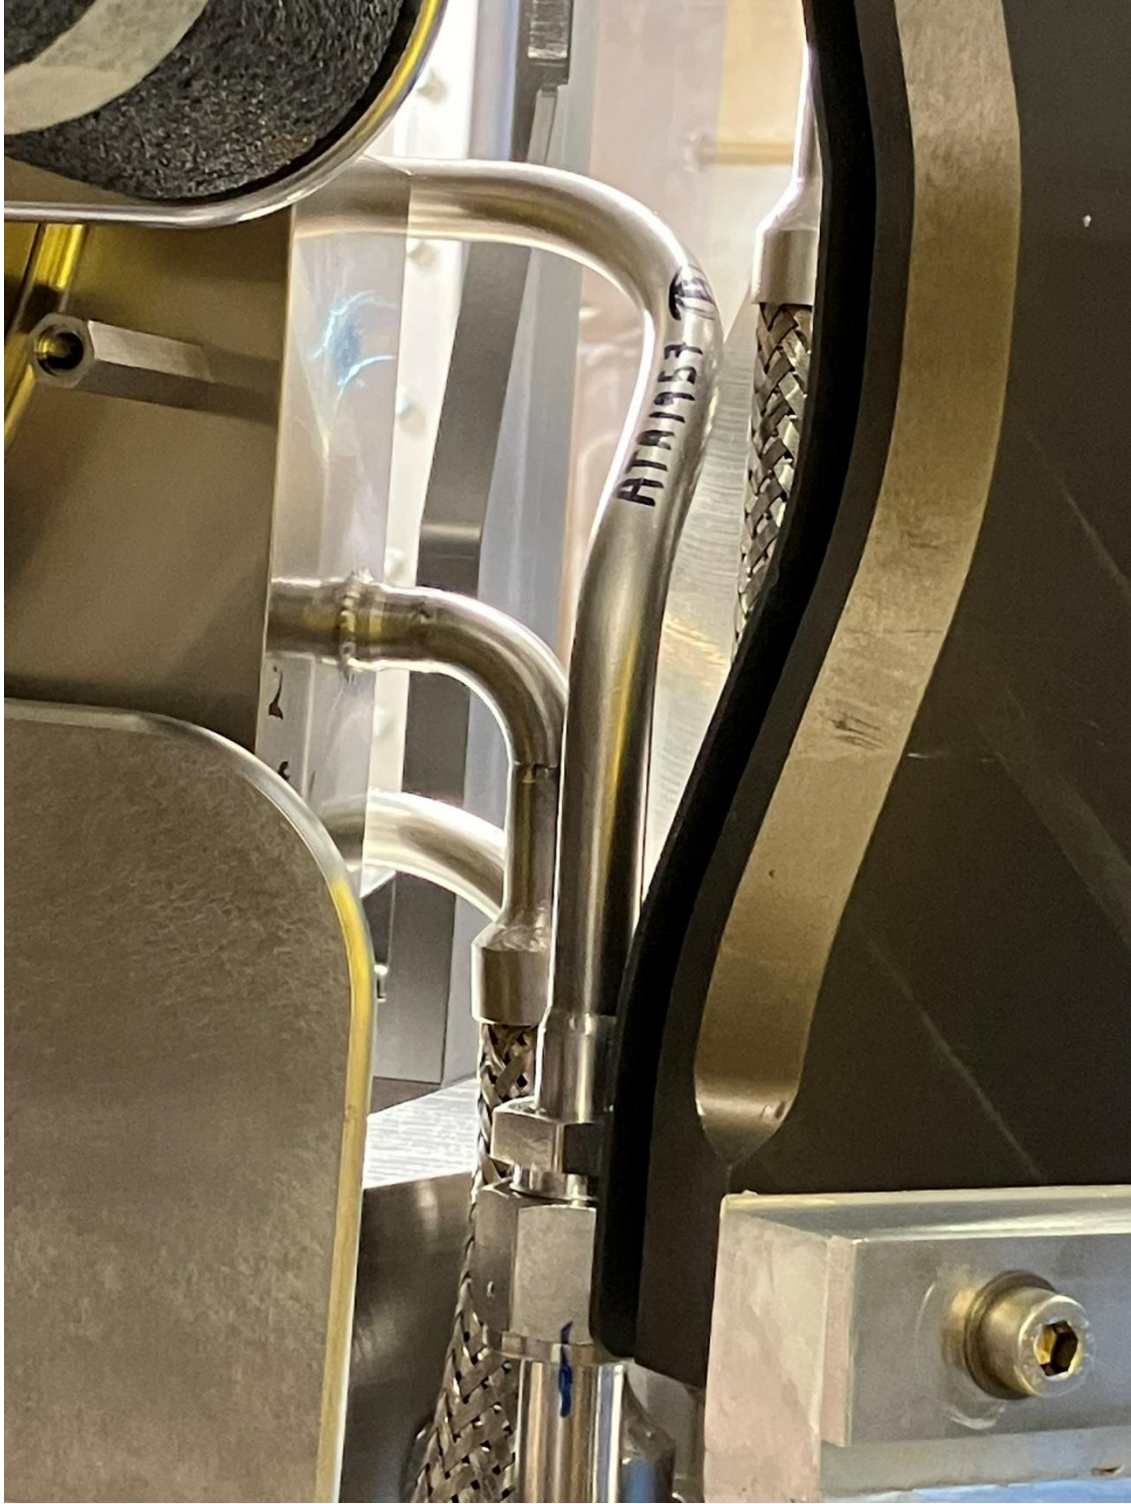
VCR nut obstructed by bus bar

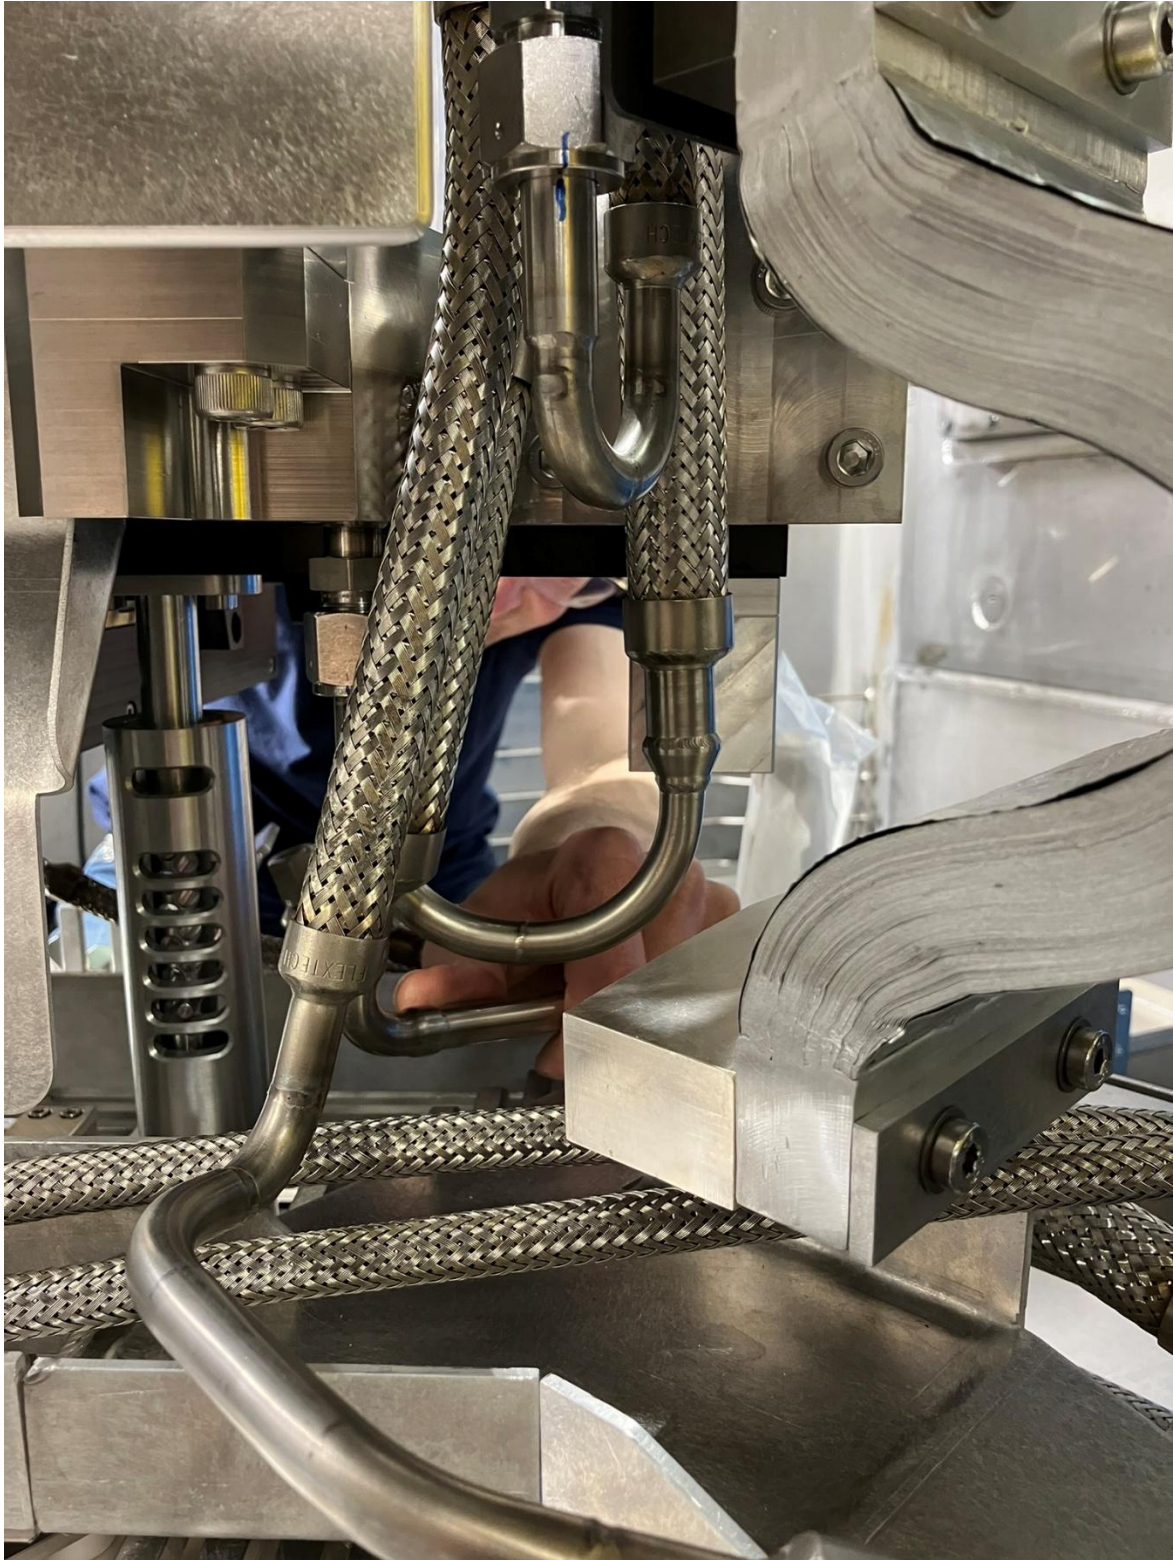
Deep VCR for top most line.

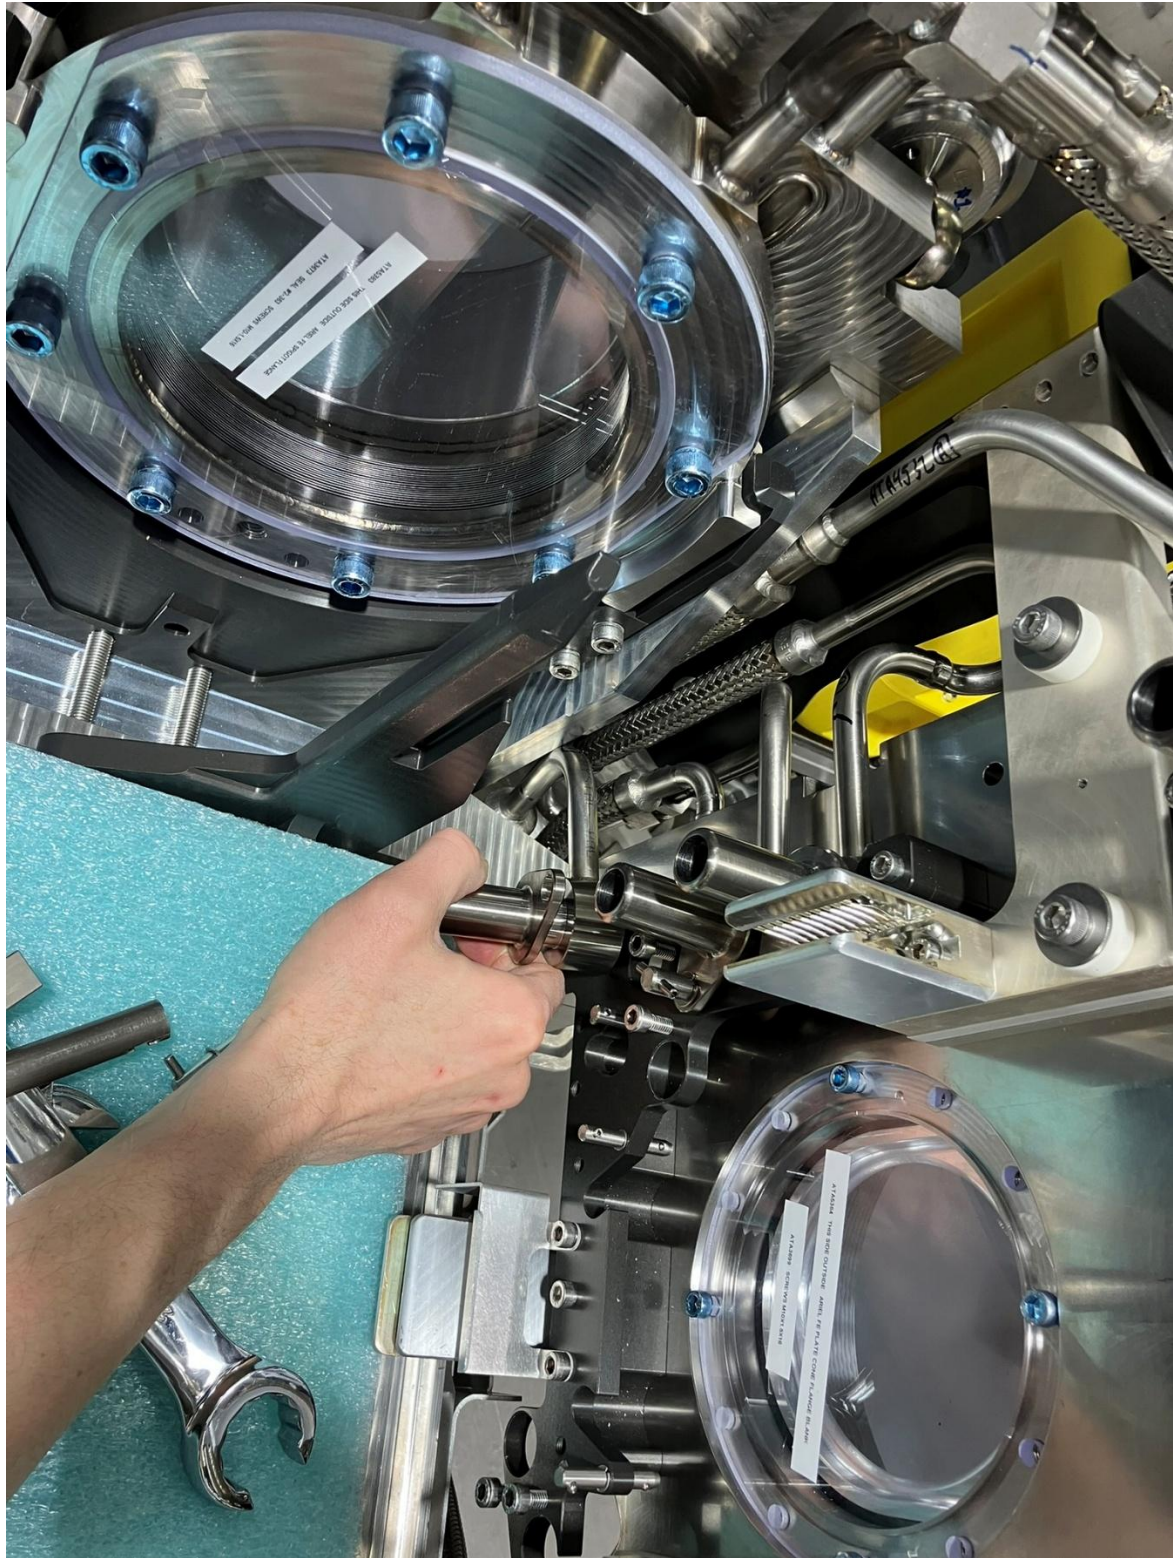
Bottom most line has interference with other lines when attempting to remove
