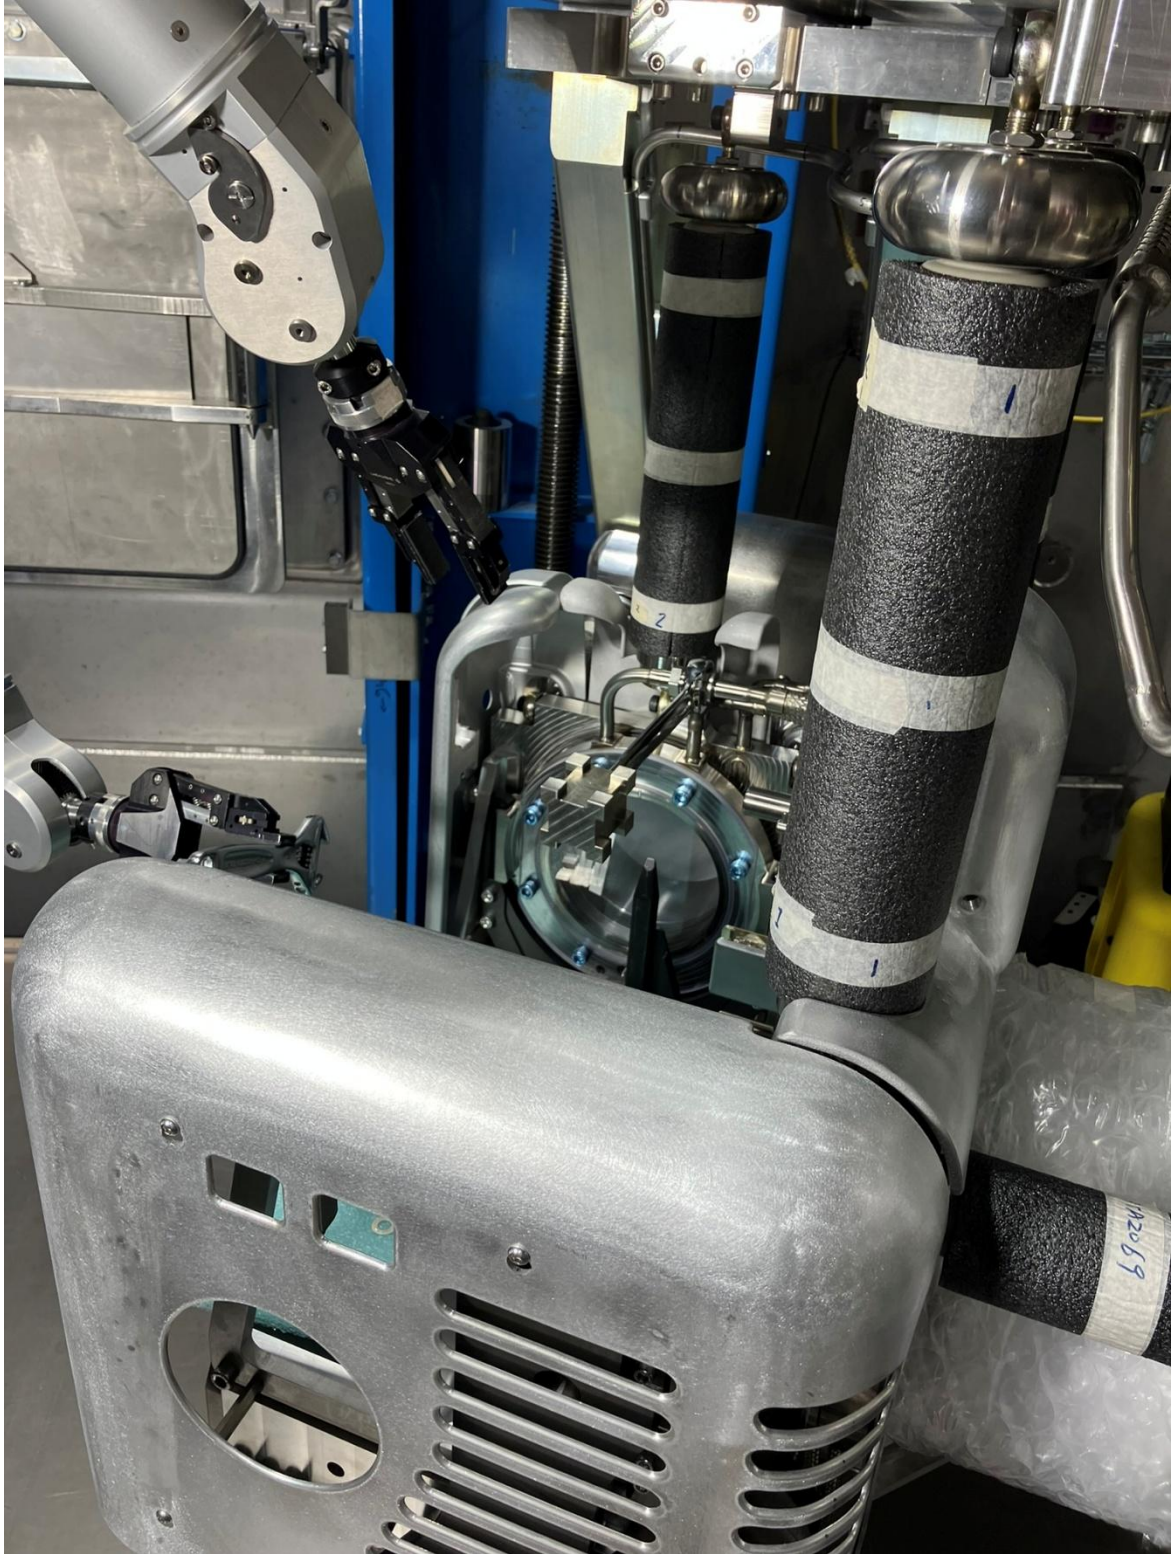
12-point closed wrench on VCR nut.

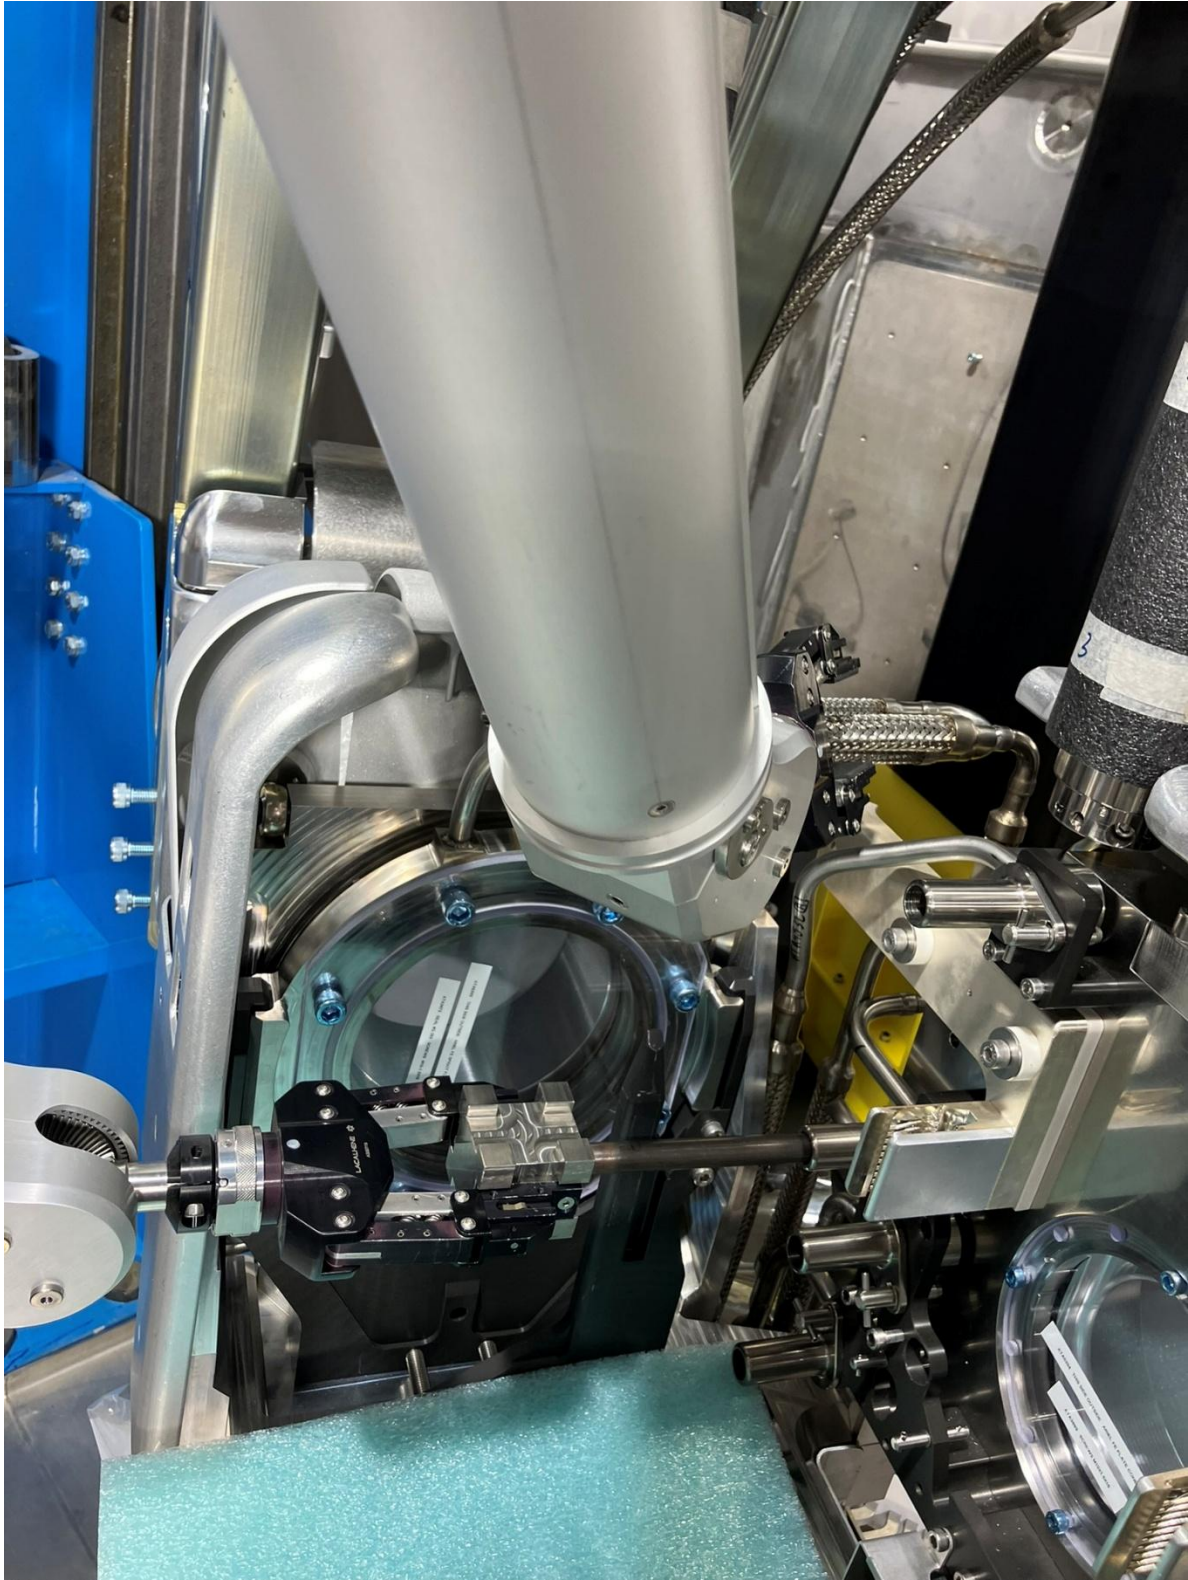
Pin tool interfering with HTV post when using for the second to top line.

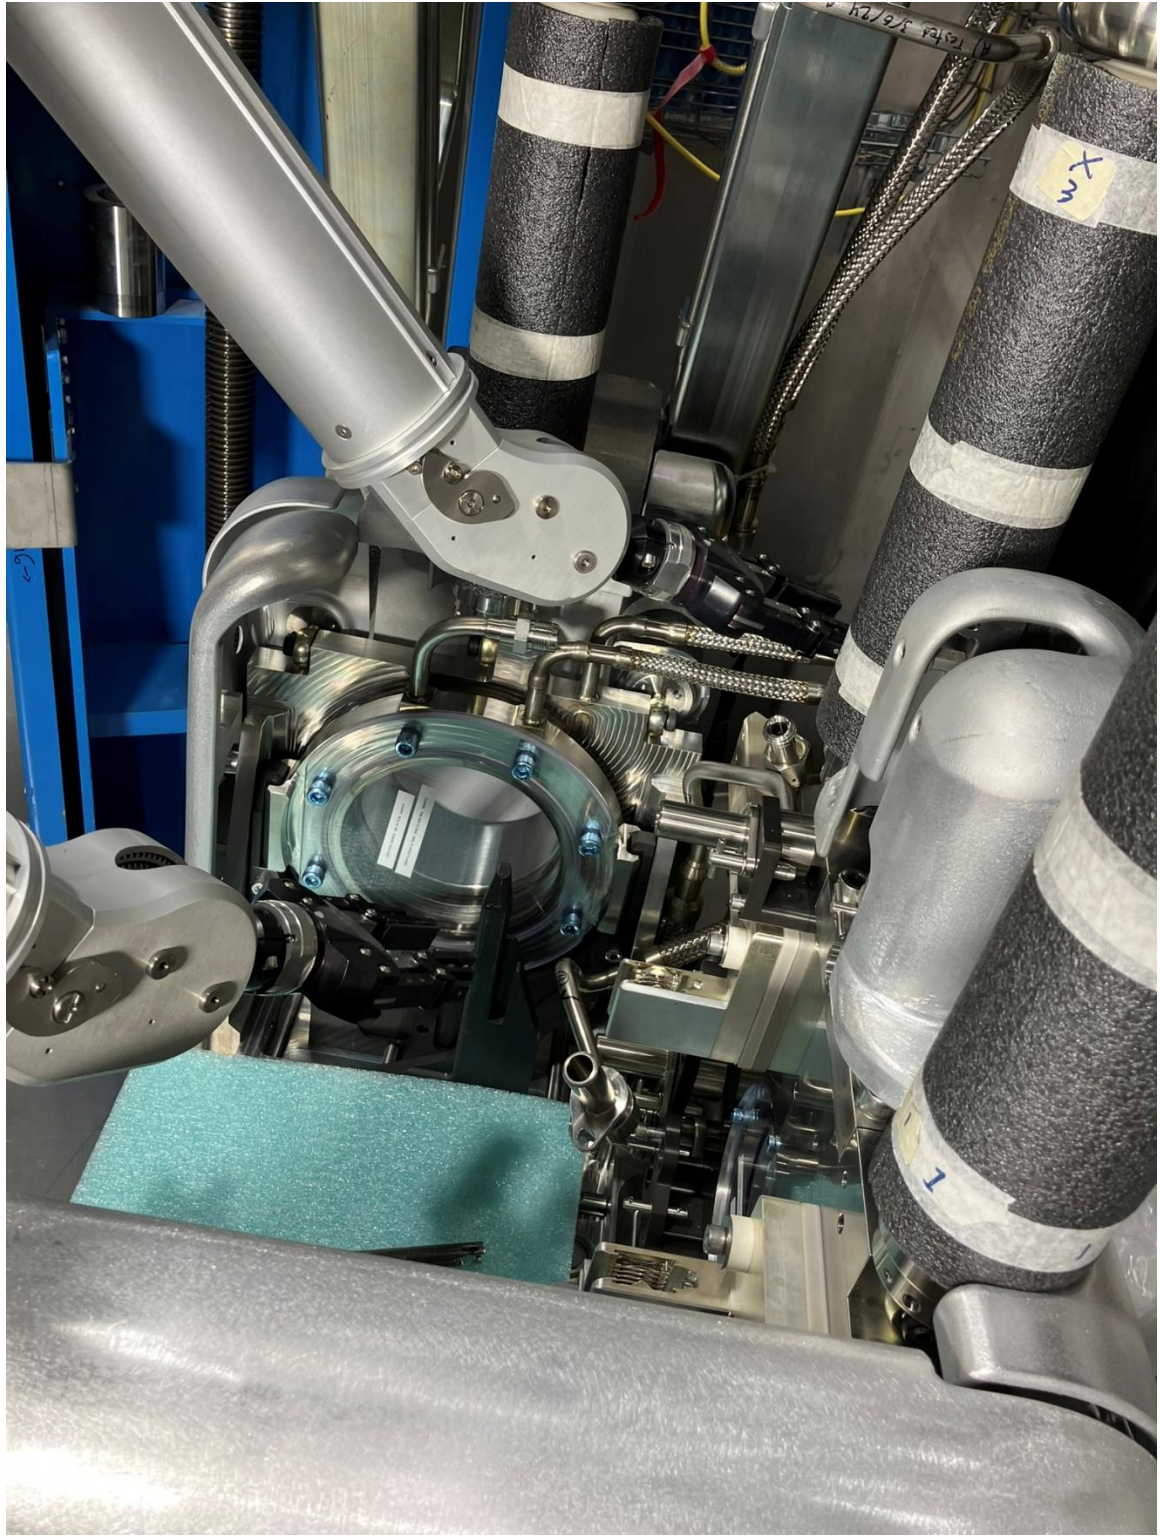
Second to top line being removed

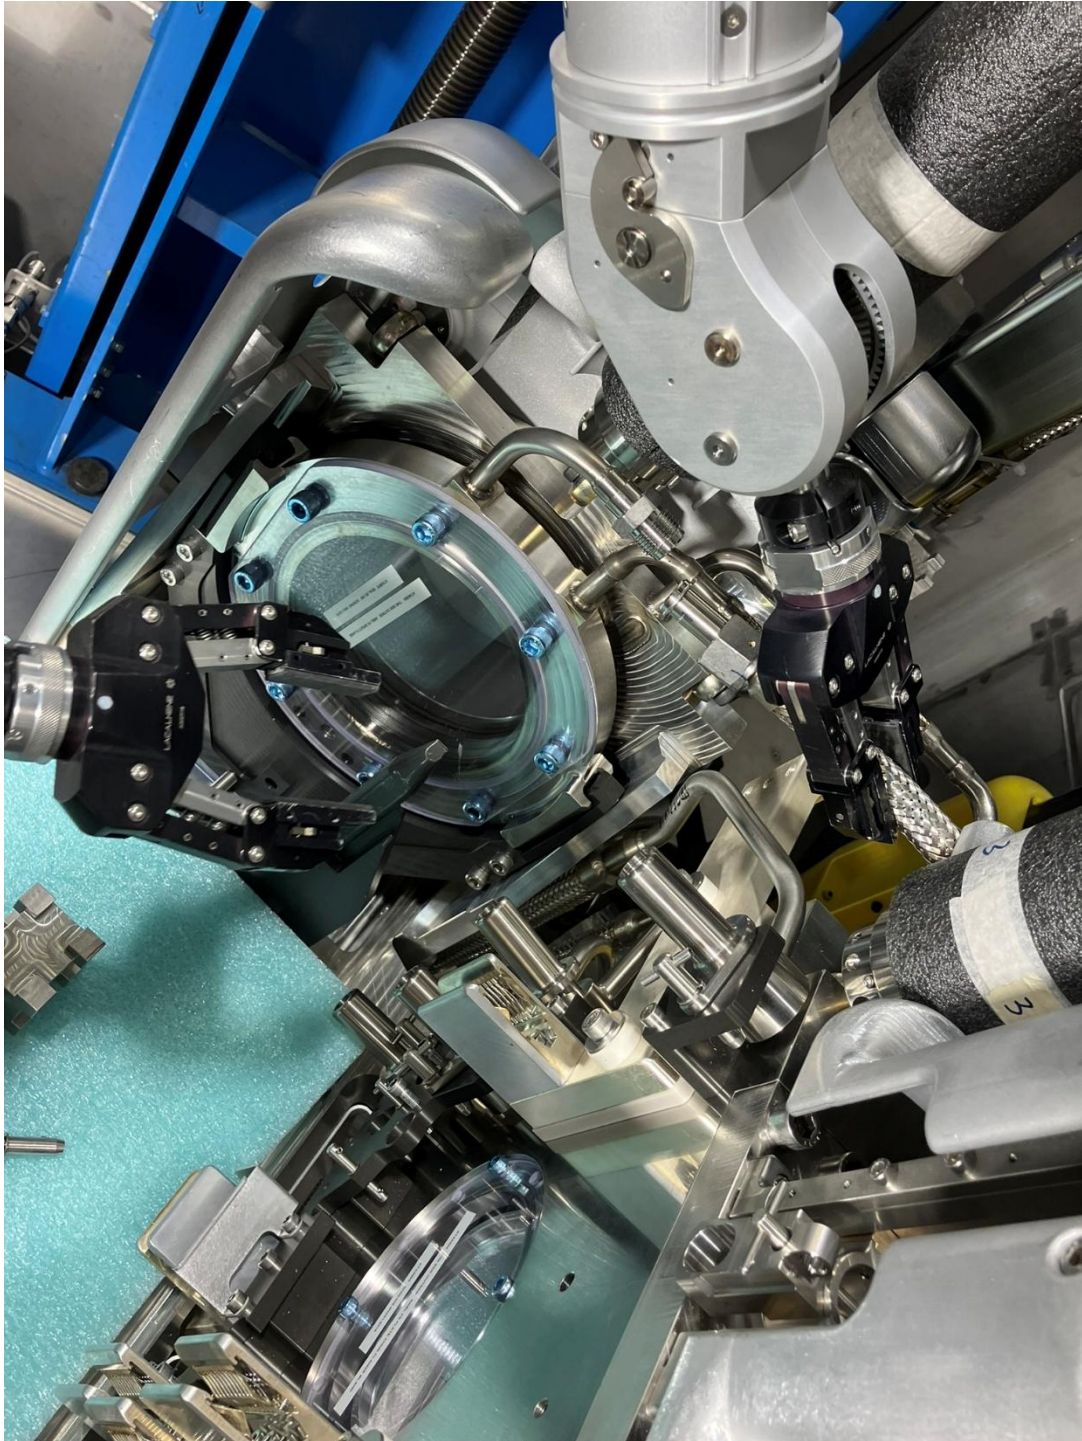
Second to top line returned in place.

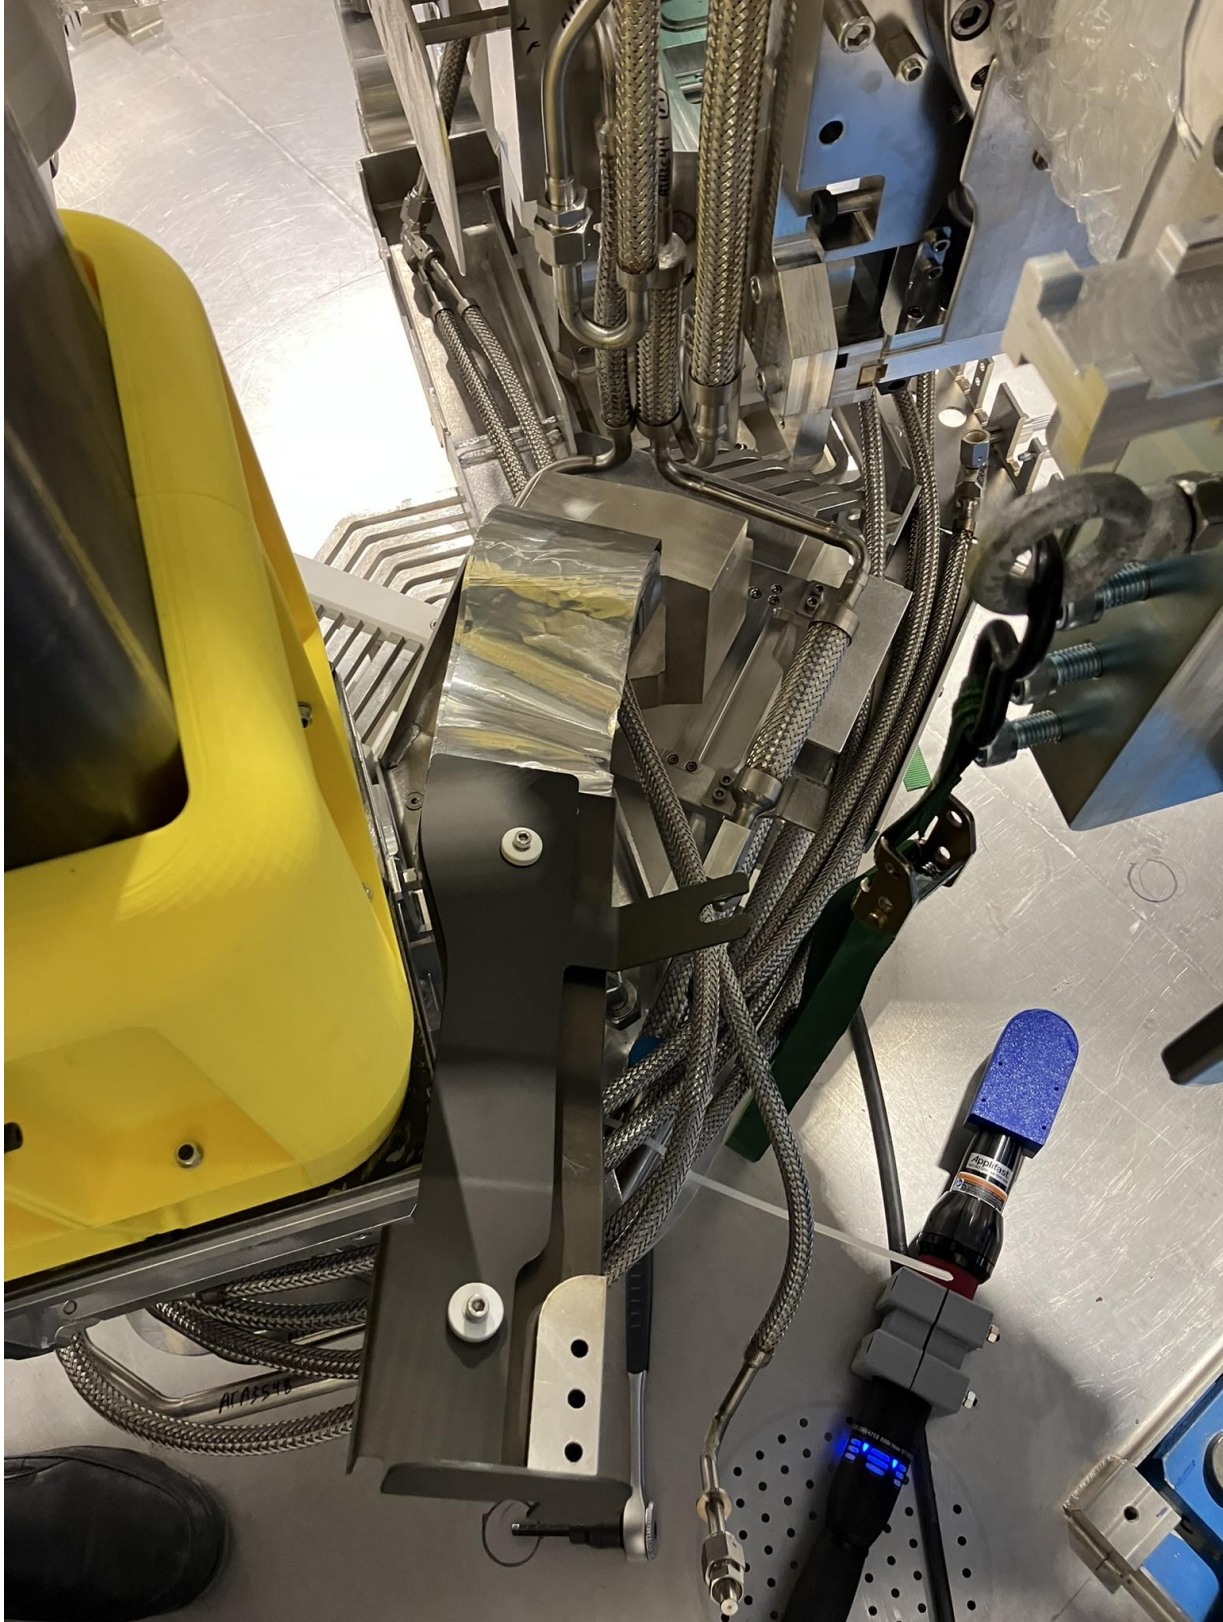
Rear bus bar removed

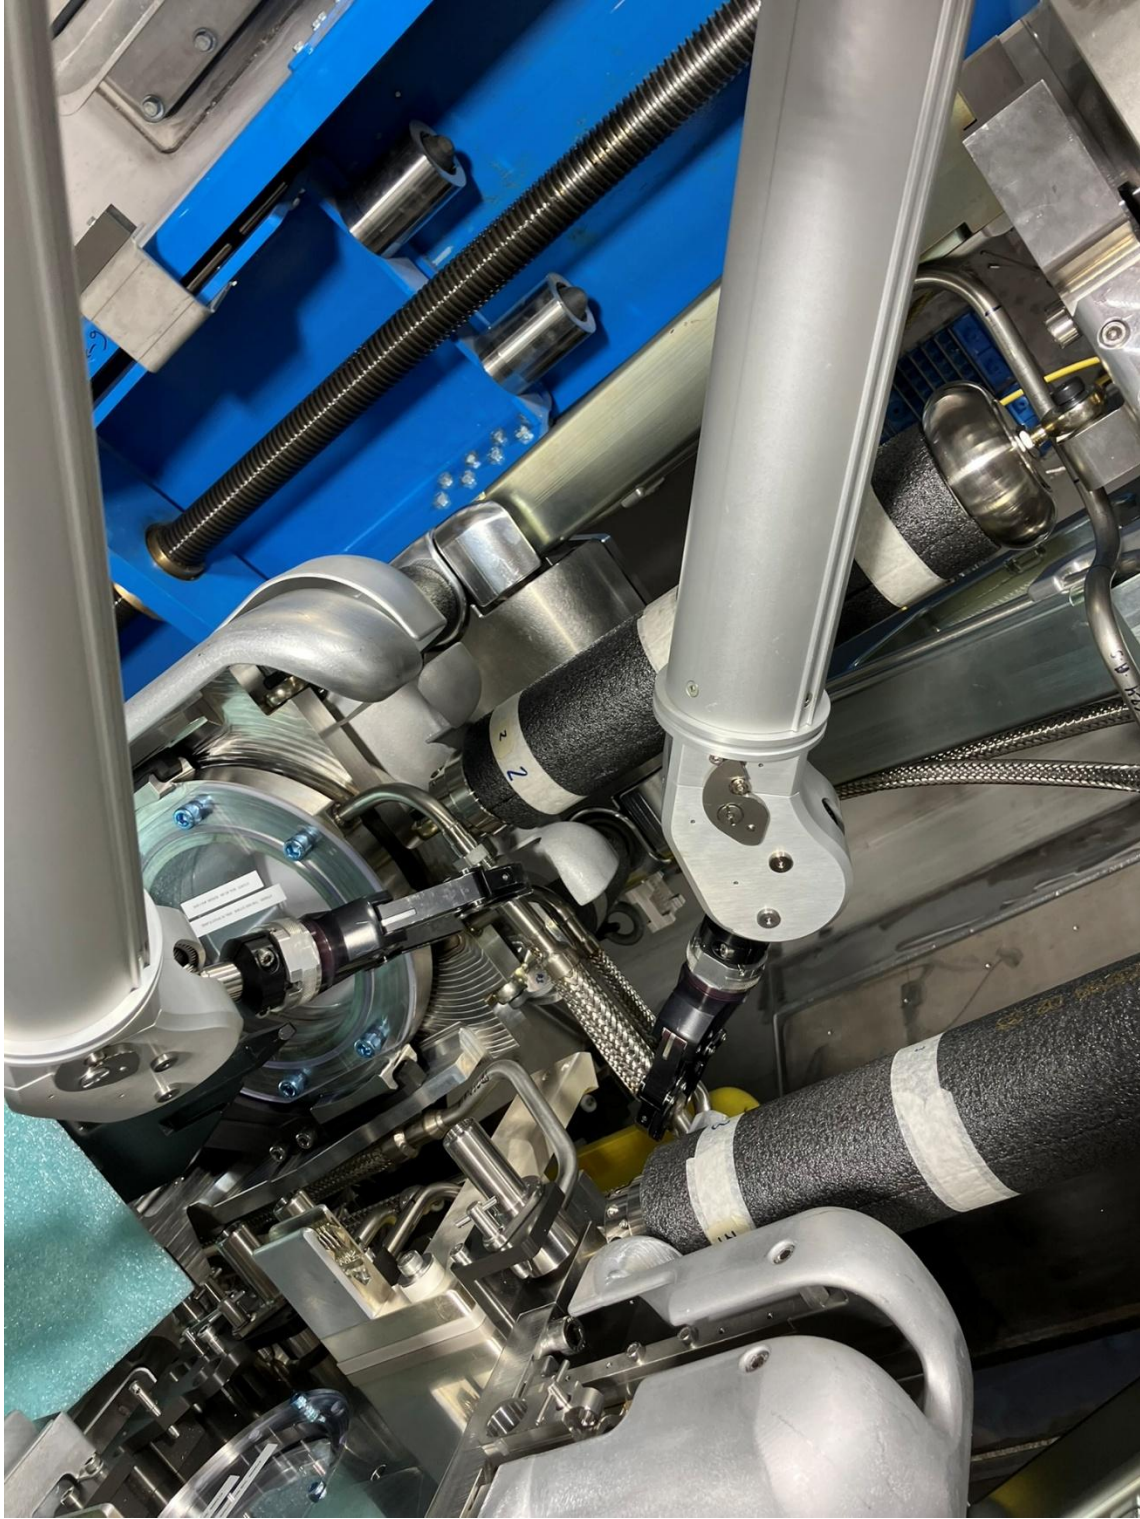
Starting VCR joint on second to top line with difficulty

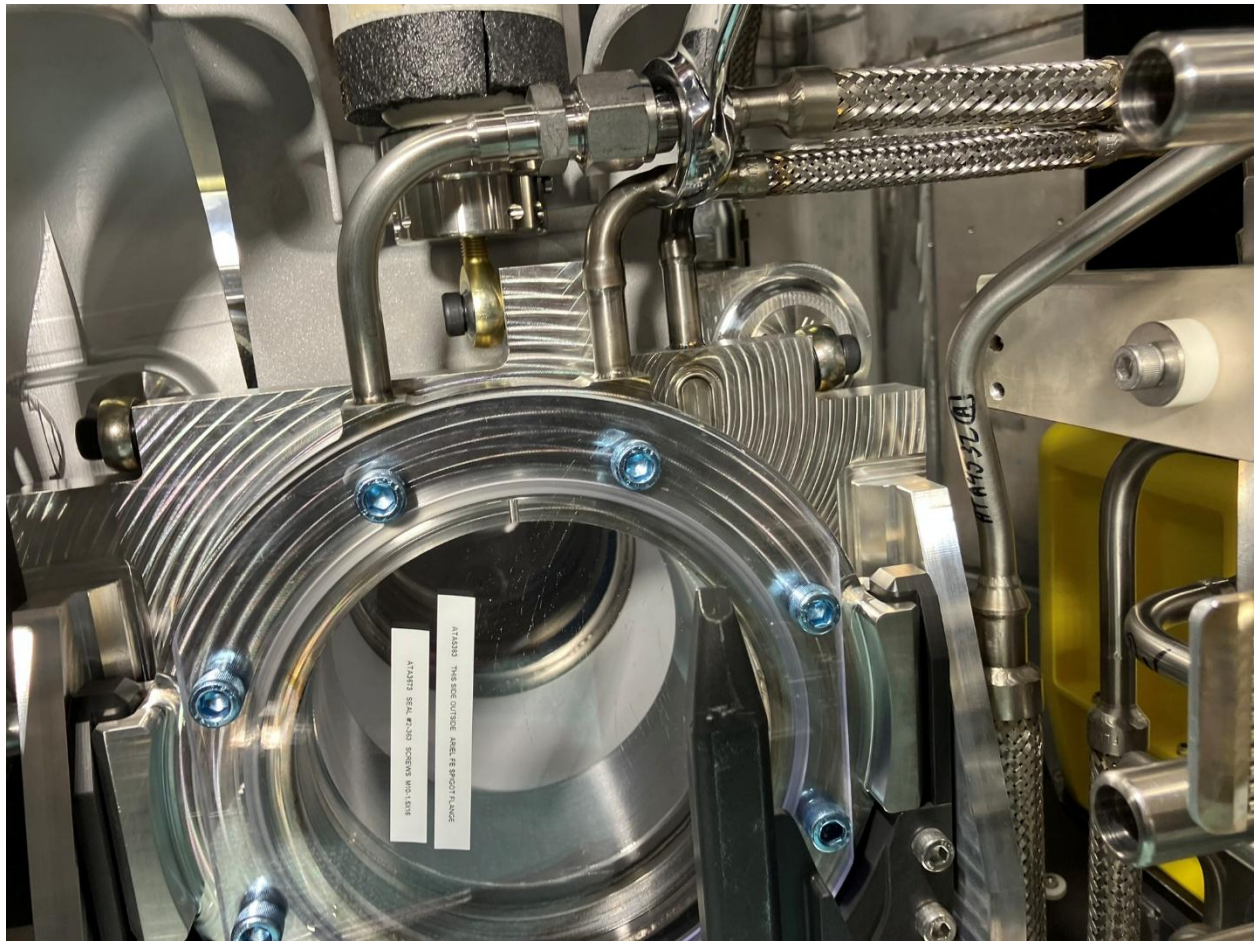
Wrench interference with adjacent line in second to top line's VCR joint

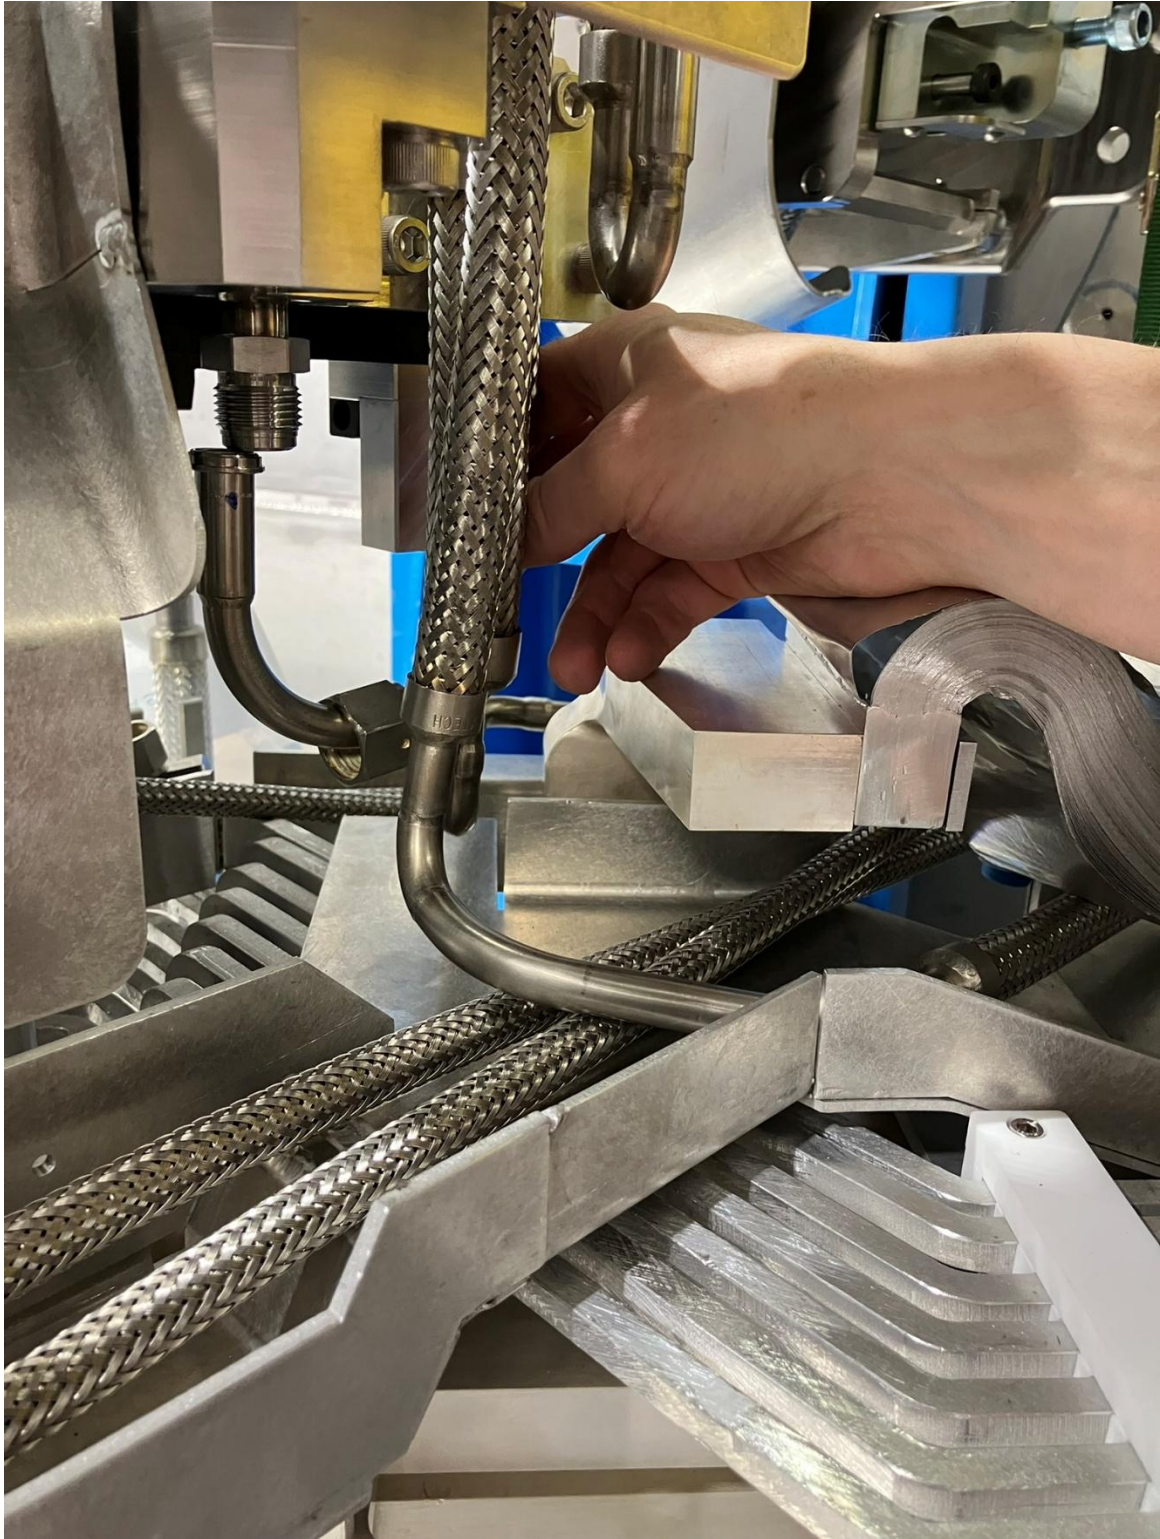
Nut falling in top line's VCR joint 'U' bend.

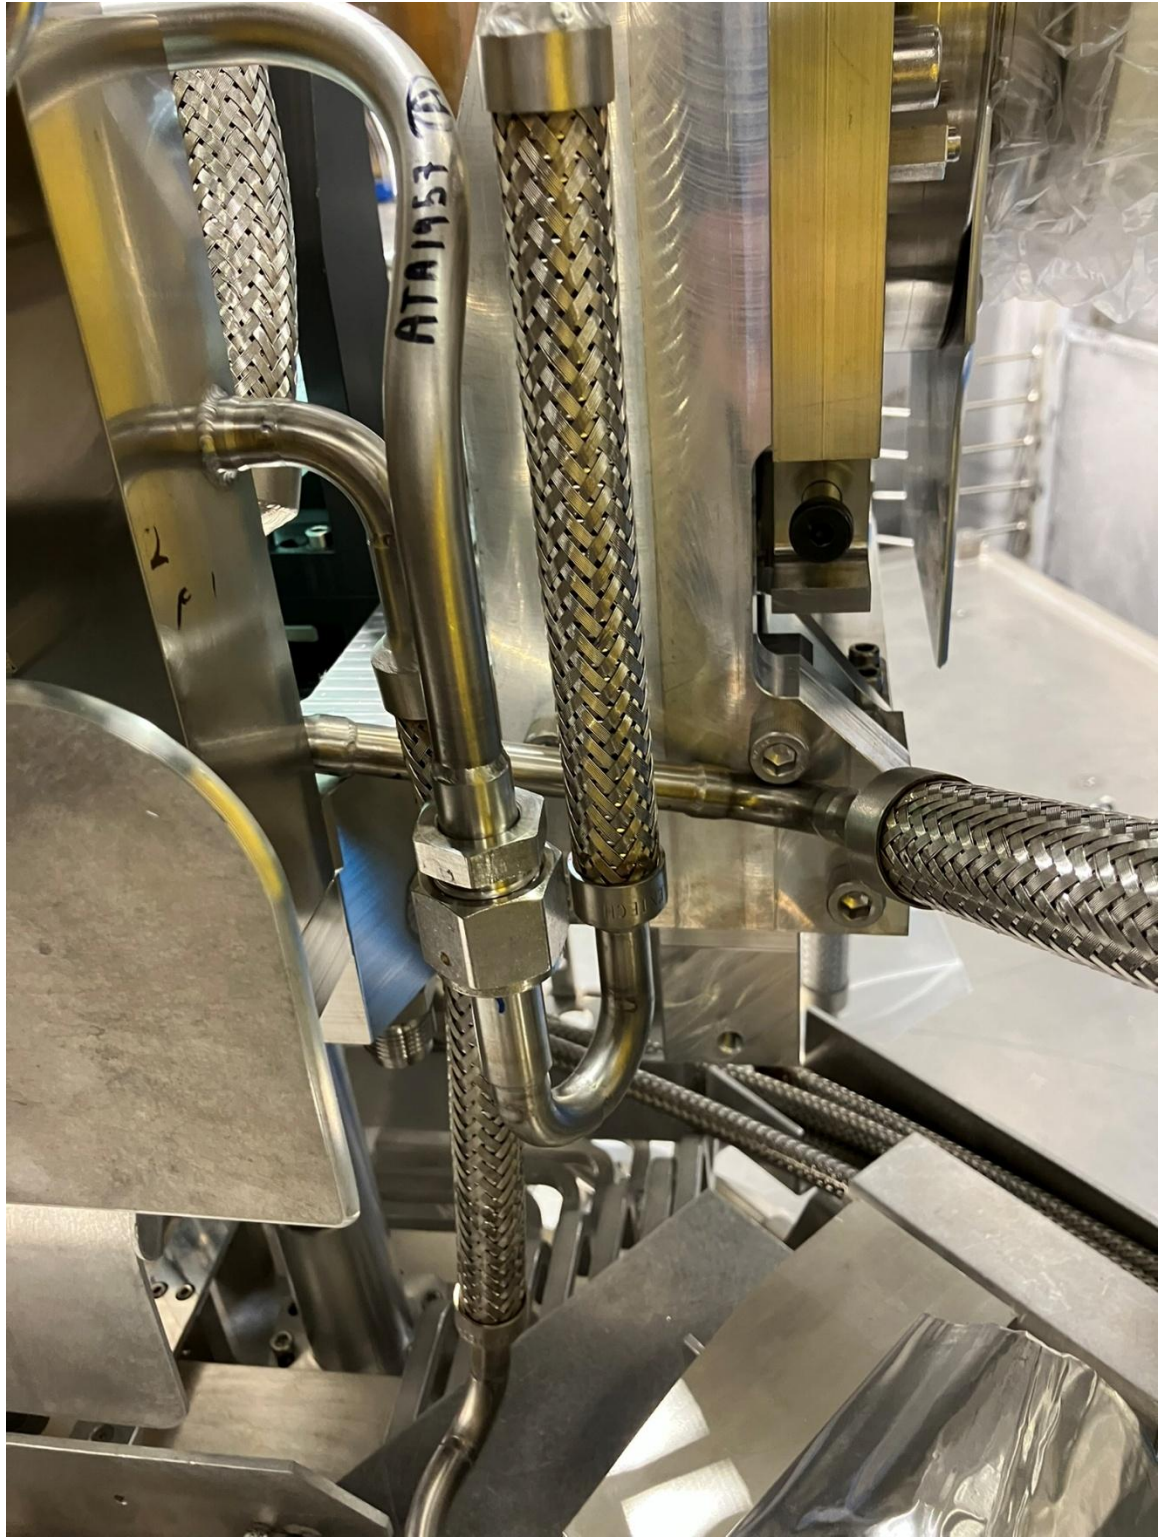
Bottom line catching on screws when returned/removed.
