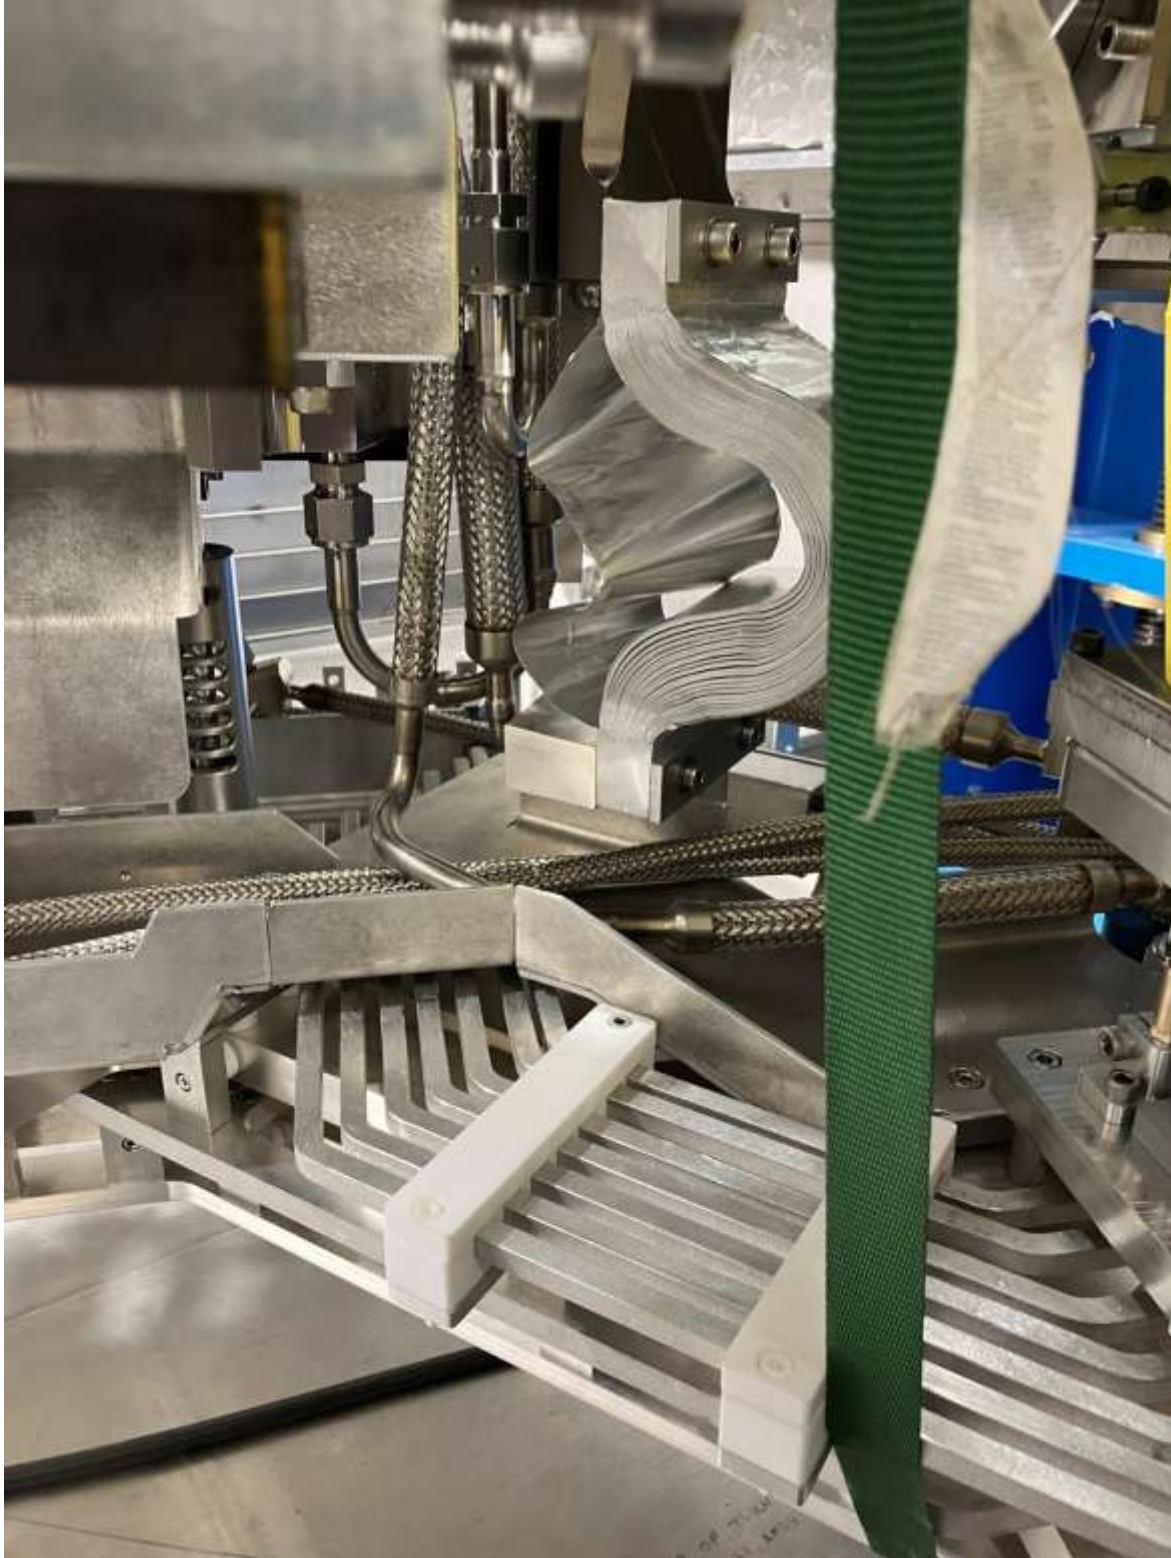
Flexible aluminum sheet conductor was found like this after manually returning the busbar (in person). In the future, we should keep in mind to check this and 'tidy' it if needed.

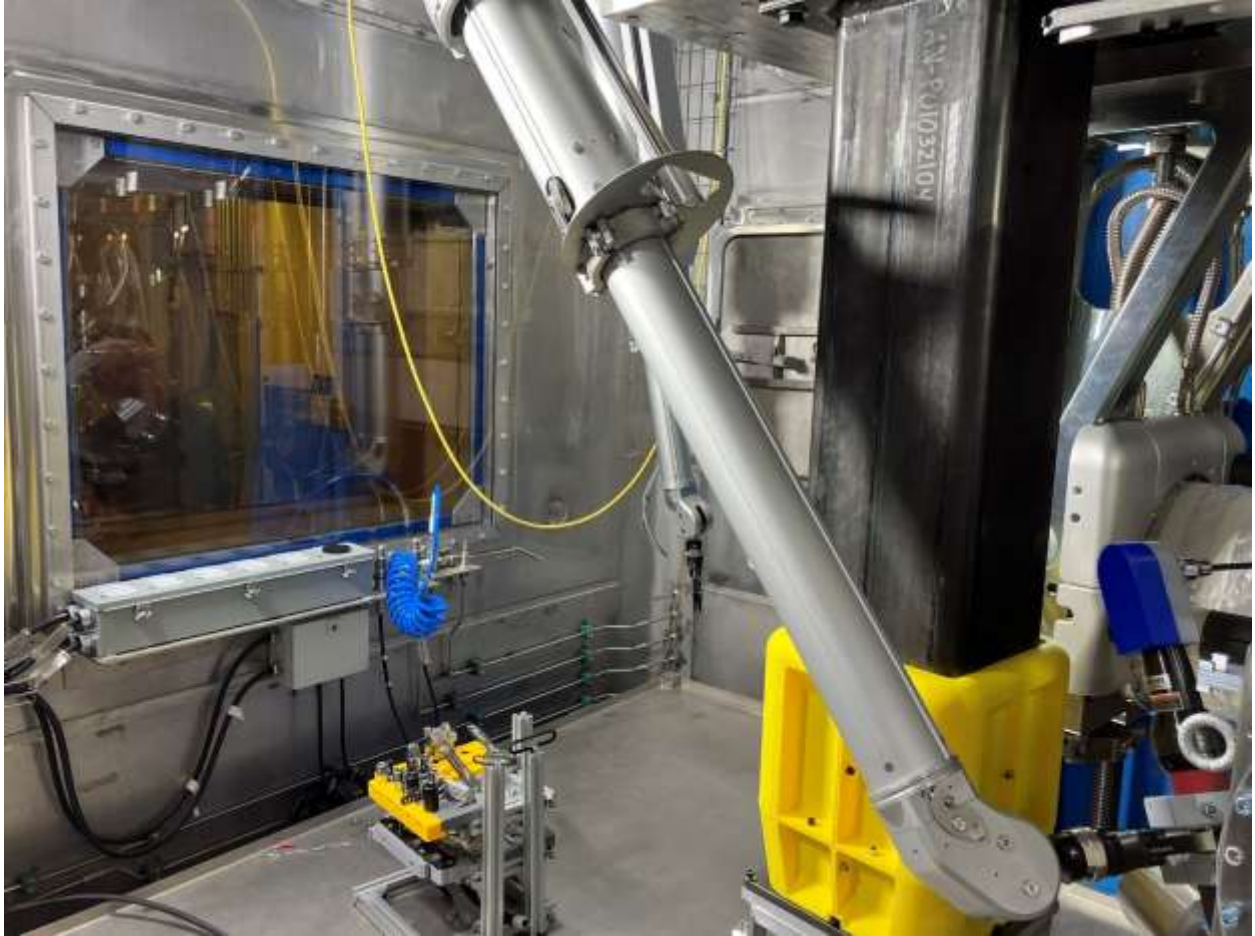
Accessing top three screws on busbar

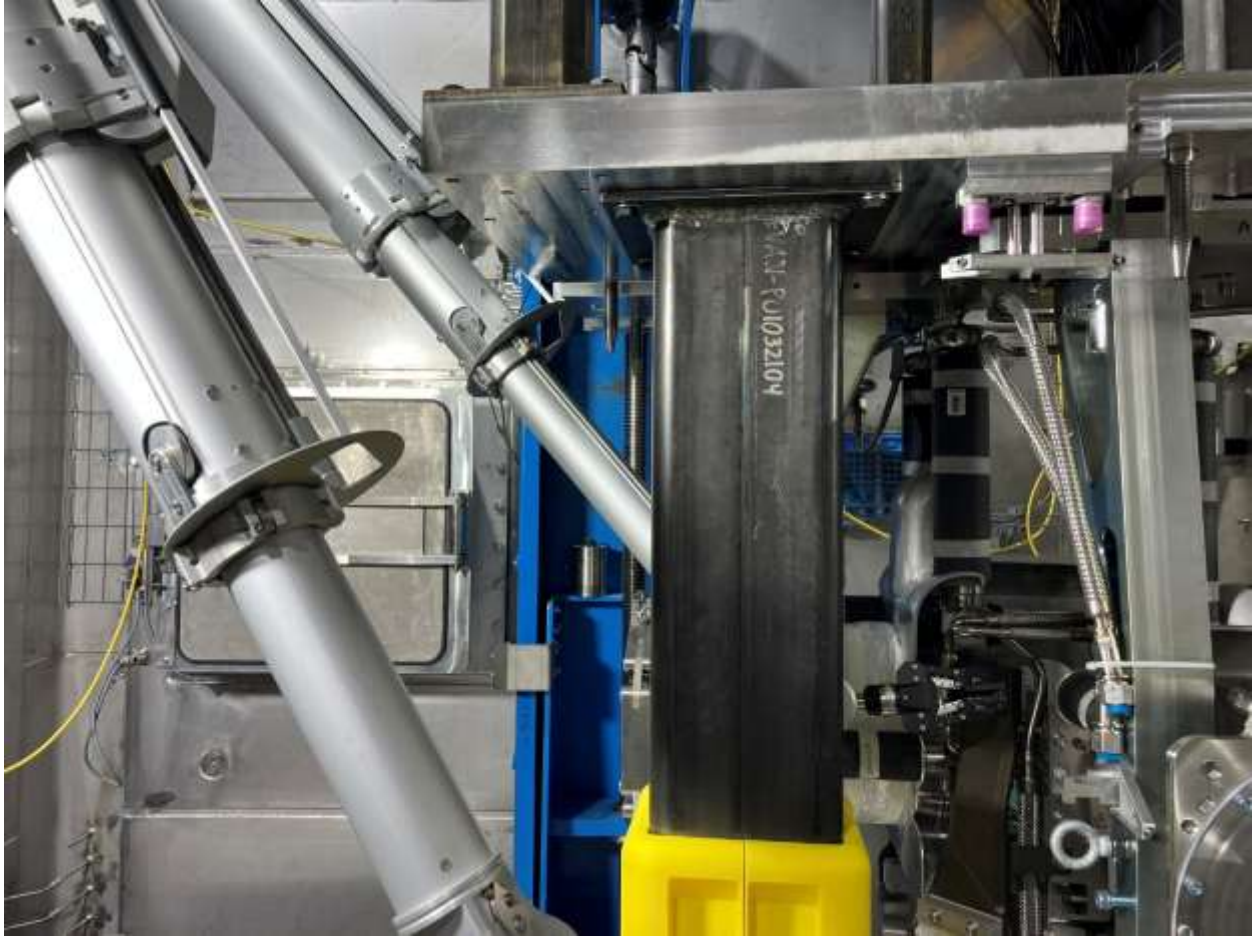
Second manipulator coming in to retrieve busbar screw, minor interference with shielding at the top.

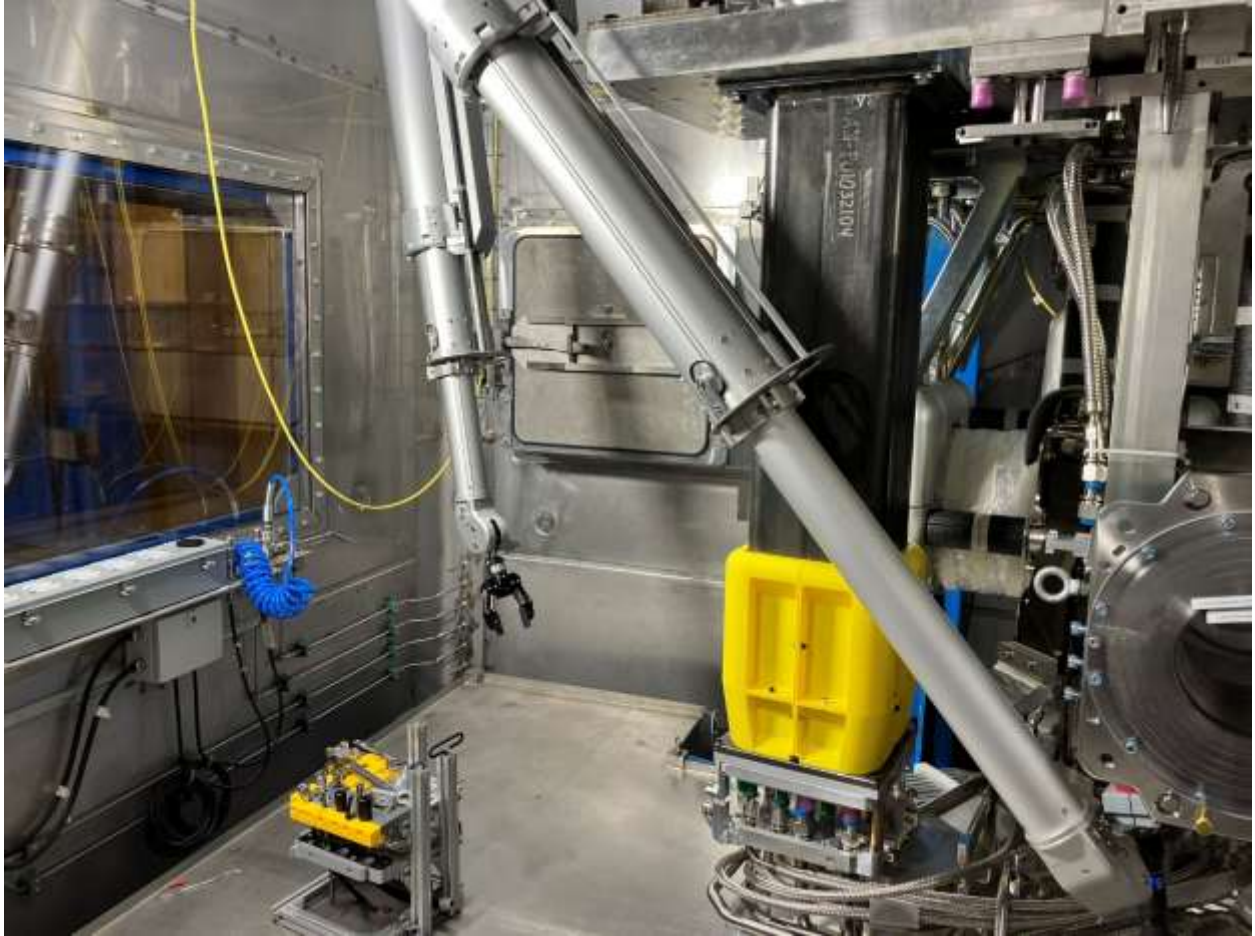
Attempting to reach big screw for the busbar sheet, some interference between manipulator shaft and shielding above

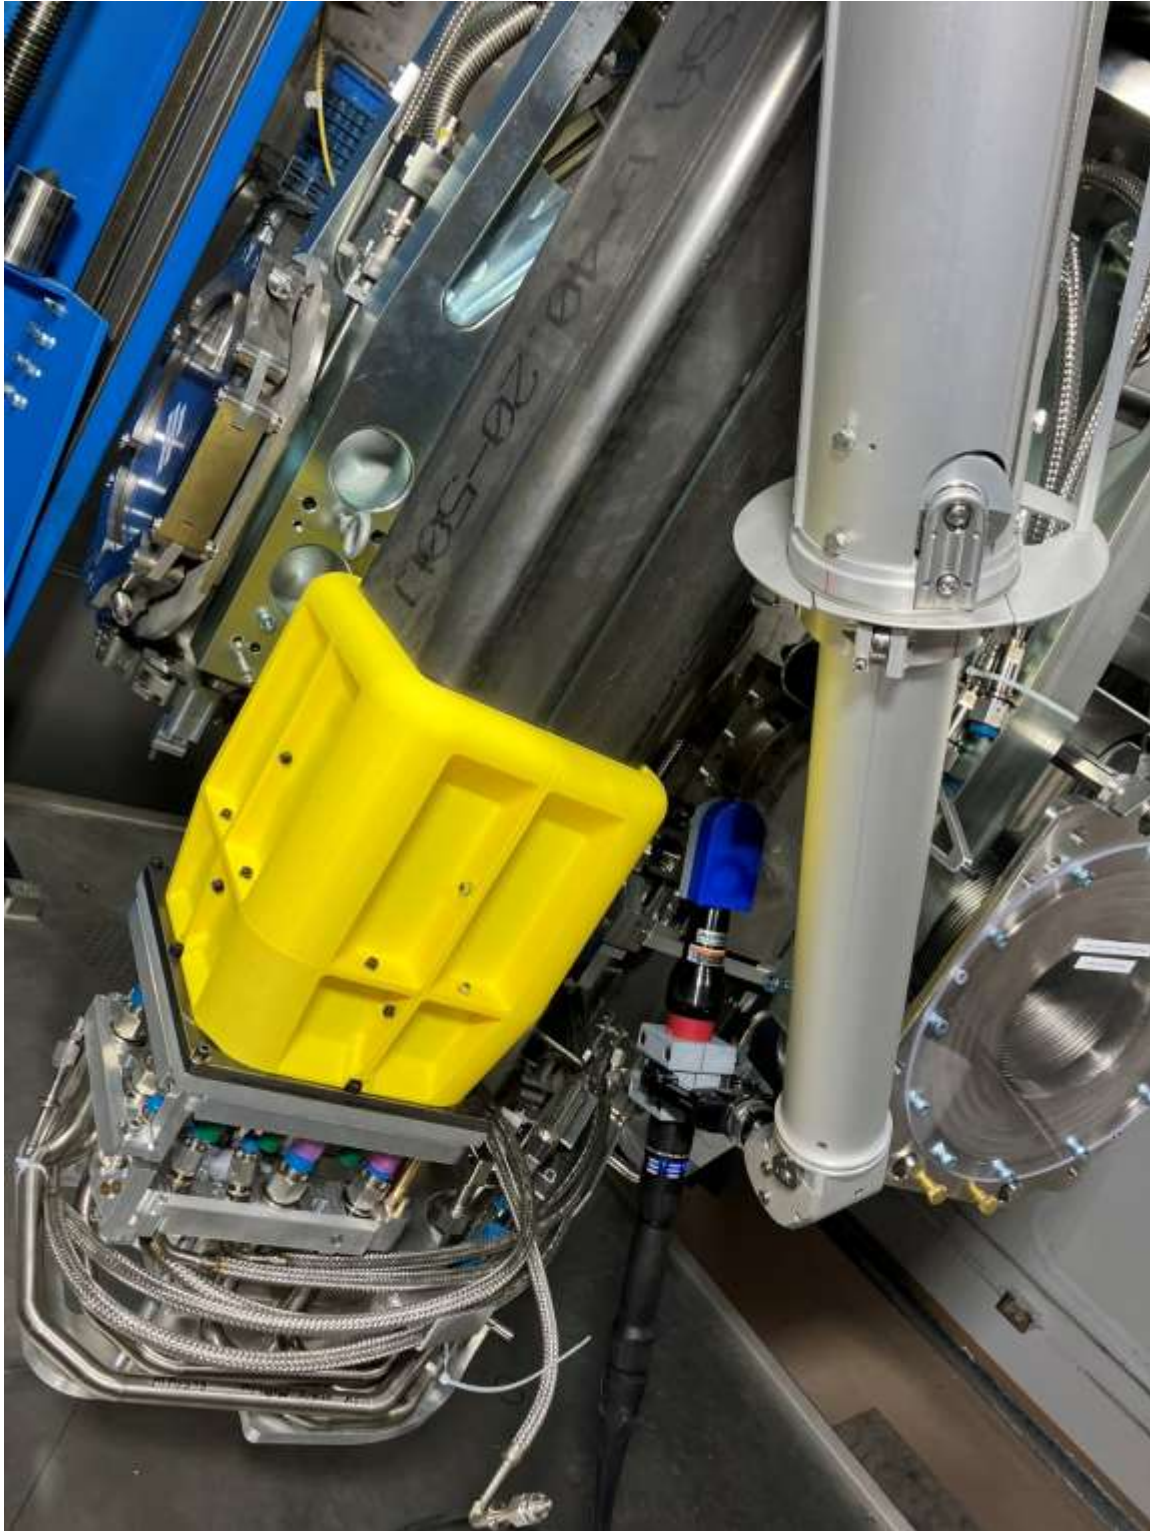
Difficulty getting torque tool to access big screw due to clearance limitations

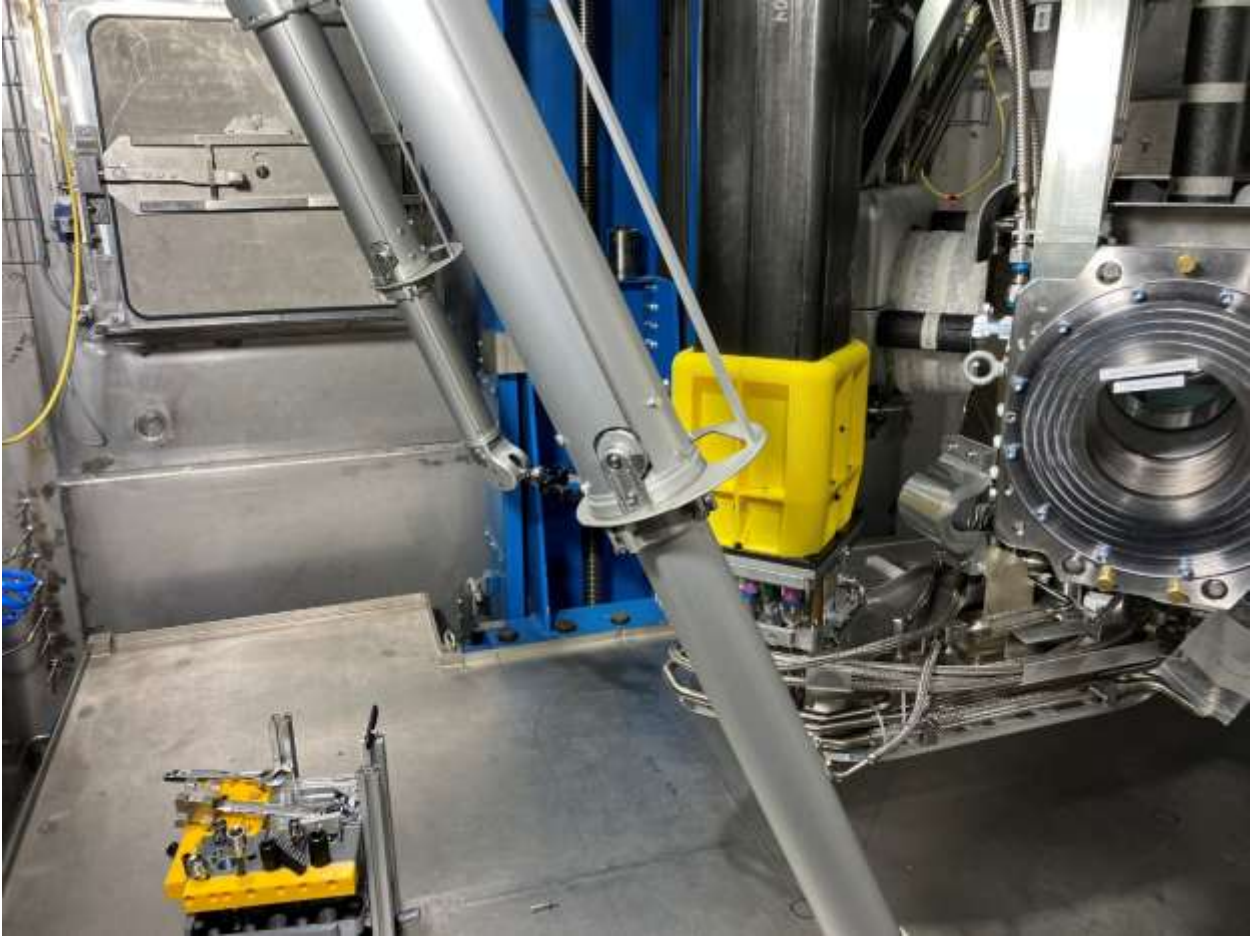
FE rotated to get a better view of the big screw

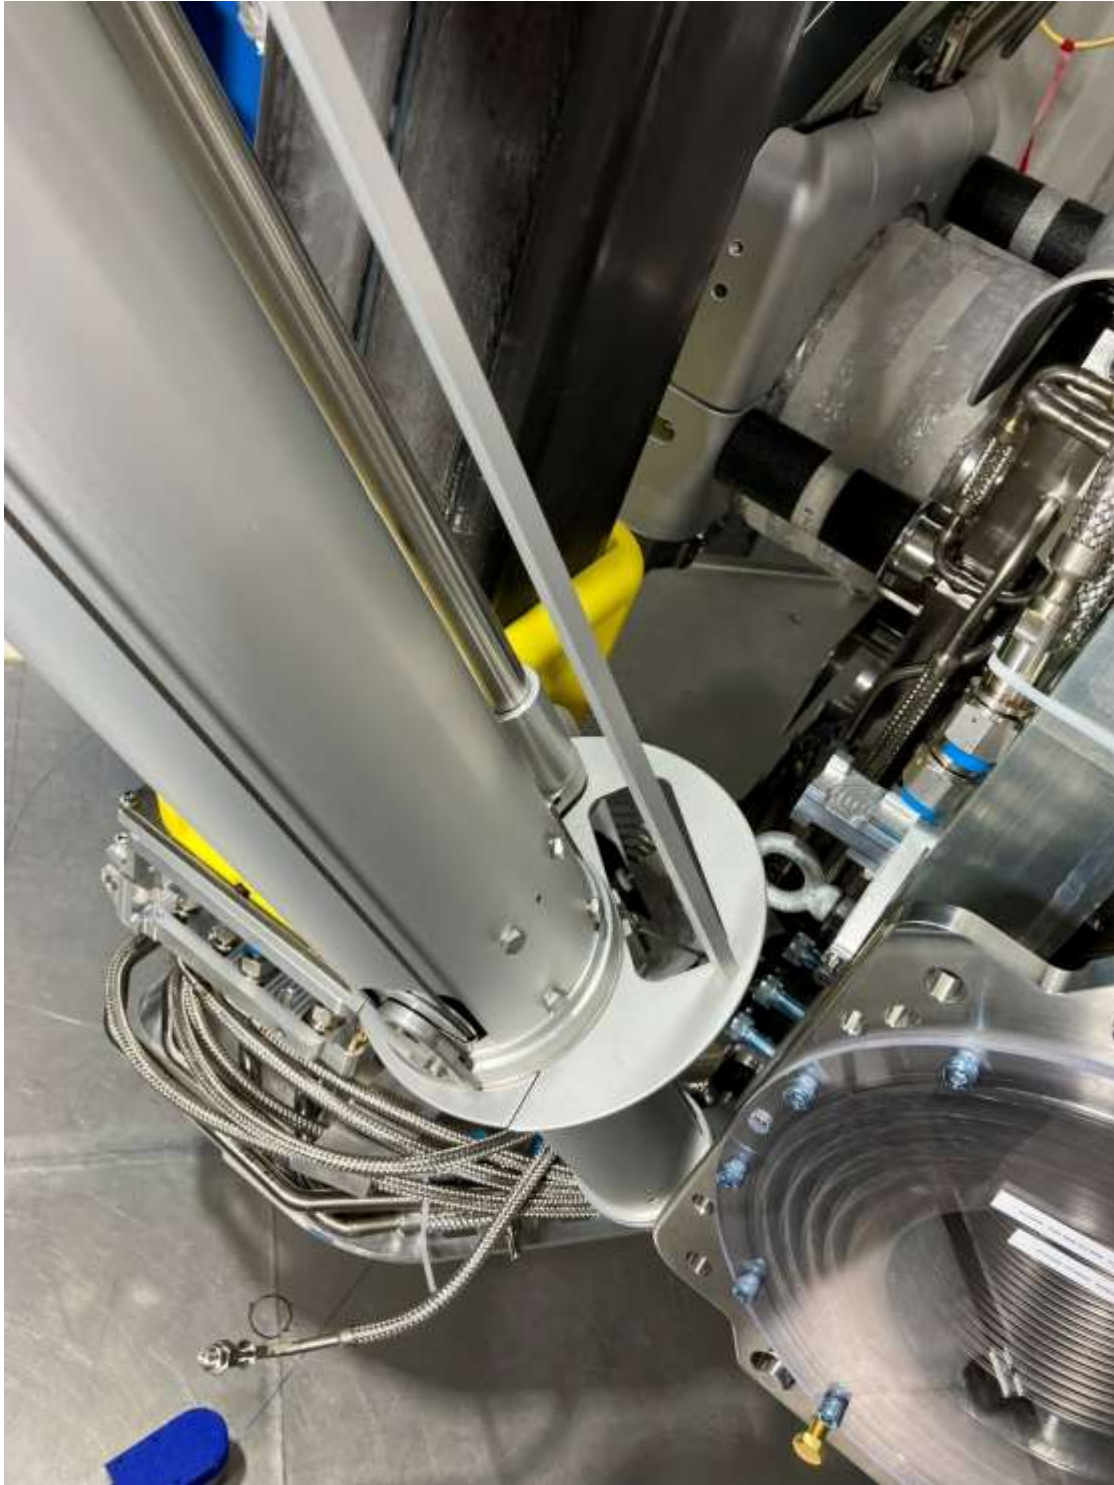
Manipulator arm interference with polished plate assembly

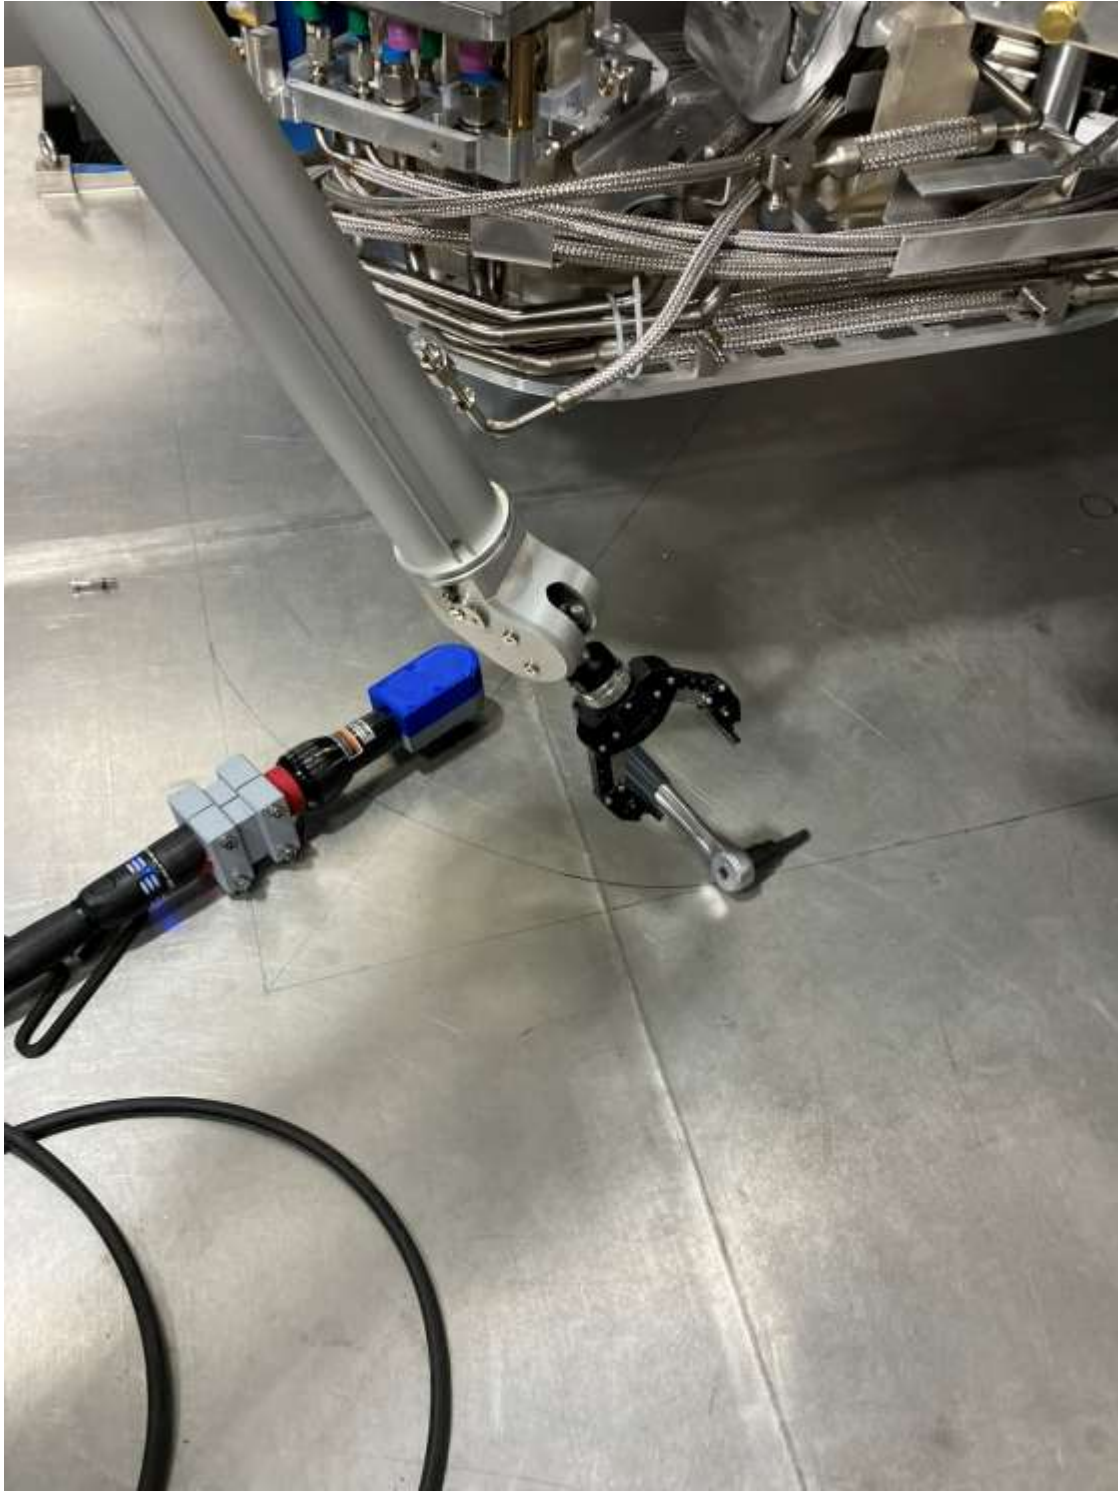
Using ratchet successfully 'loosened' big screw.

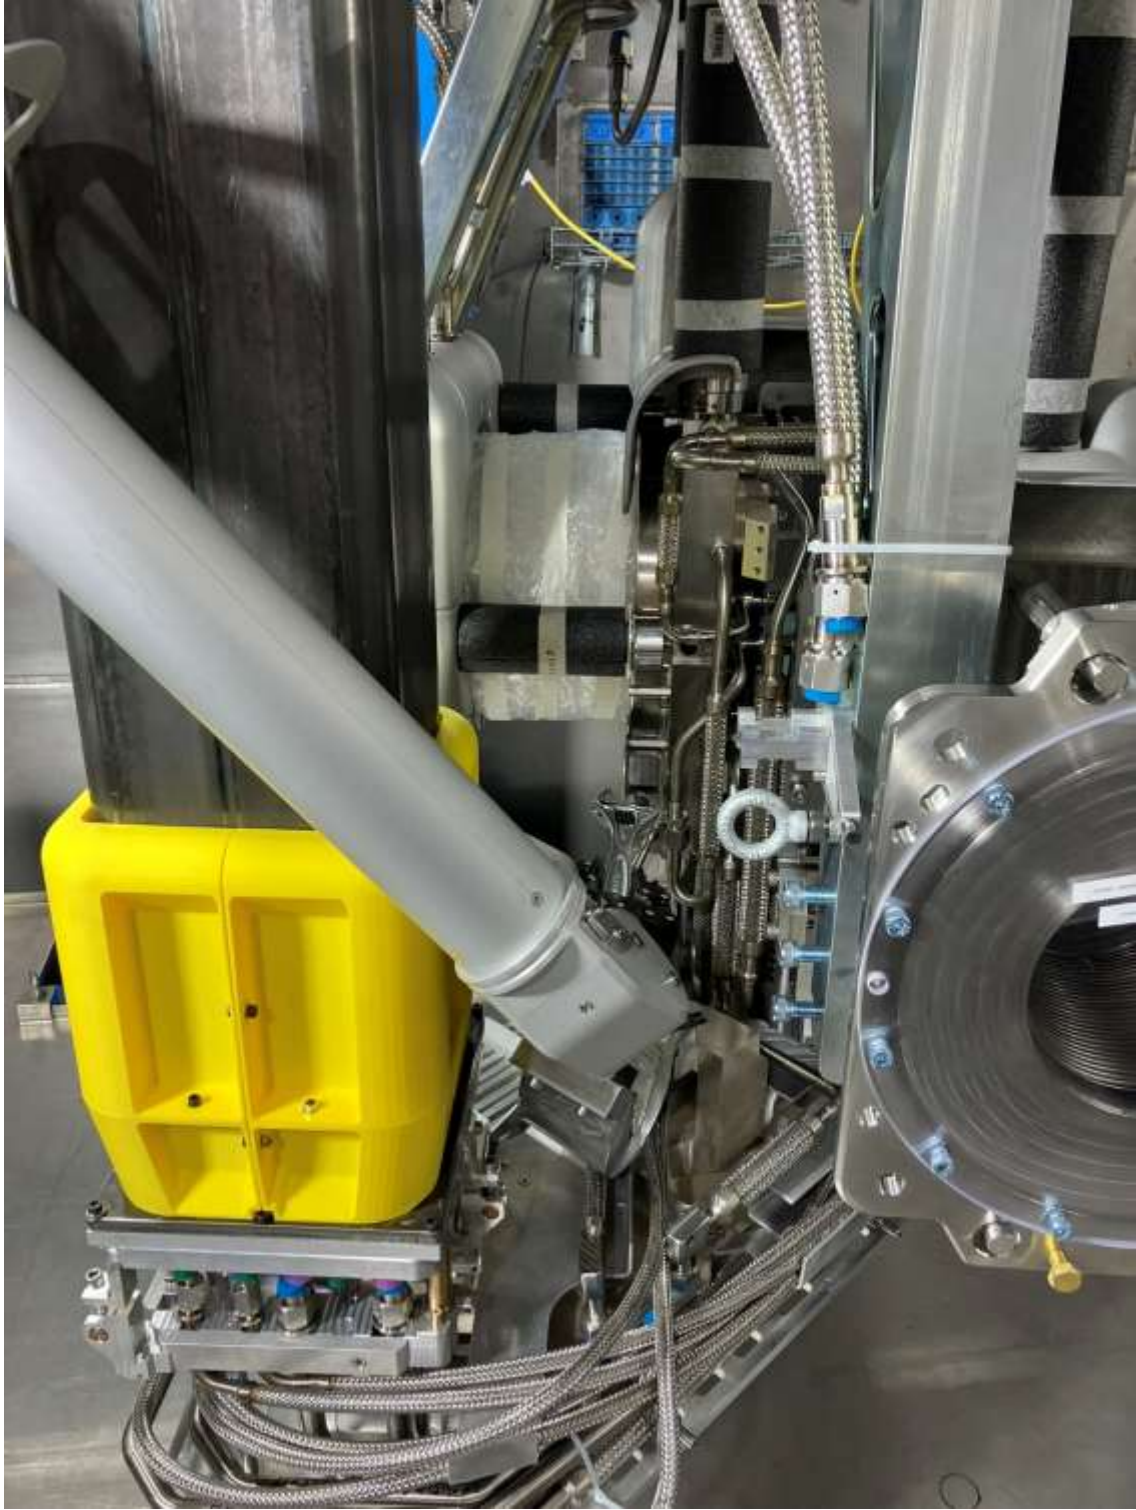
In this orientation, adjustable wrench not able to reach VCR on second to bottom line.

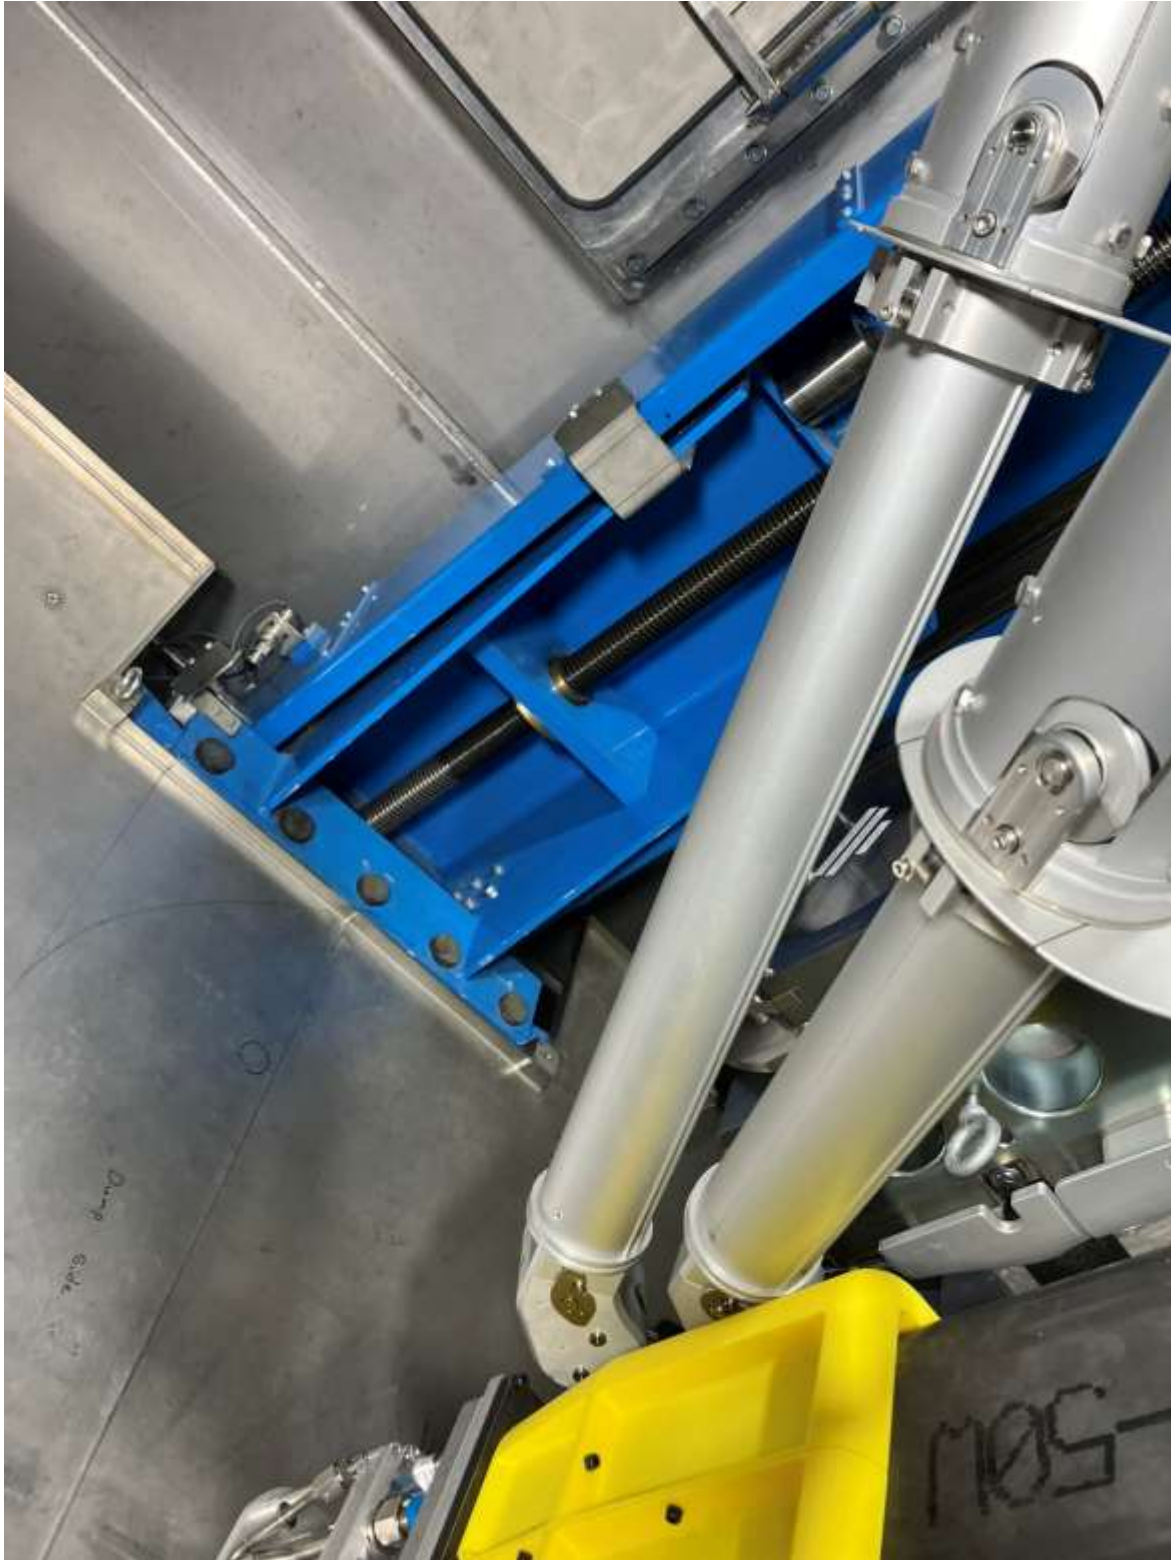
Cramped manipulators.

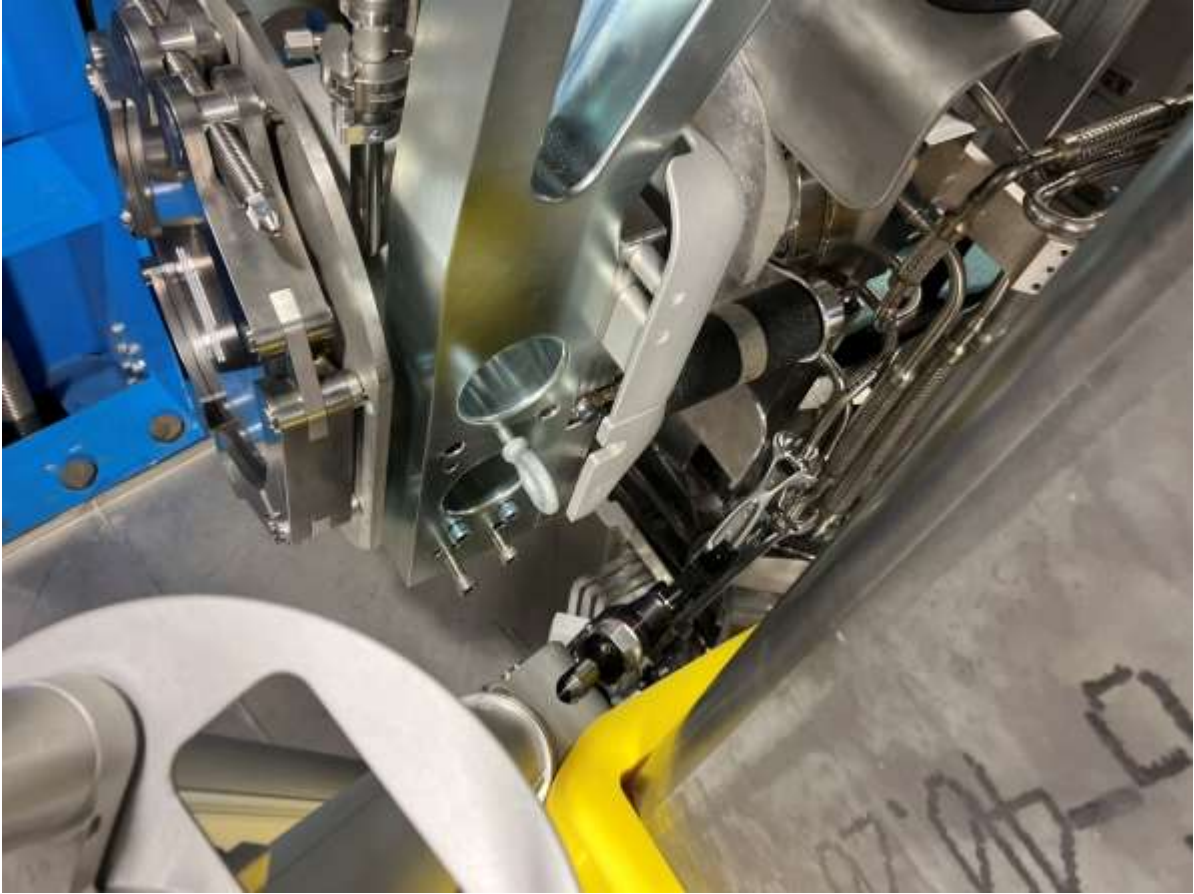
Two wrenches from one side

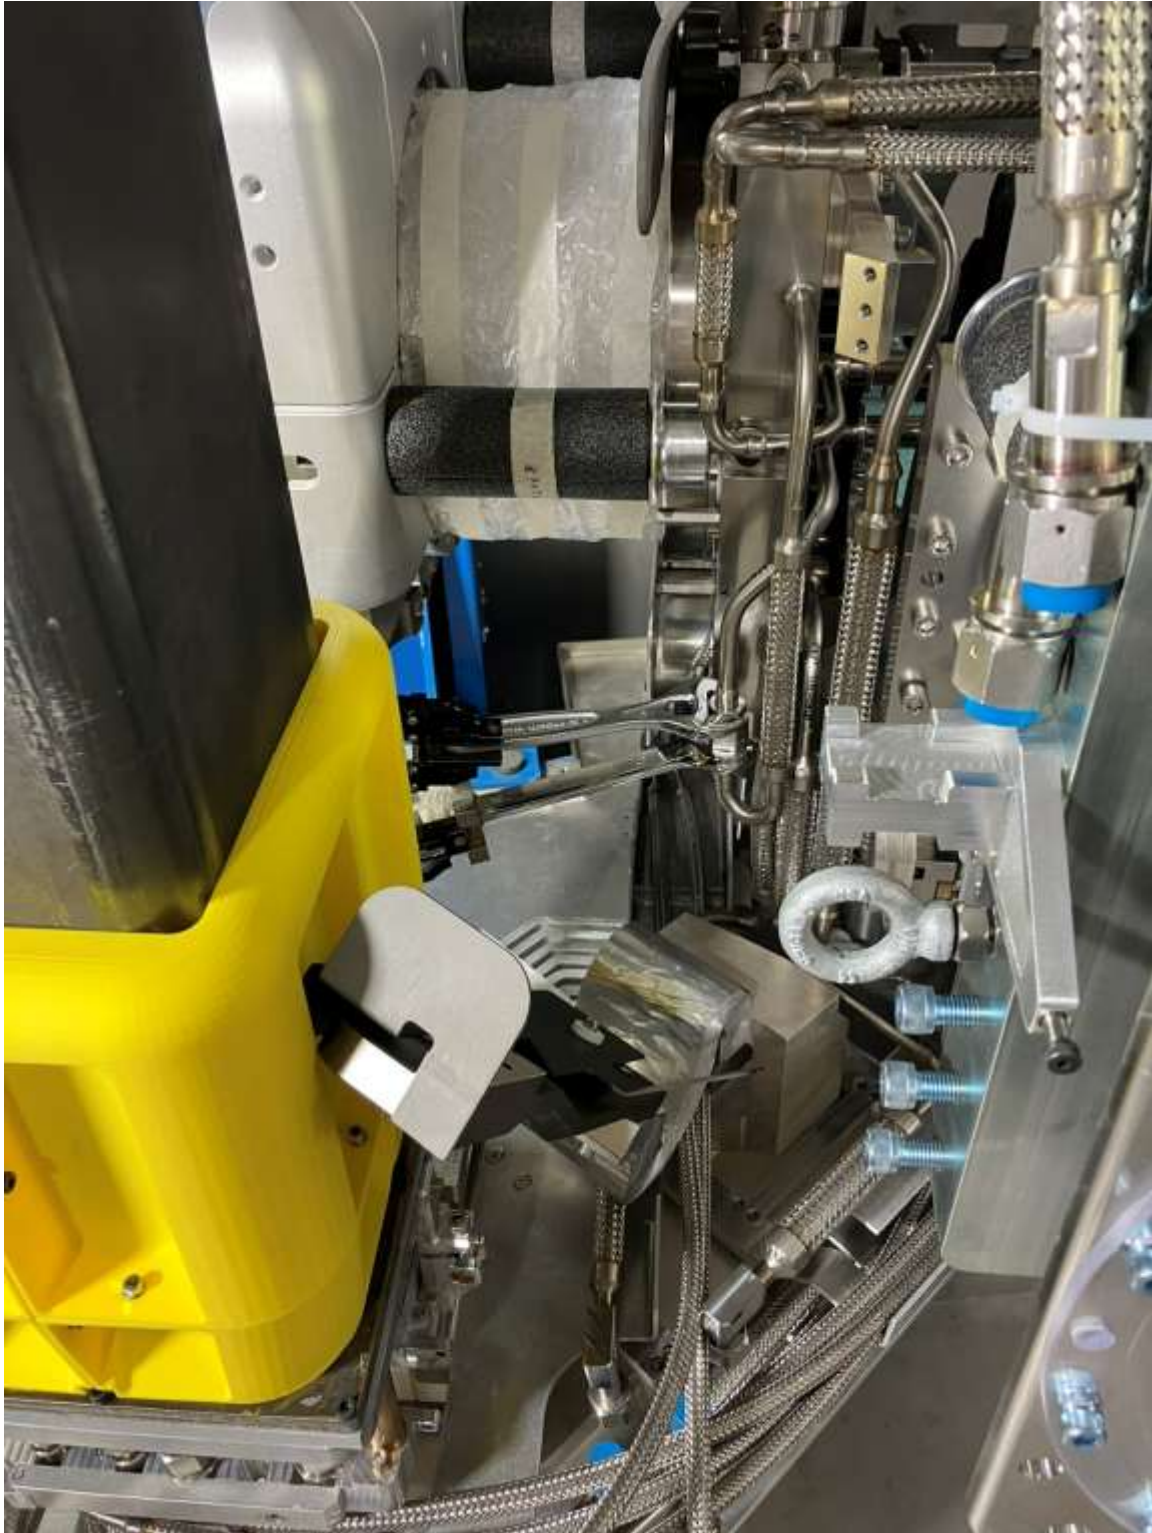
Interference with HV shield visible in this photo.

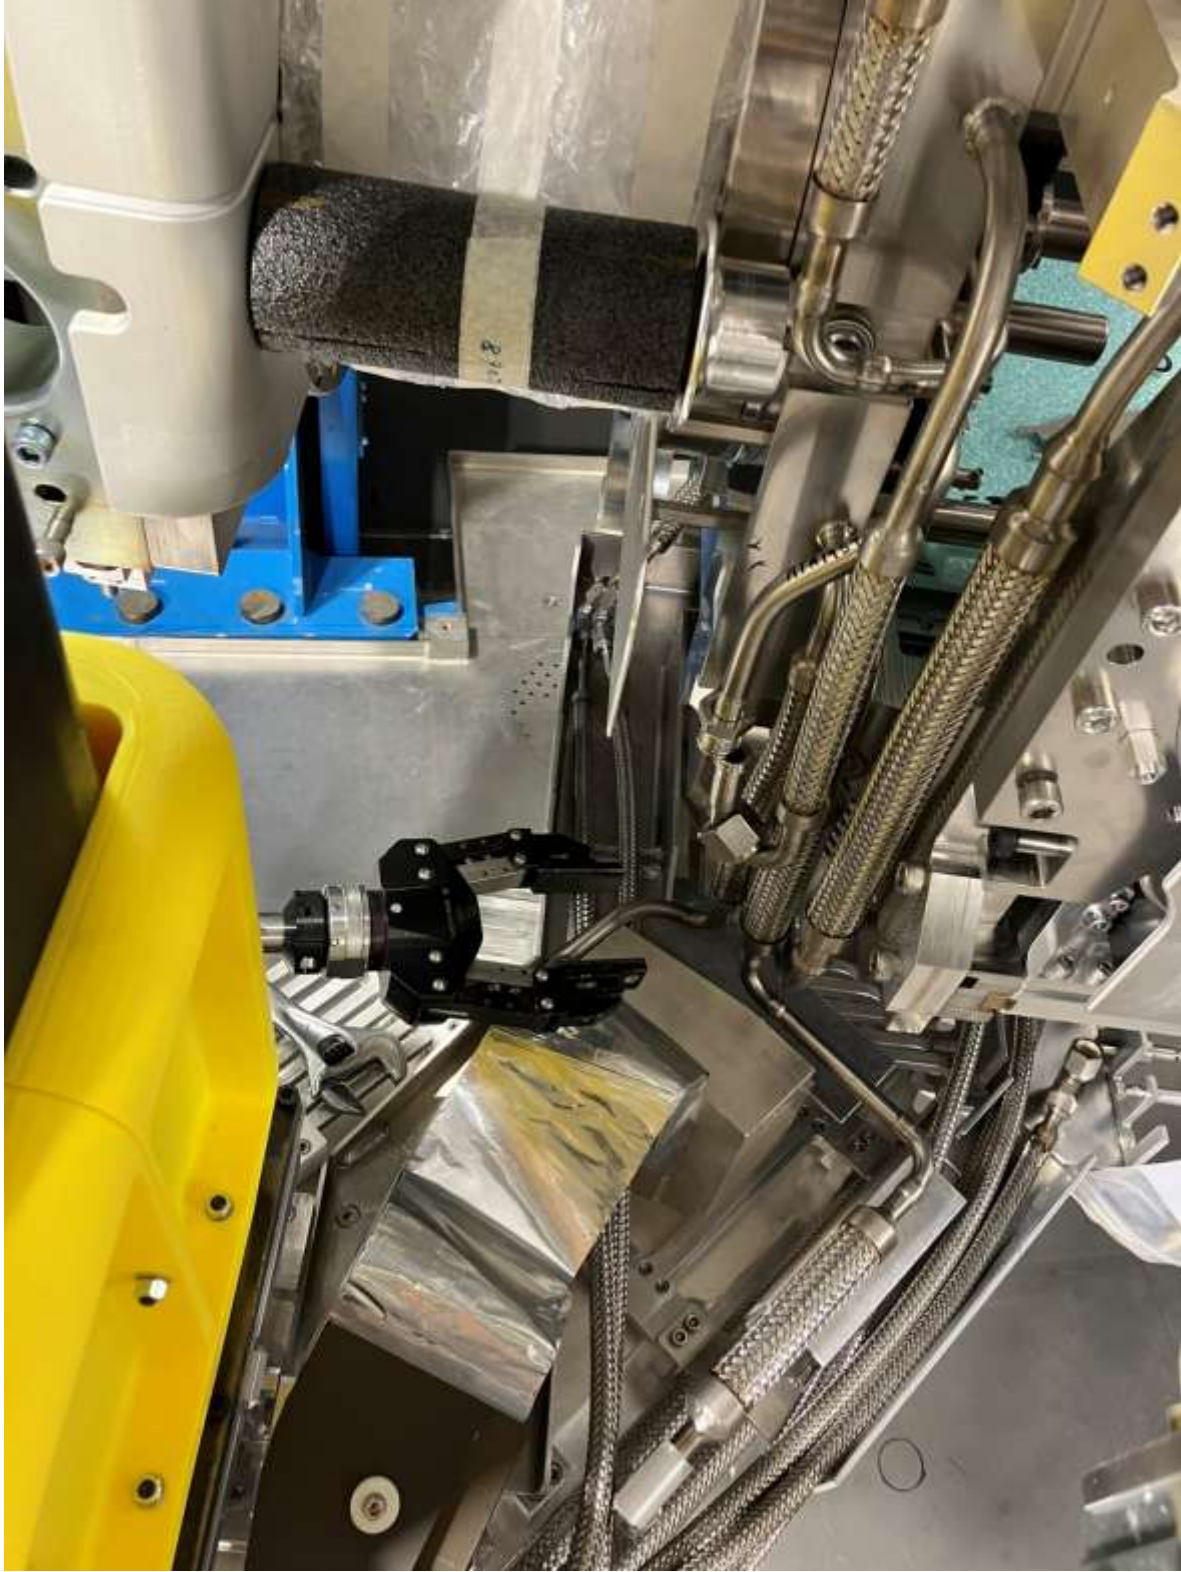
VCR joint successfully seaprated

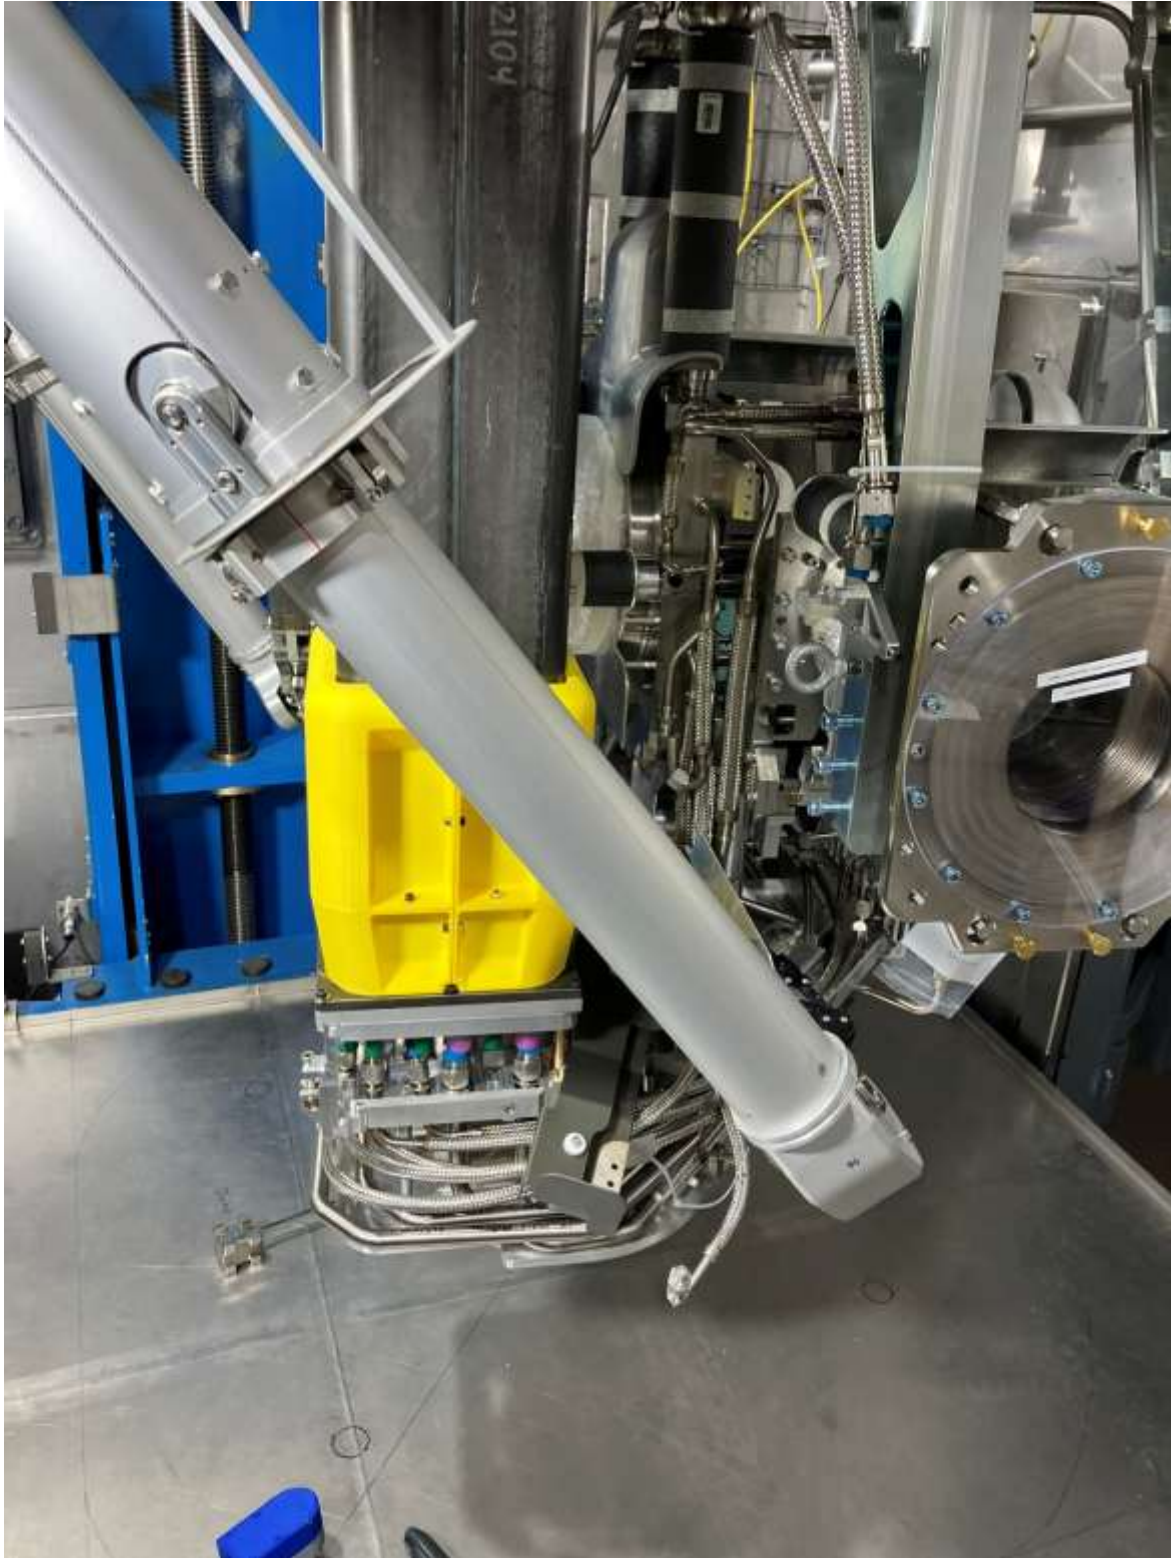
Sheet metal tool used to push the VCR nut up from U-bend

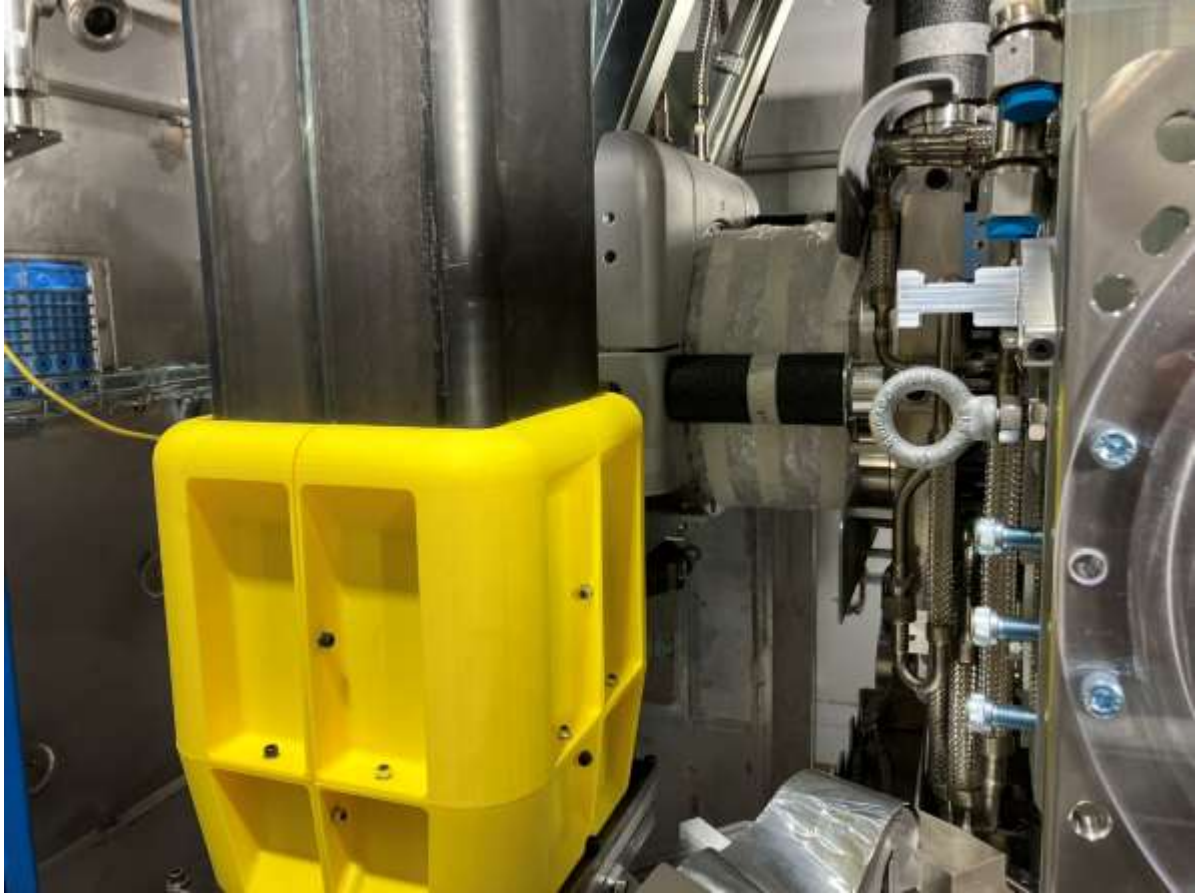
Female VCR nut 'stayed up' on its own eventually.
