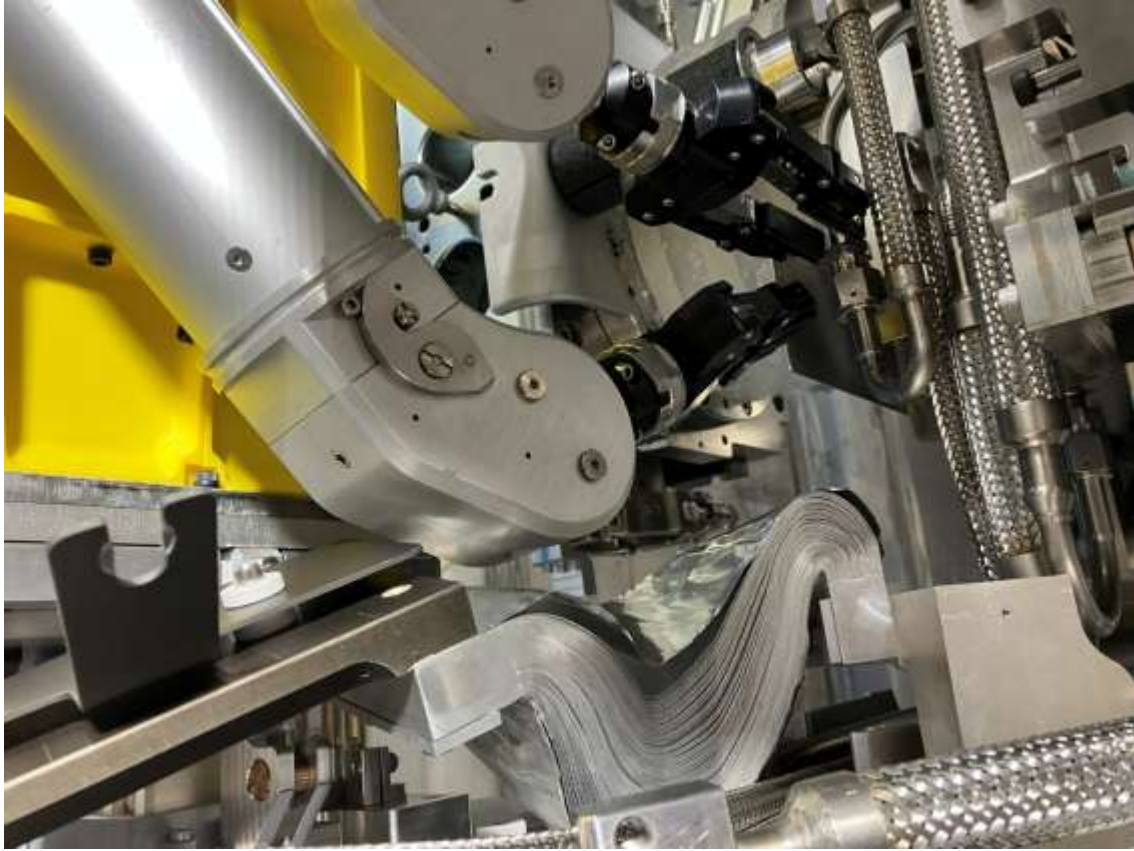
Orientation where VCR nut could be started with the manipulators without too much interference with the HV shield.

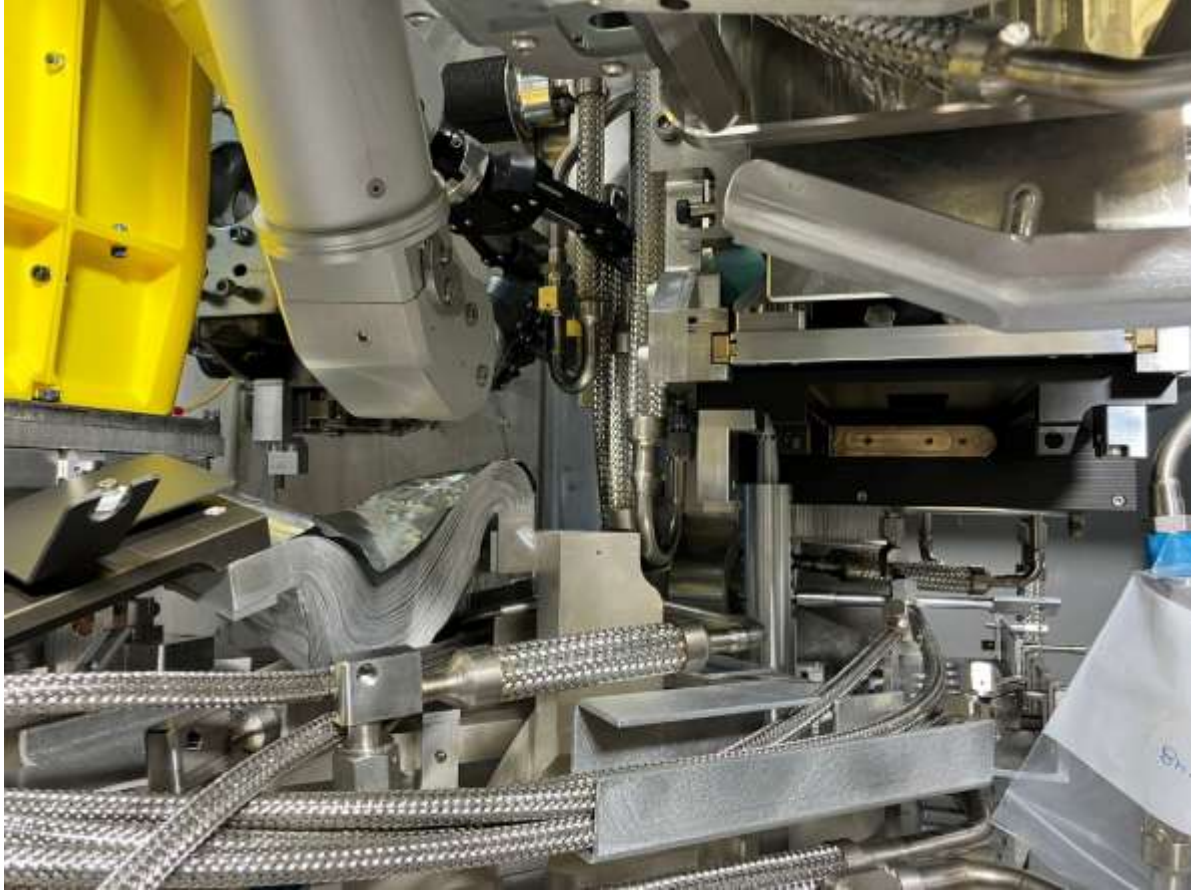
'Pinching' action to position the flexible line and keep the male side from rotating.

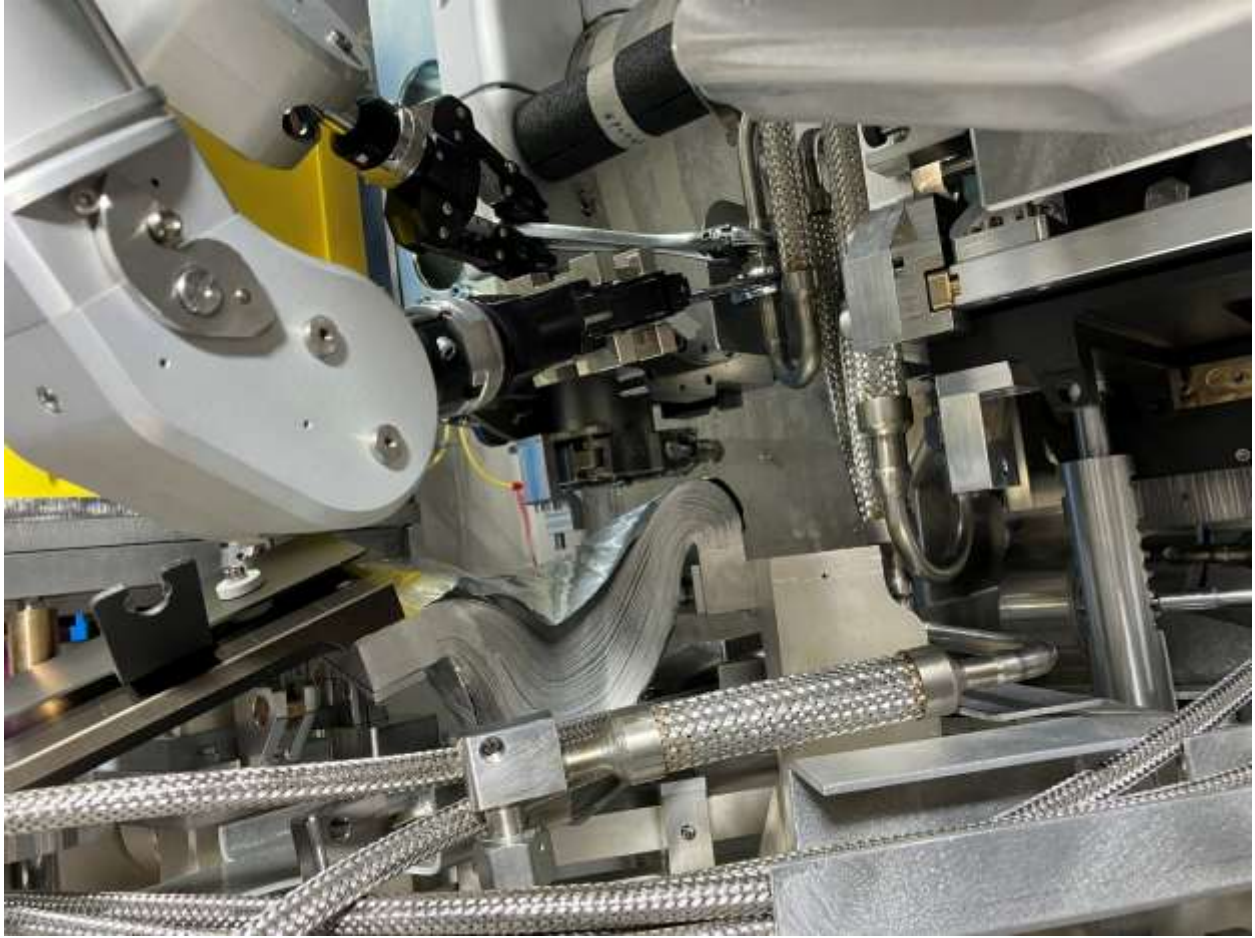
VCR joint re-tightened.
