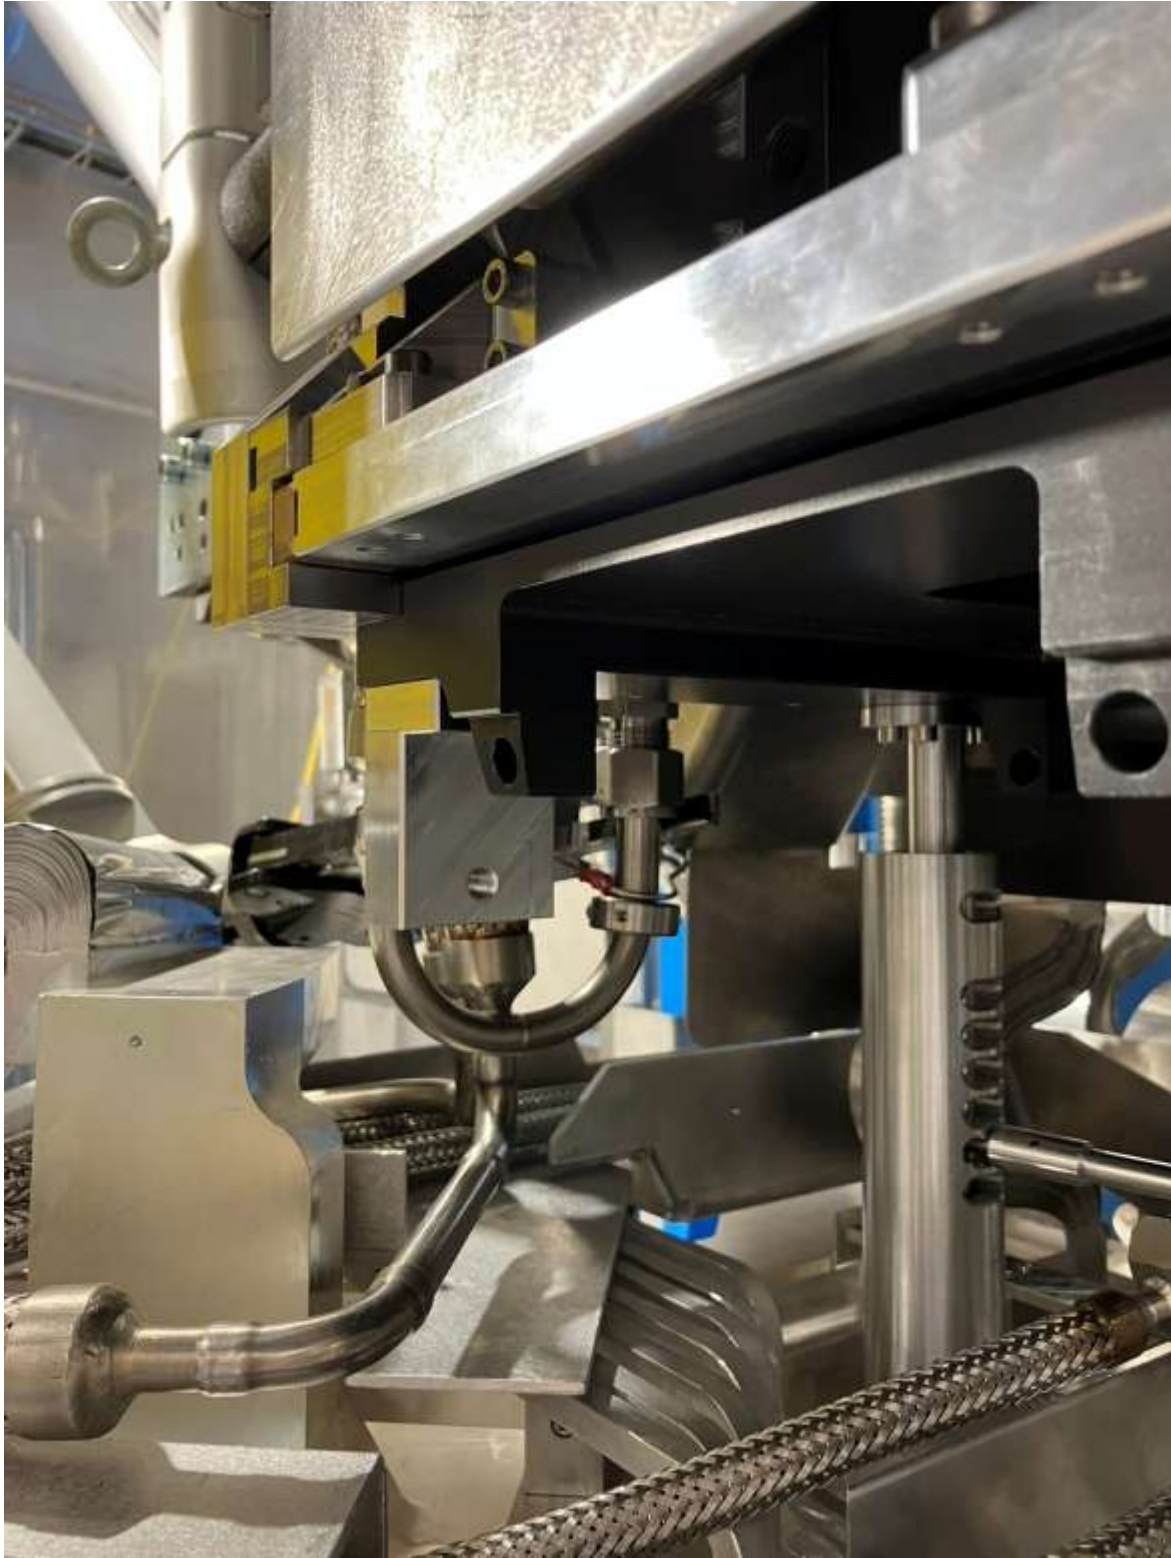
Testing the use of a hook to position VCR joint on top most water line

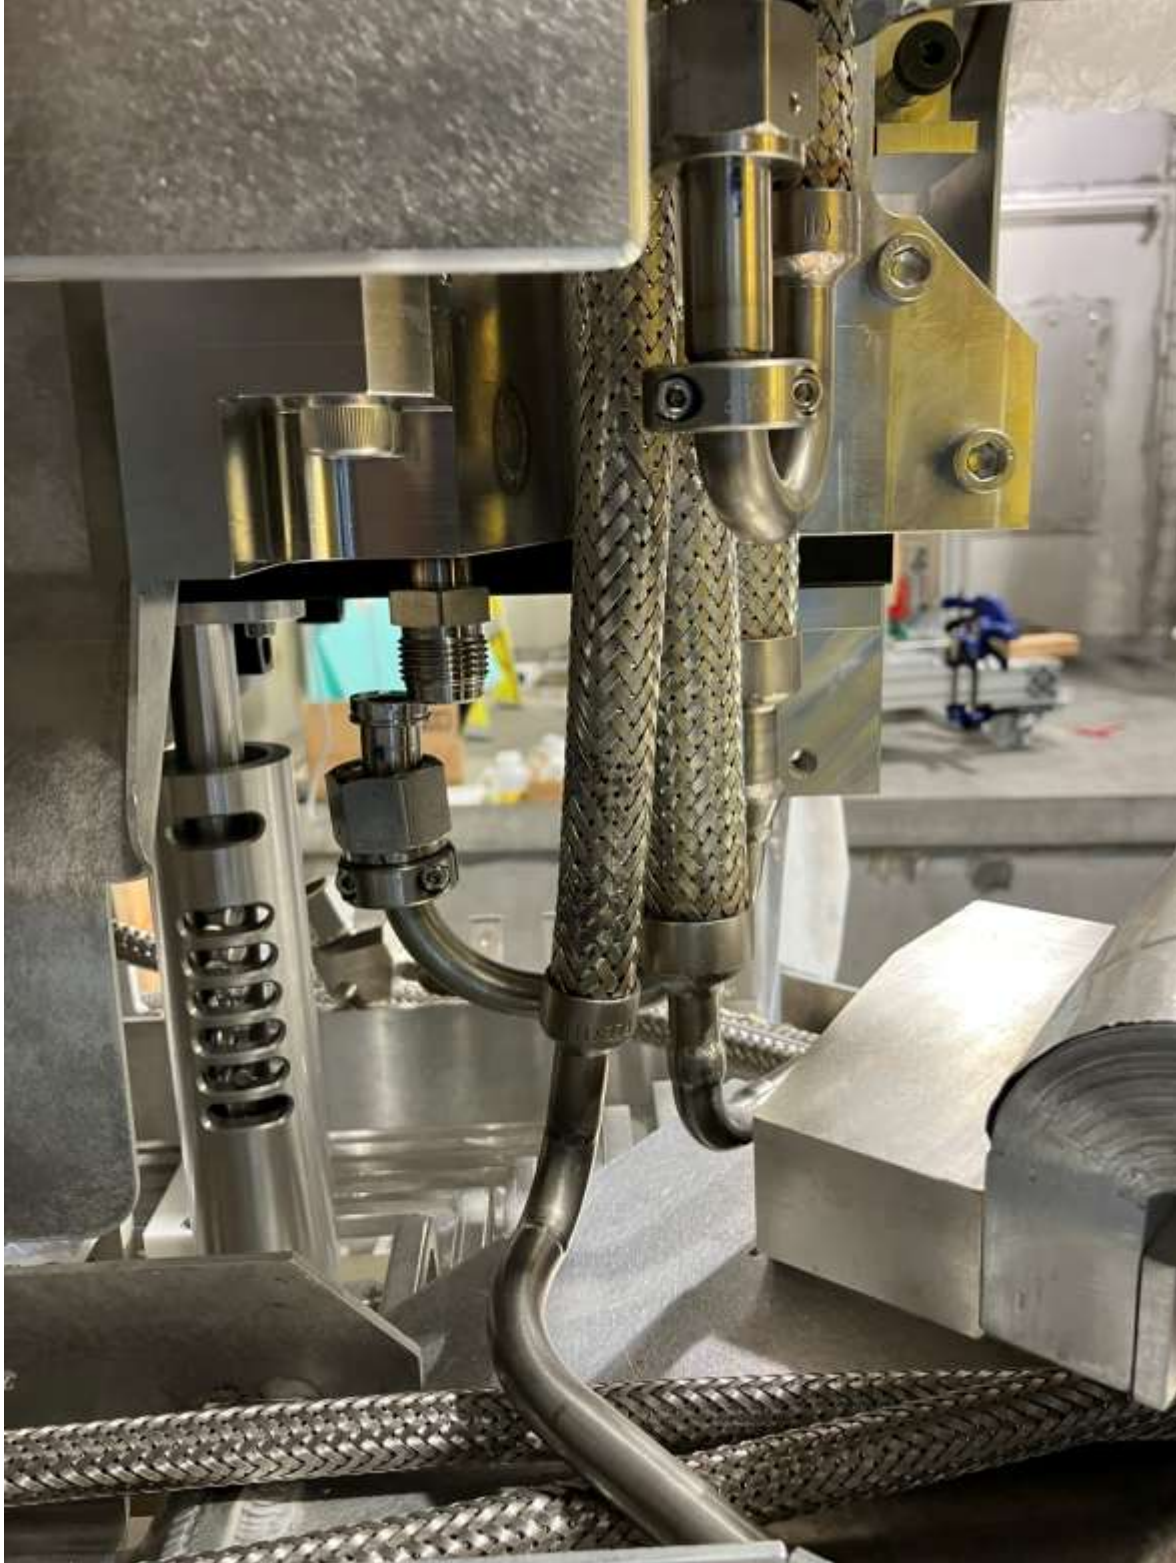
Resting 'misalignment' on this line when not done up. Purchased shaft clamp (McMaster 9648T5) works well to keep the nut from falling too far, also works for u-bend on the second to bottom line. The clamp does not cause the line to catch when being exchanged.

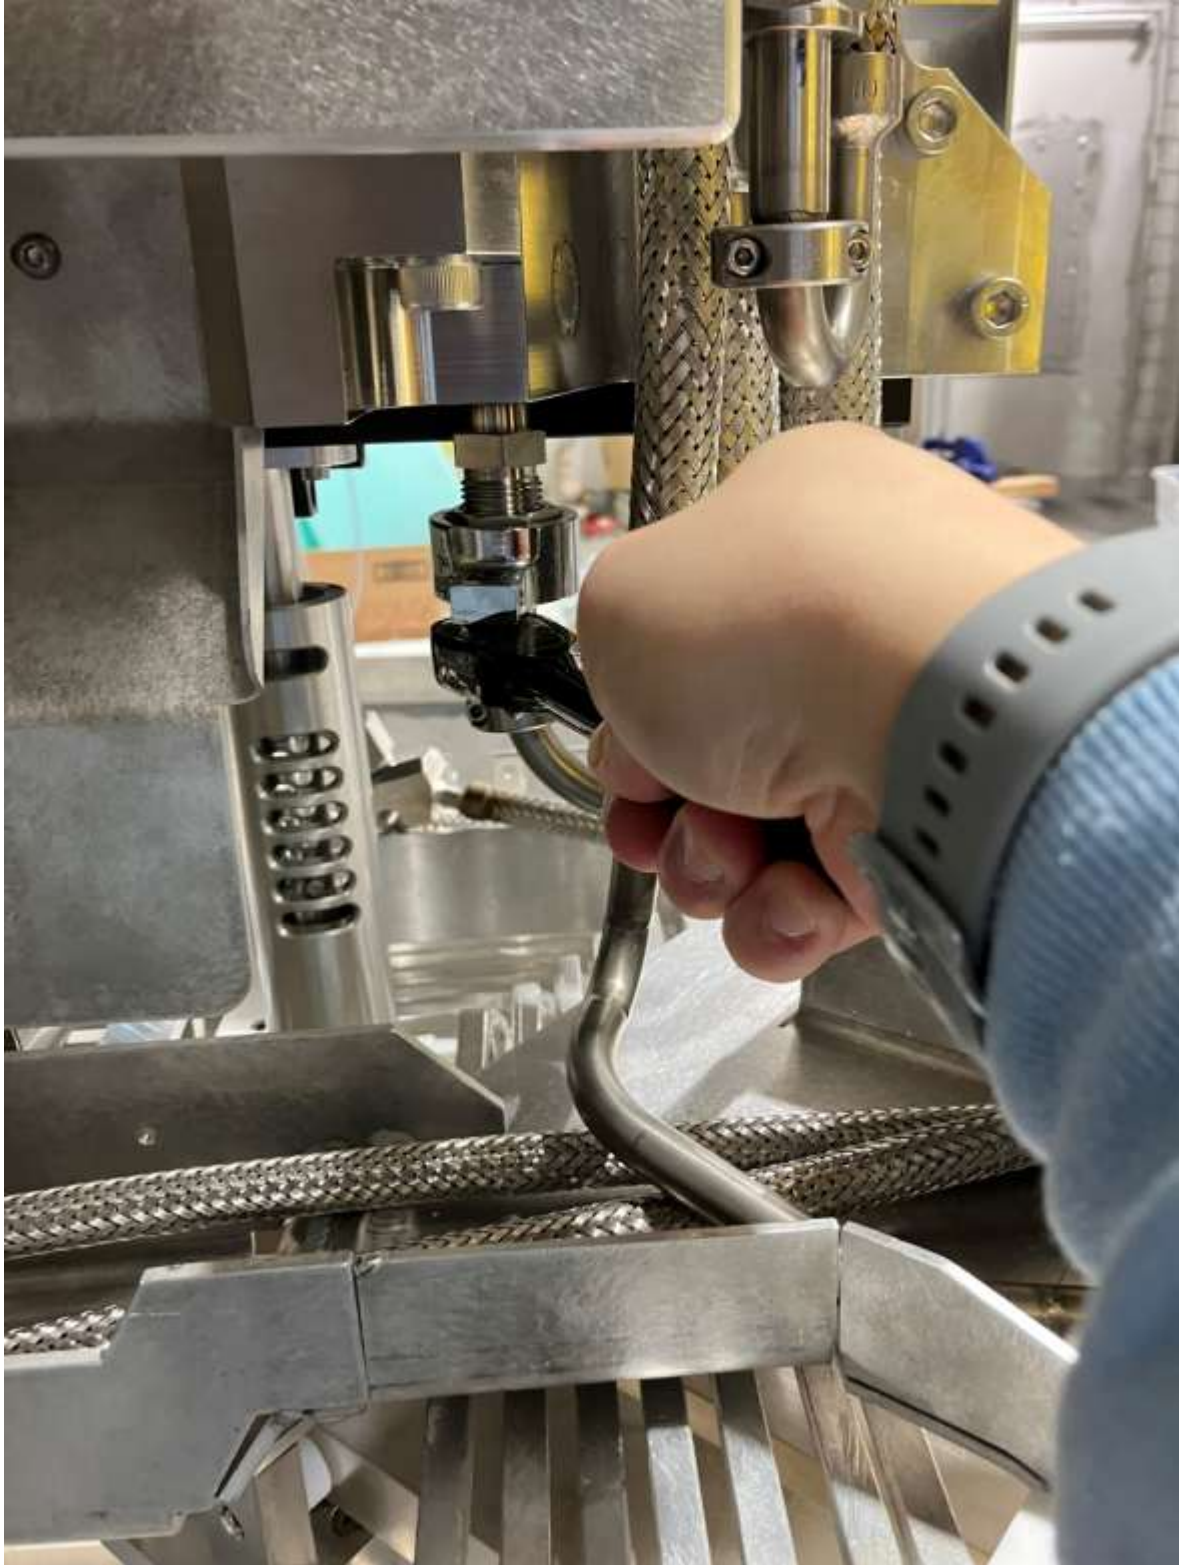
Ratchet and 12-point secure crow's foot wrench can be used in this location for low clearance tightening operations.

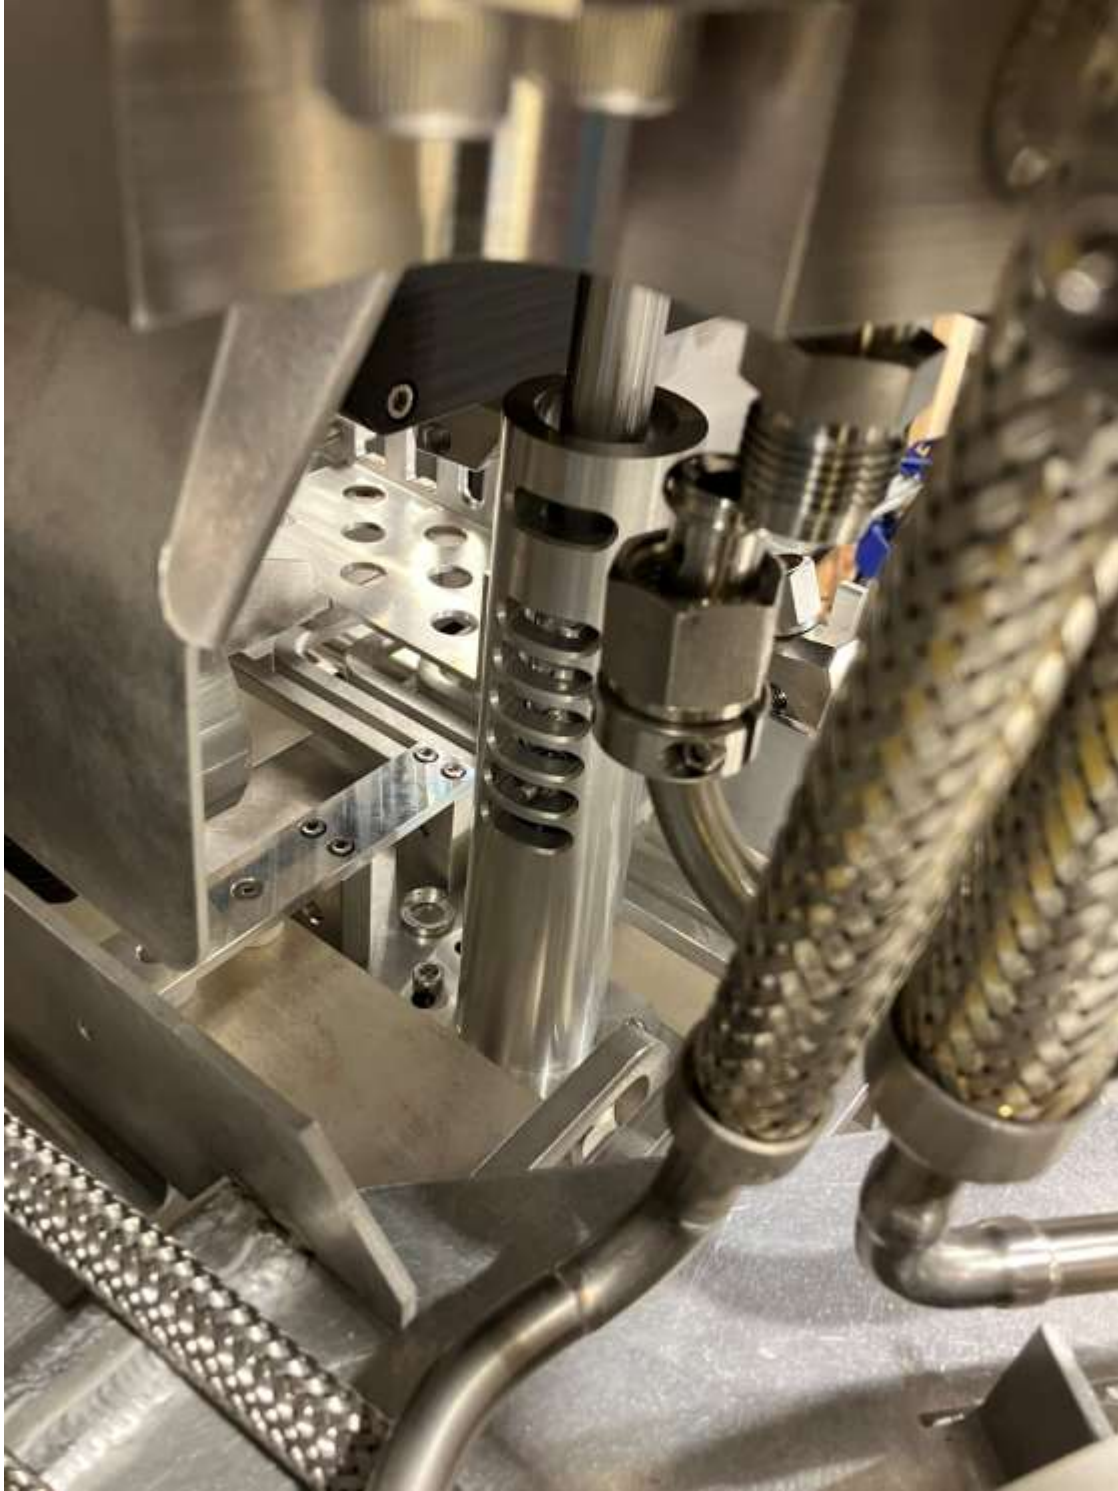
If VCR gasket gets dropped for the top most water line, there is a high chance that it drops to this hard to reach location.

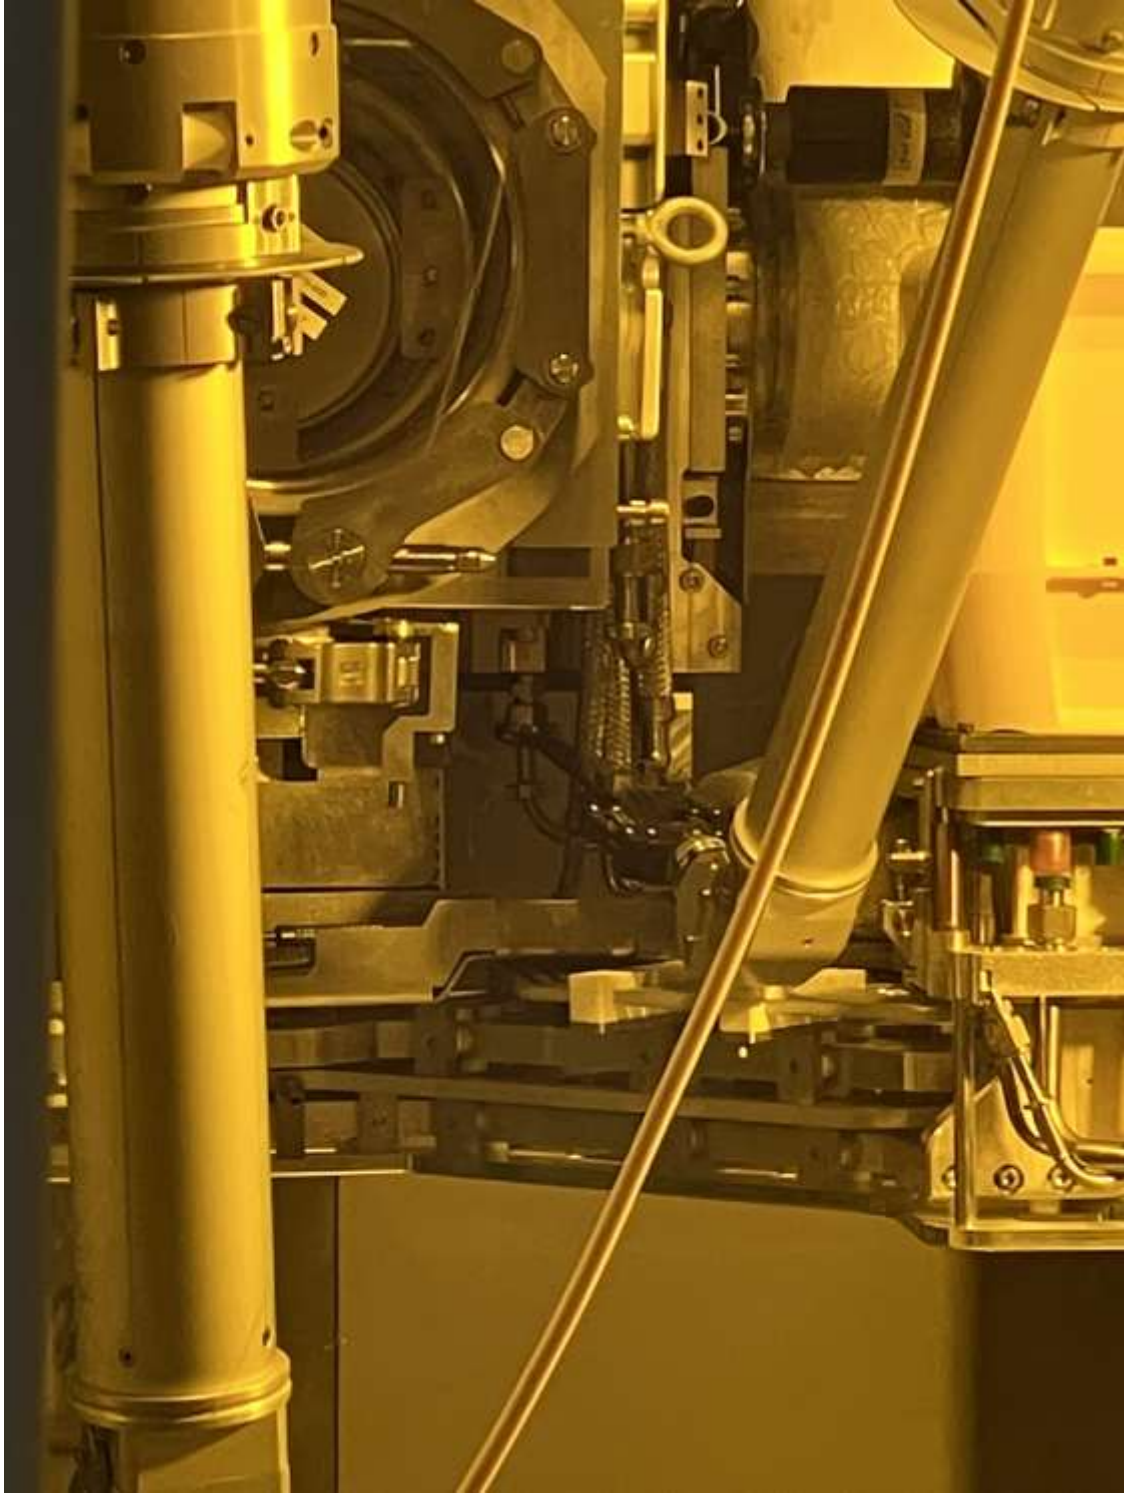
Illustration of how 'deep' the VCR joint on the top most water line is, as viewed from the hot cell window.

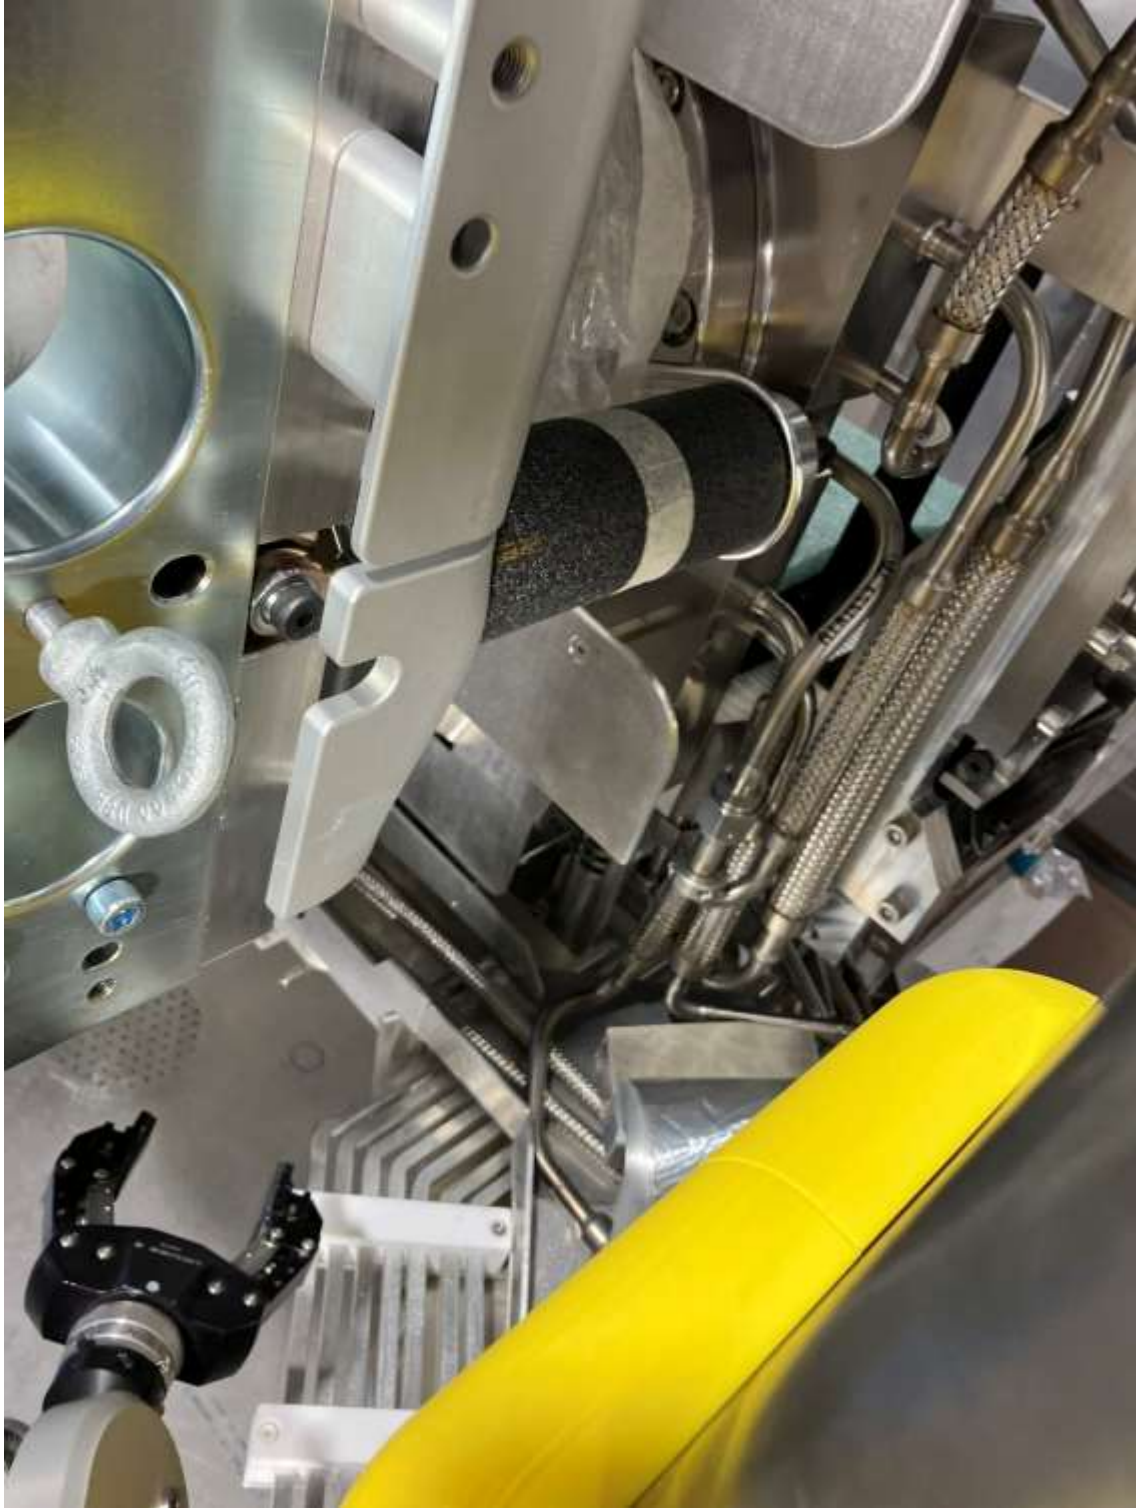
Female side of second lowest water line is hard lined so we don't need to worry about the clamp catching when performing a line exchange. Though, it may catch the bottom most water line when it is being exchanged.

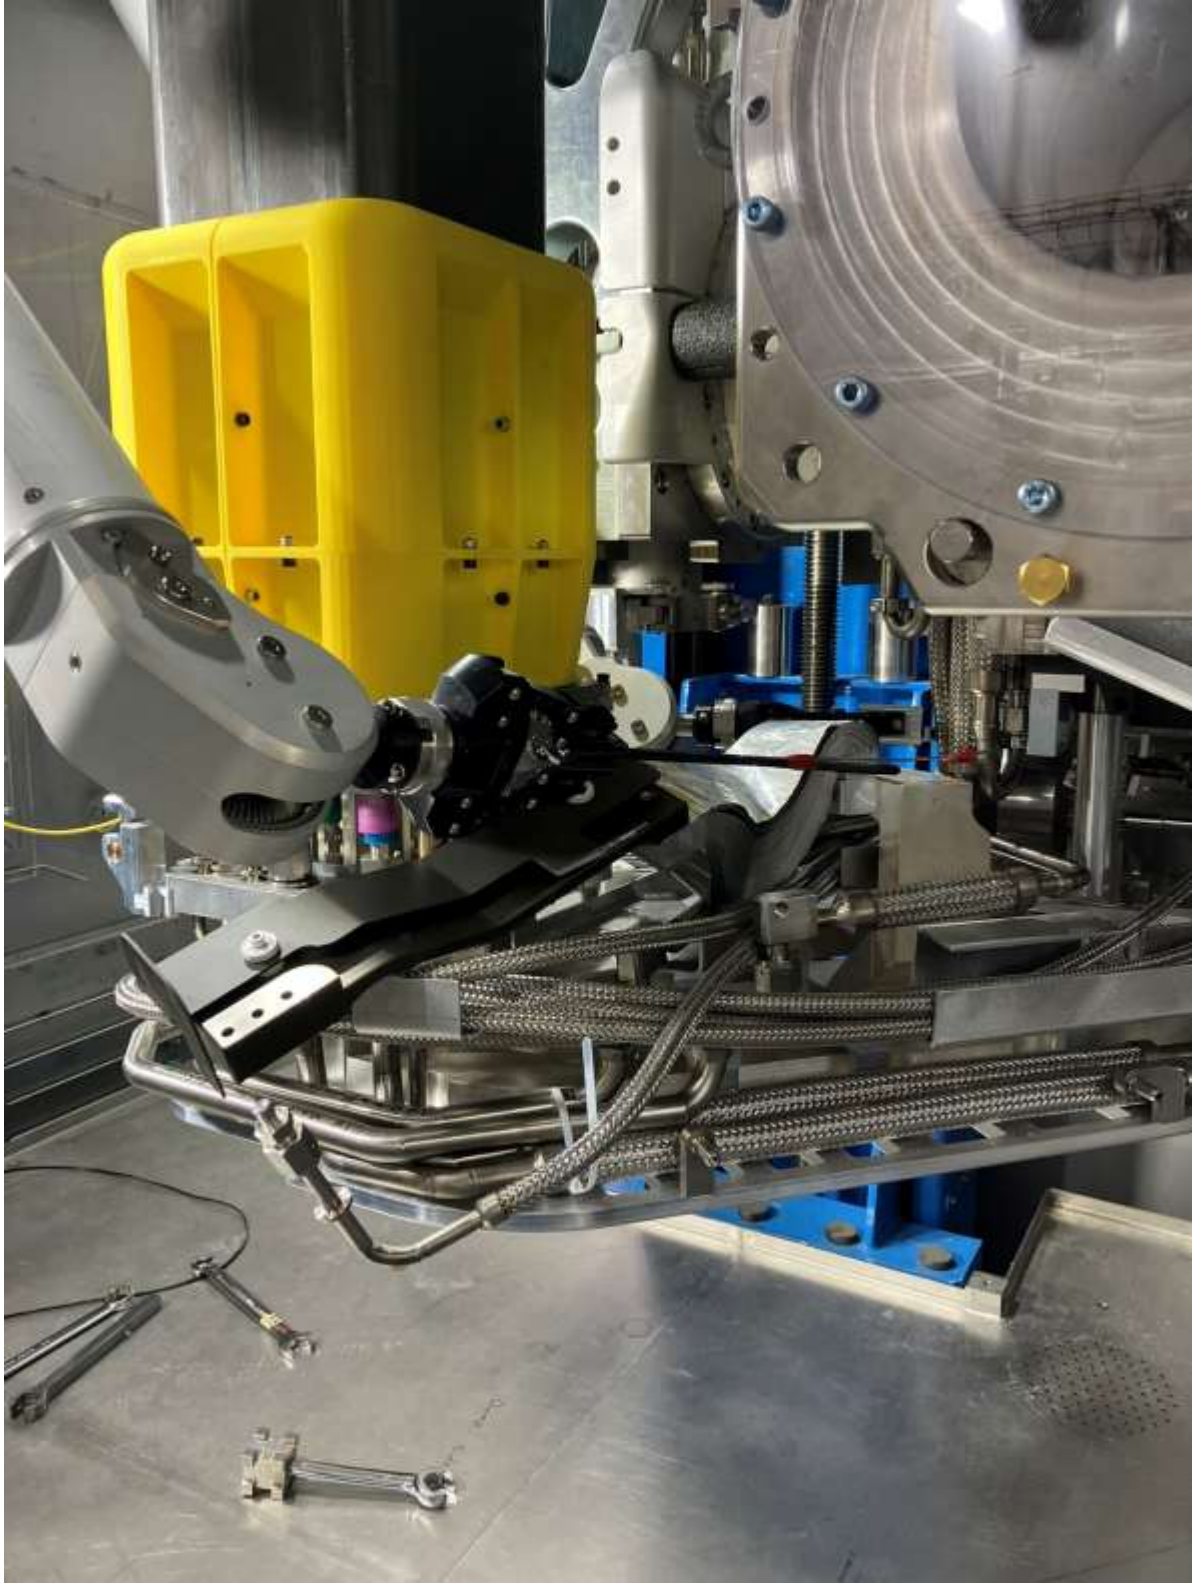
Using hook from one side to position the female VCR side.

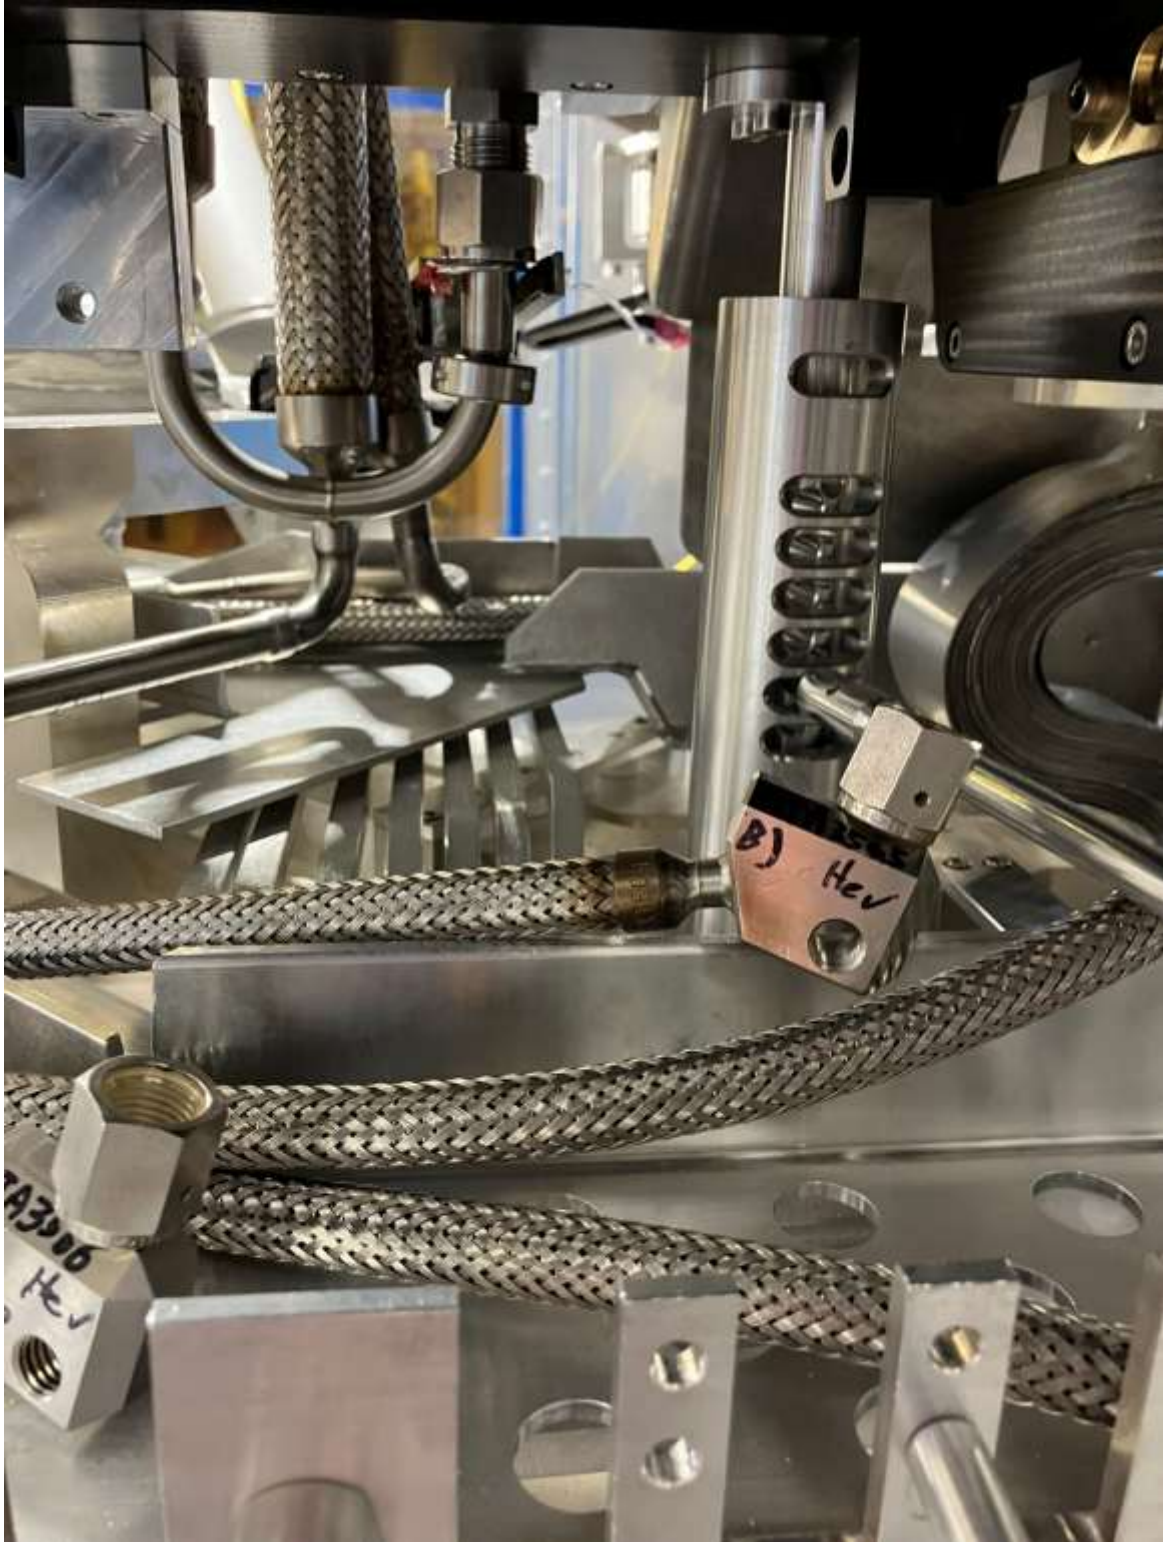
Cramped space when trying to re-start the nut with the starter tool.

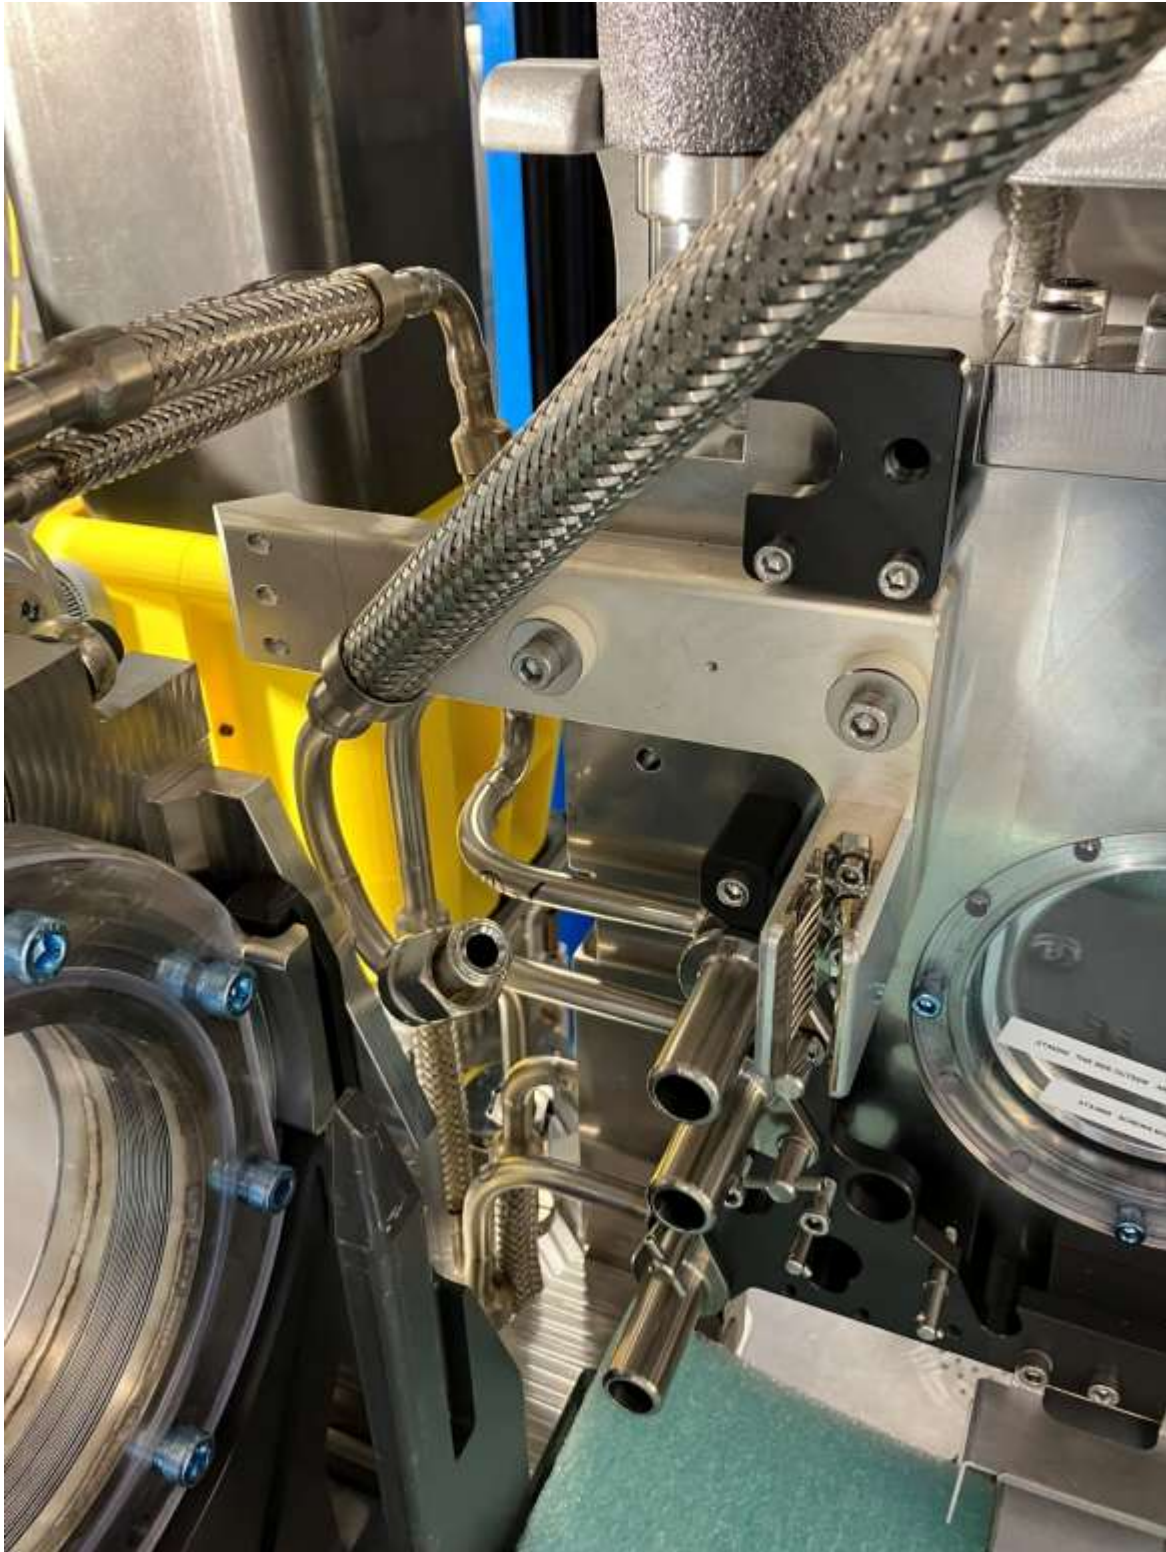
Top most VCR line could be removed and returned with the busbar out, while clamp is still on.

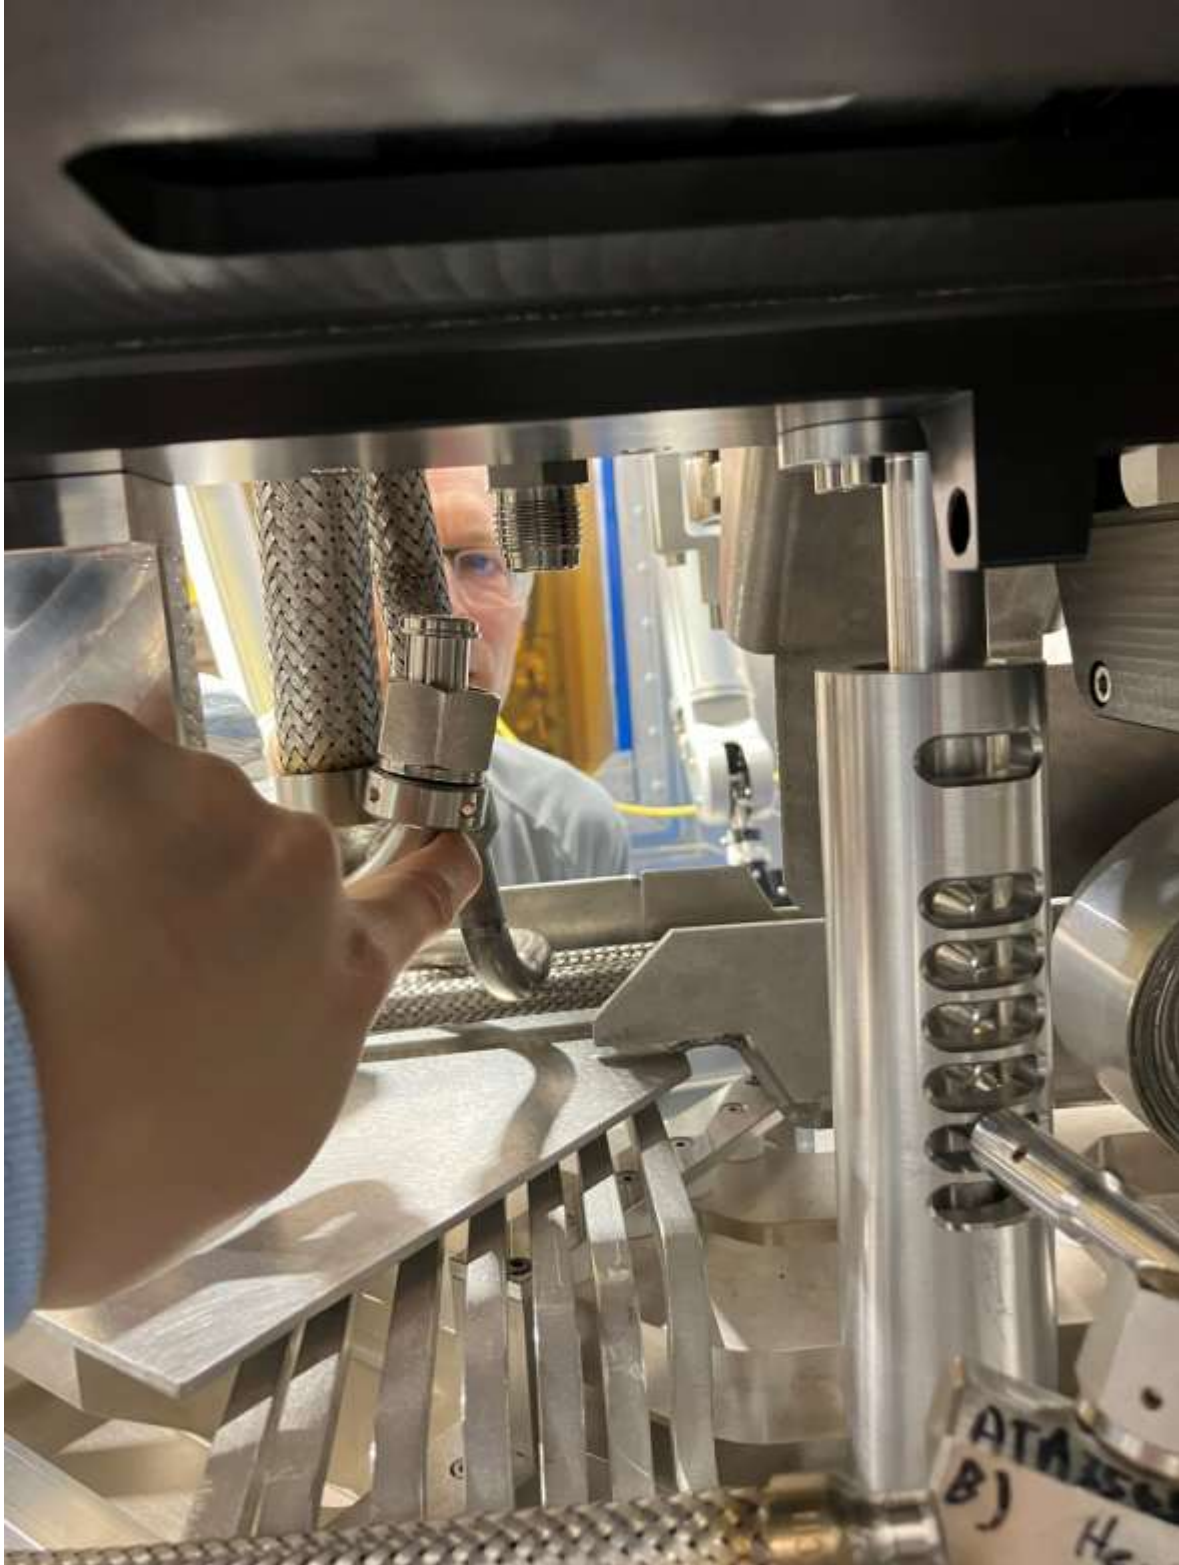
By pushing the flexible line out of the way (pin still attached at dynamic PEEK seal face), we have enough access to insert a VCR gasket to the fixed male VCR.

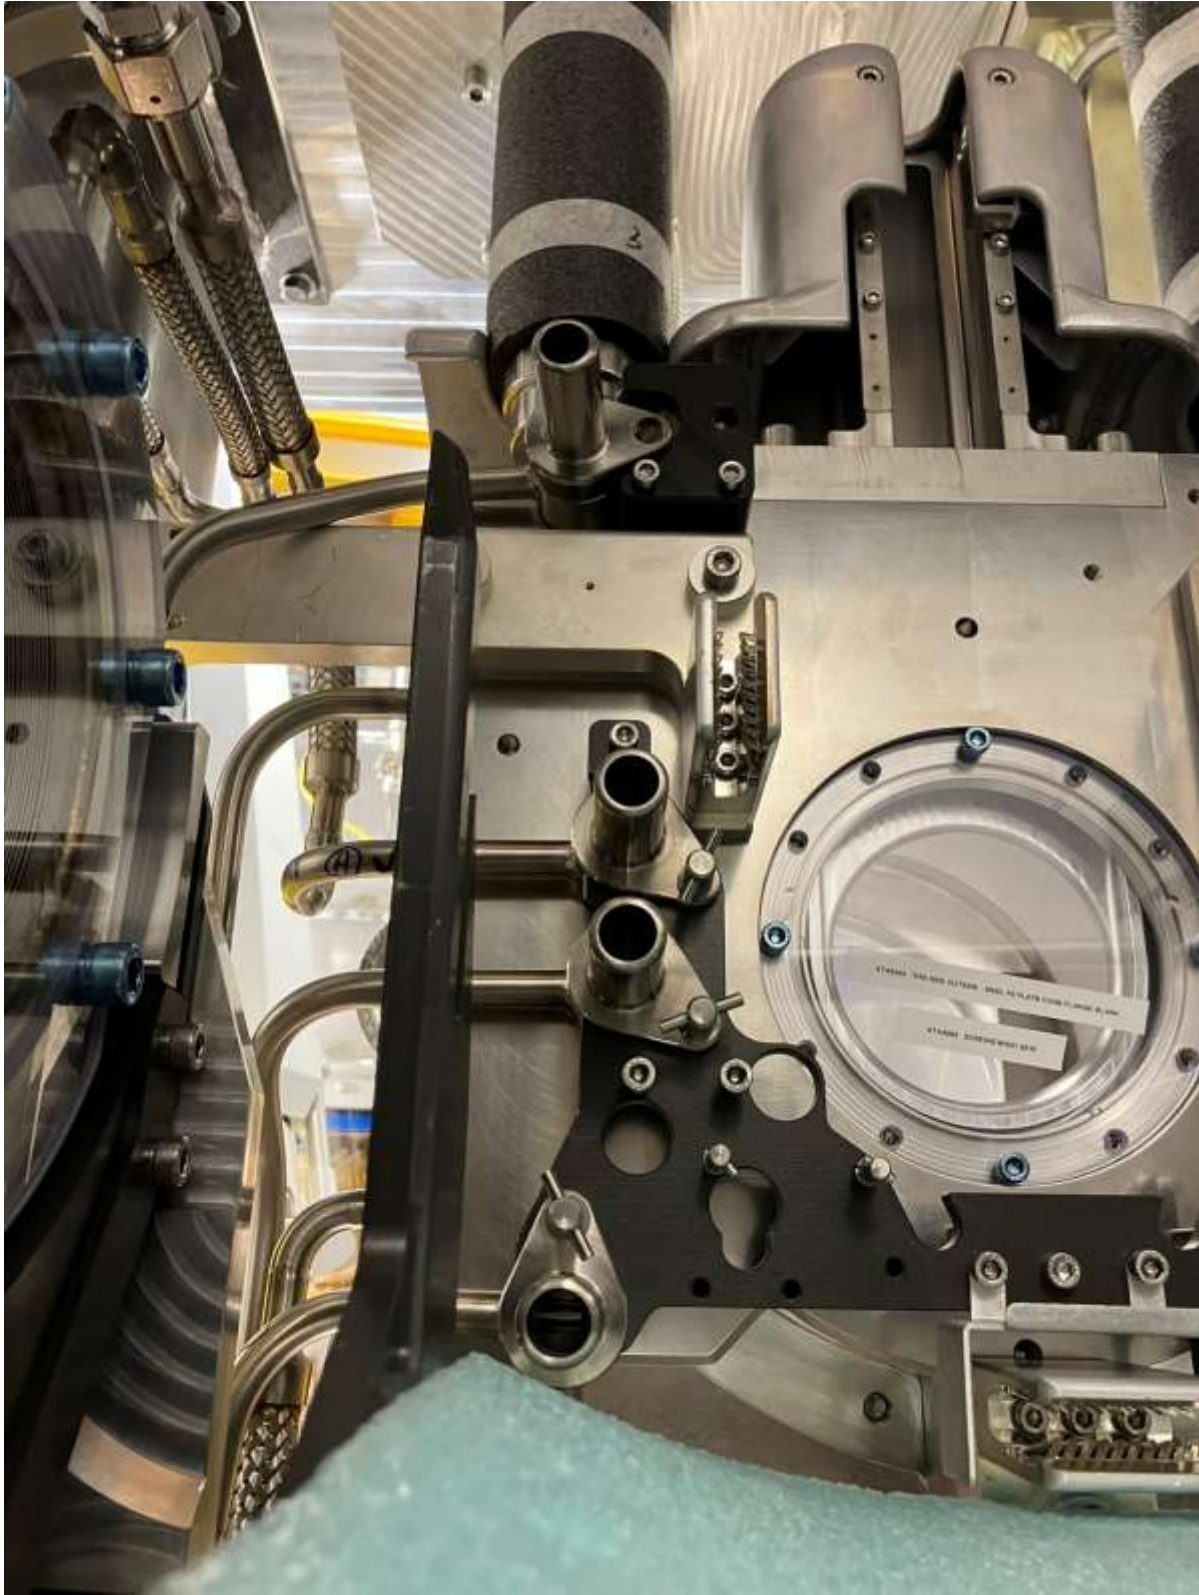
Pin should stay on the top most VCR line during gasket insertion and re-establishing the VCR joint.

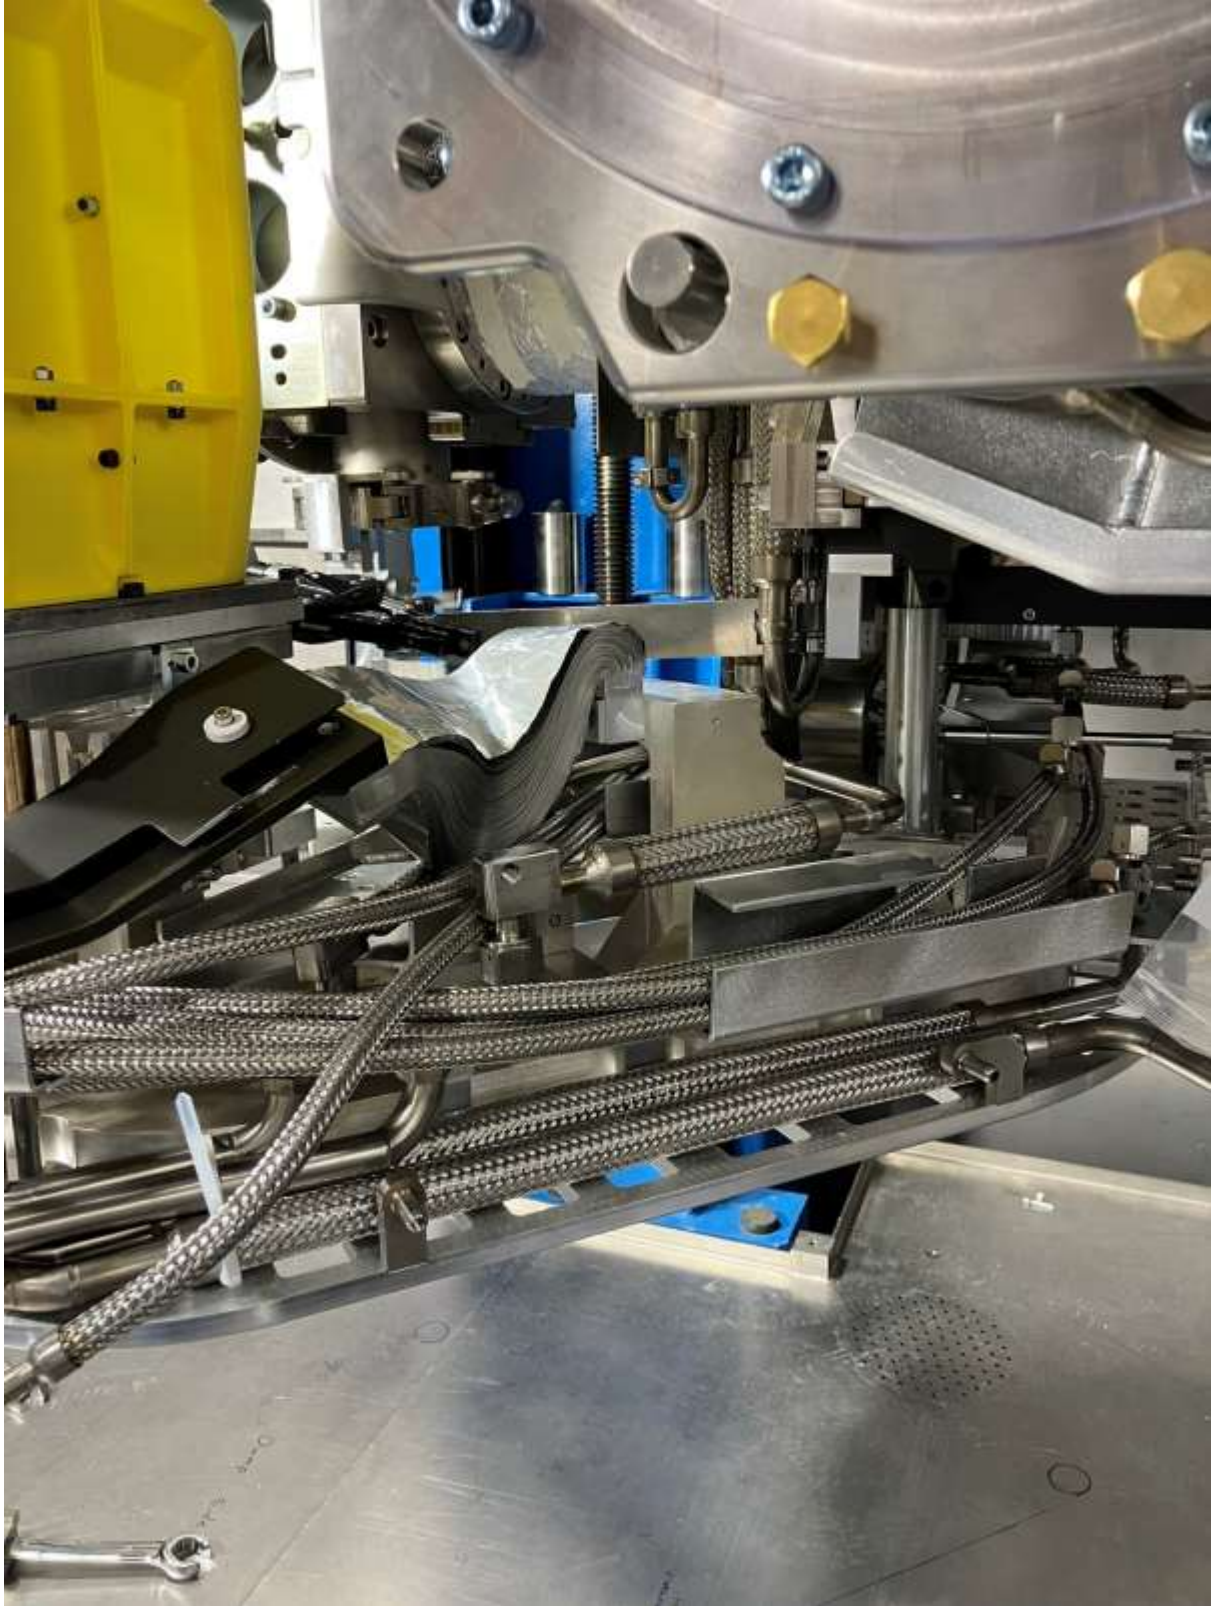
Reach of existing sheet metal barely enough to reach top most water line's VCR joint.
