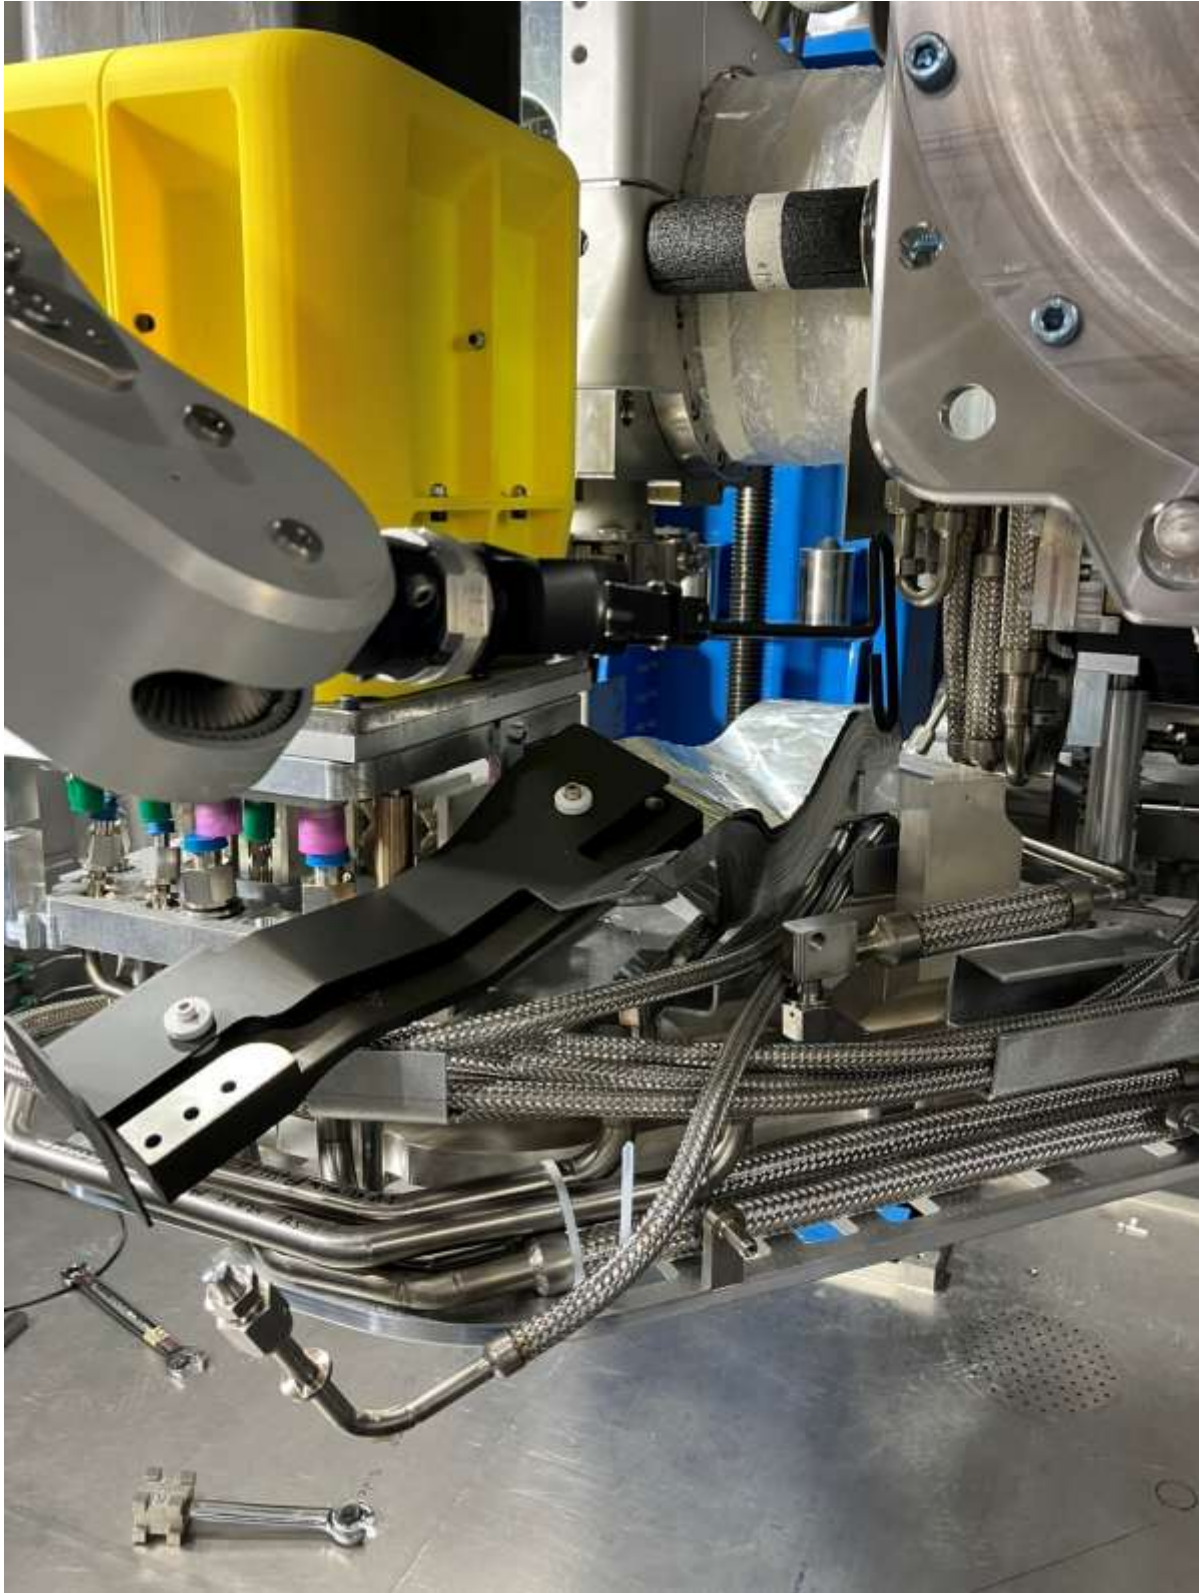
Standard T-handle tool not sufficient to access VCR joint on top most water line for positioning (butts up against HVFT).

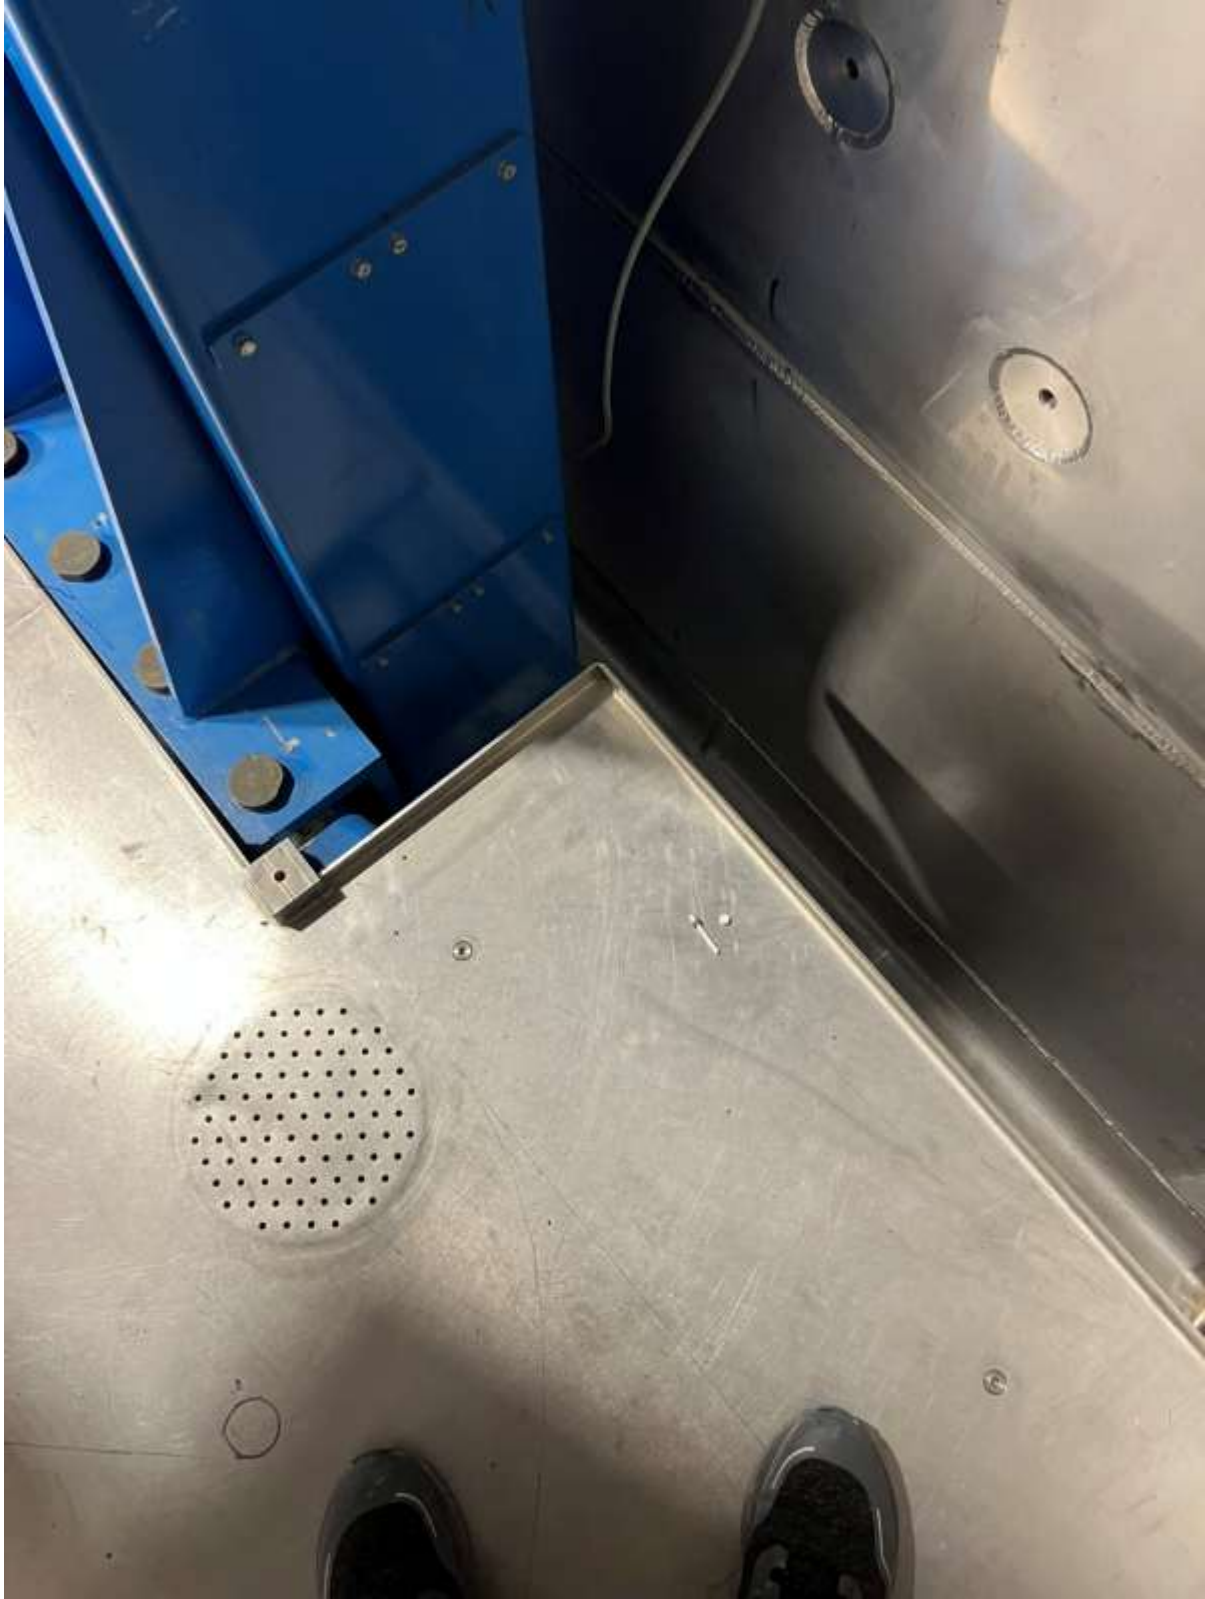
A ceramic screw broke from a dropped wrench when we first undid the top most water line's VCR joint.

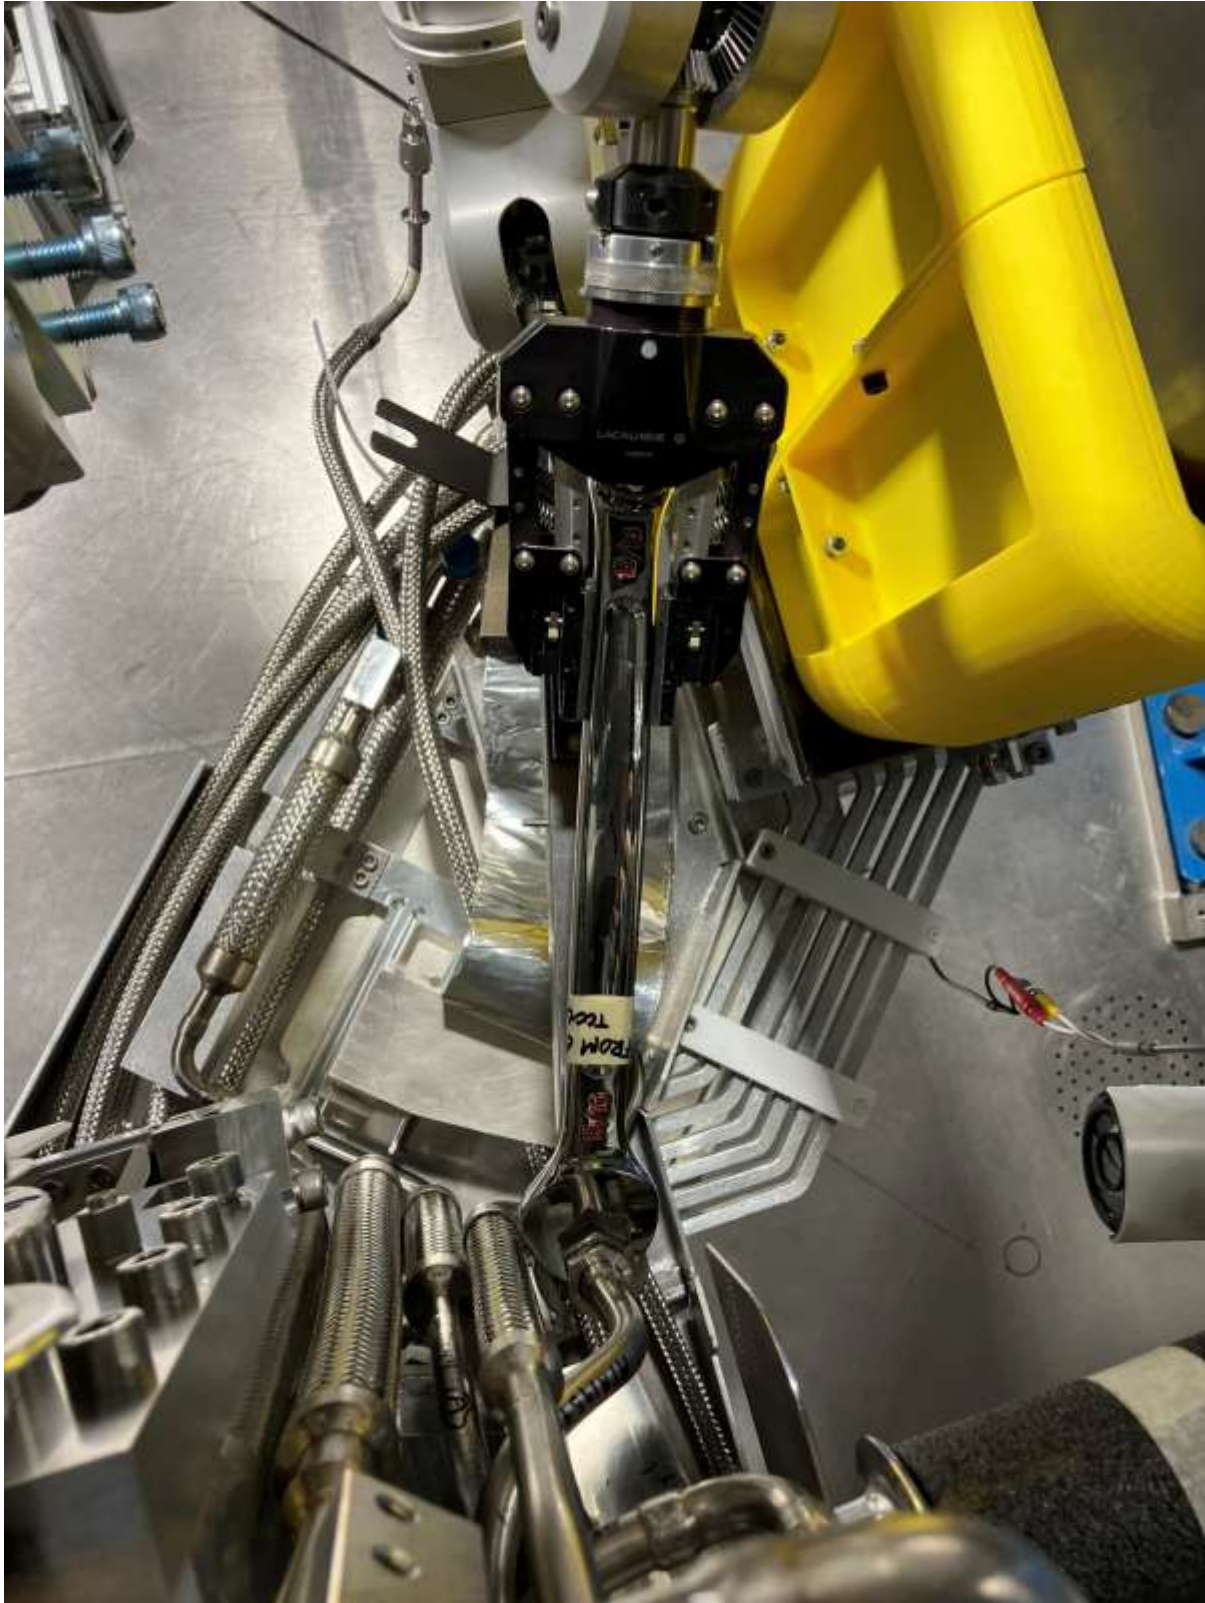
Some interference possible between full size wrench and male side of VCR joint on second to bottom water line.
