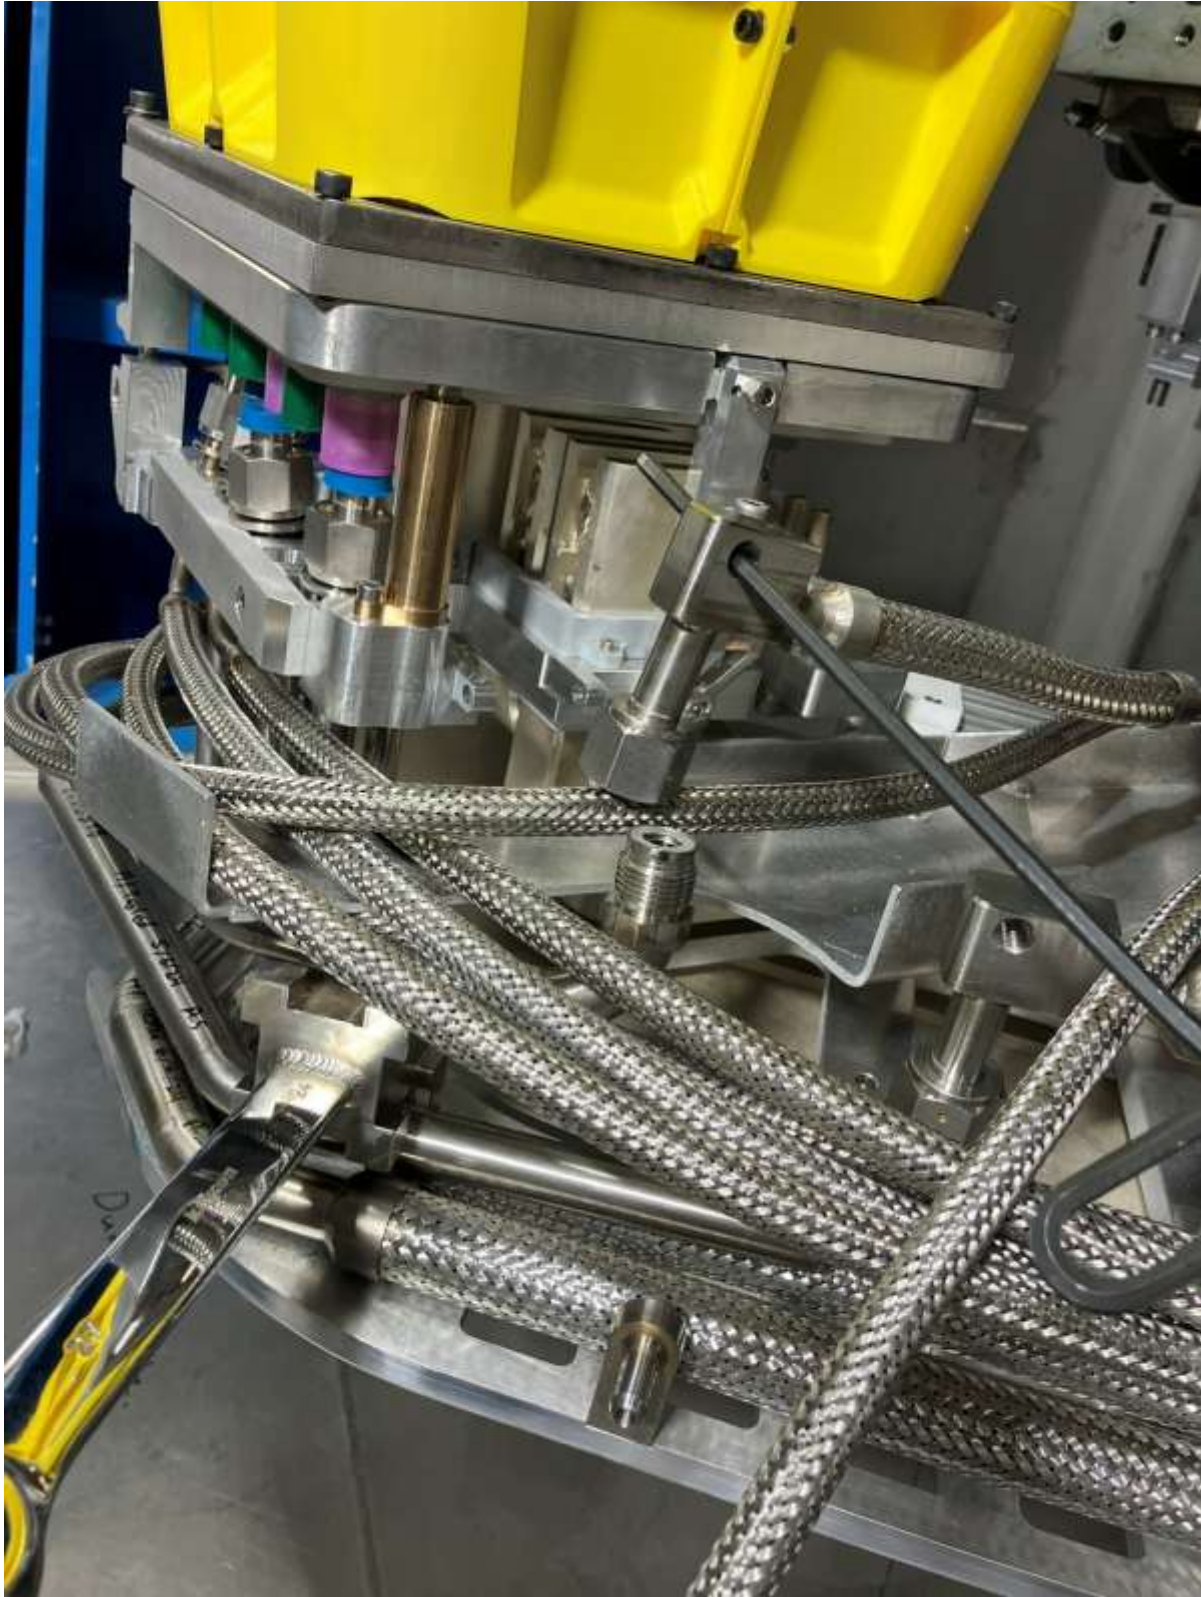
Wrench used to prop up the male side of the line. Using the thru hole on weld body to maneuver the female side into alignment

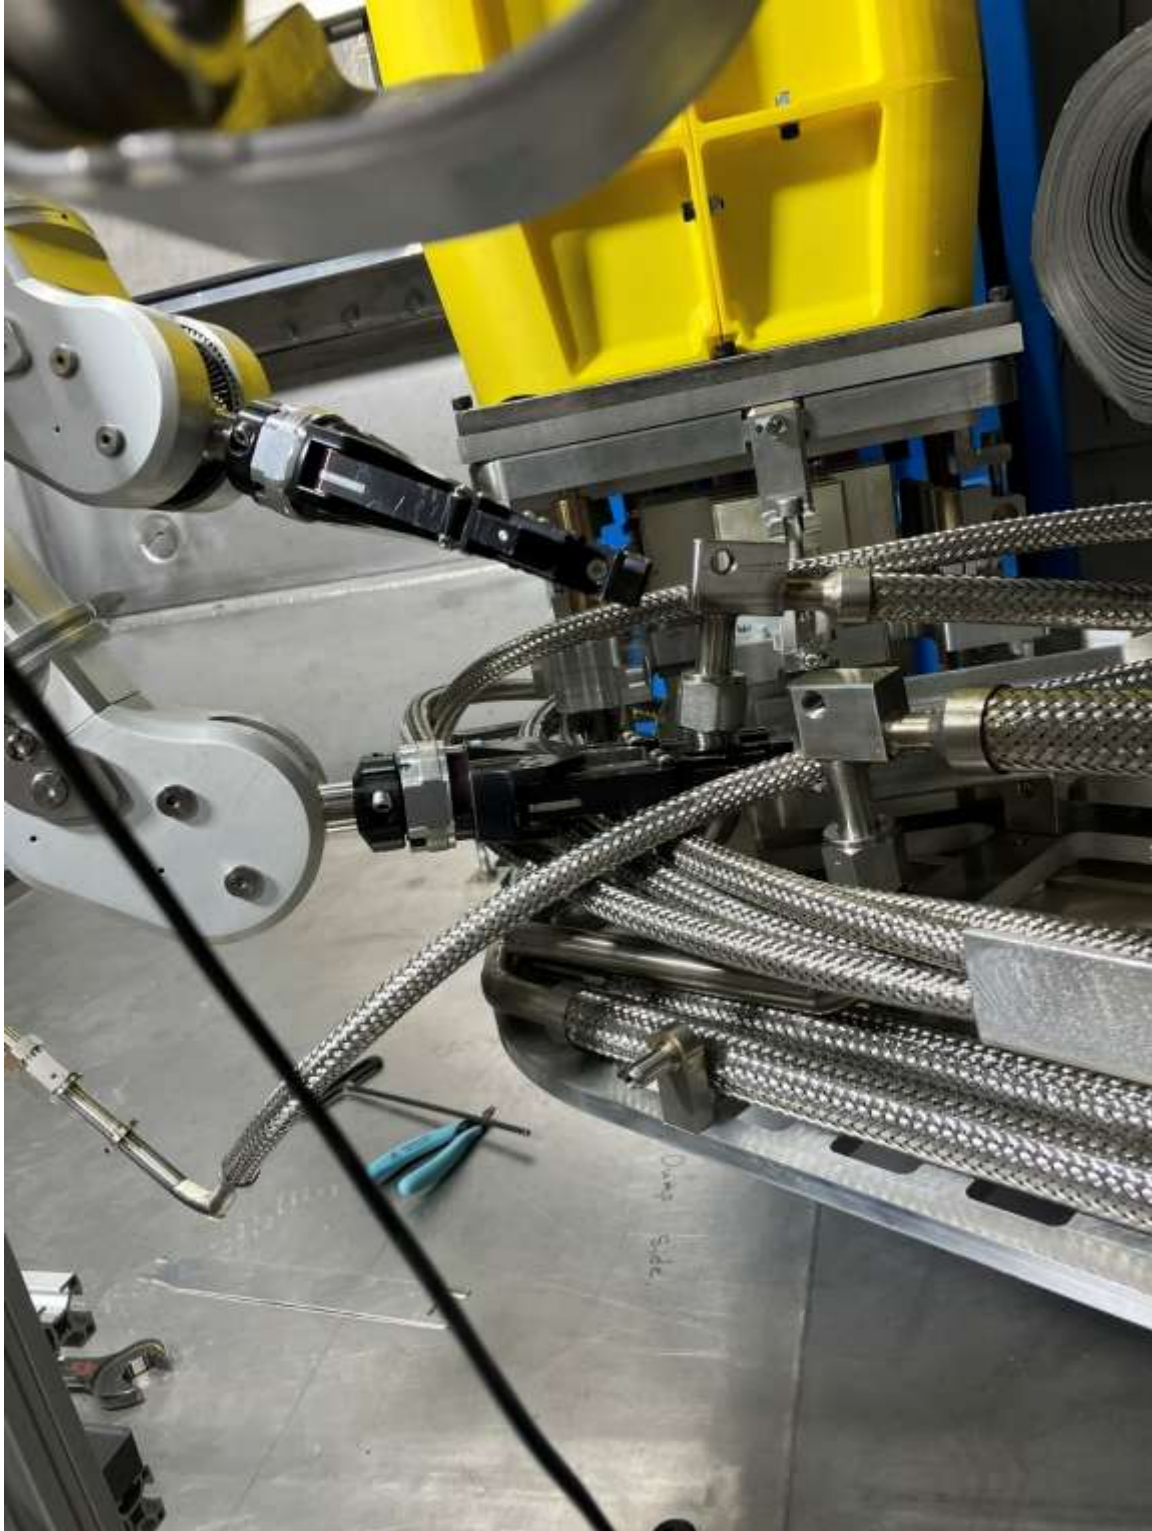
Illustration of 'resting' relative orientation between the male and female sides.

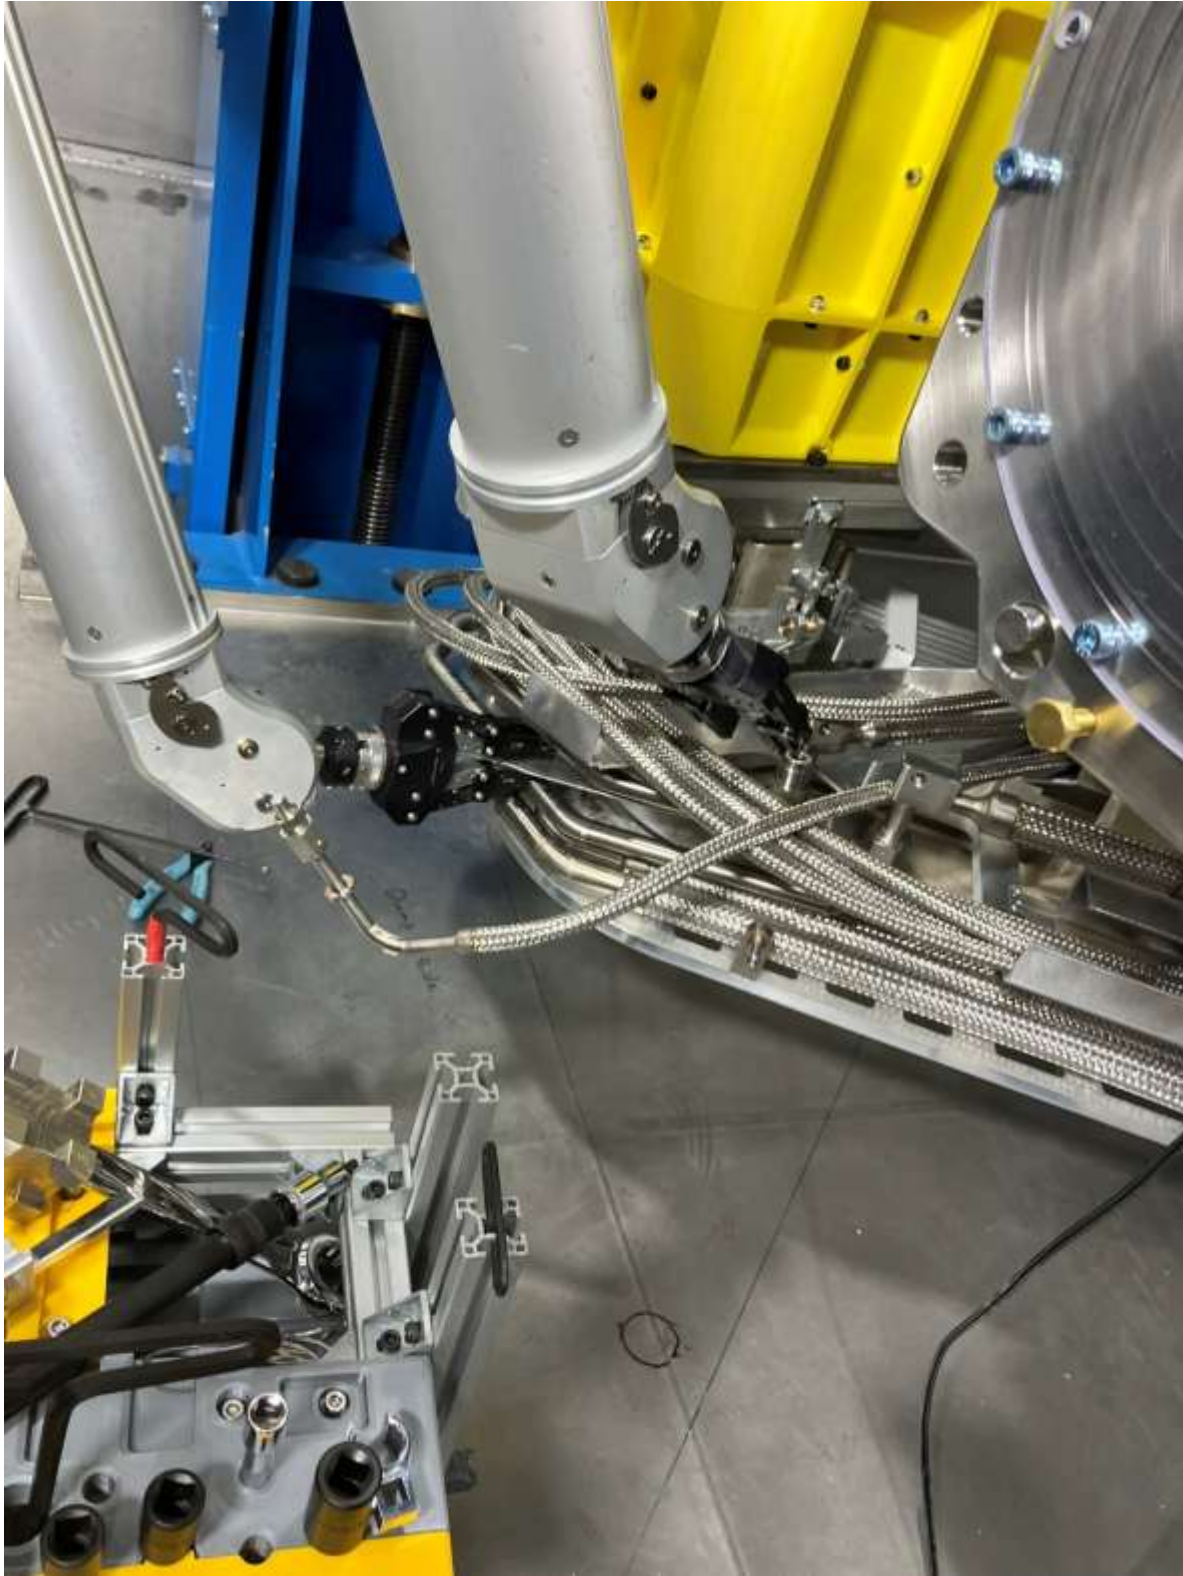
Initial attempt at propping up using flexible sheet tool.

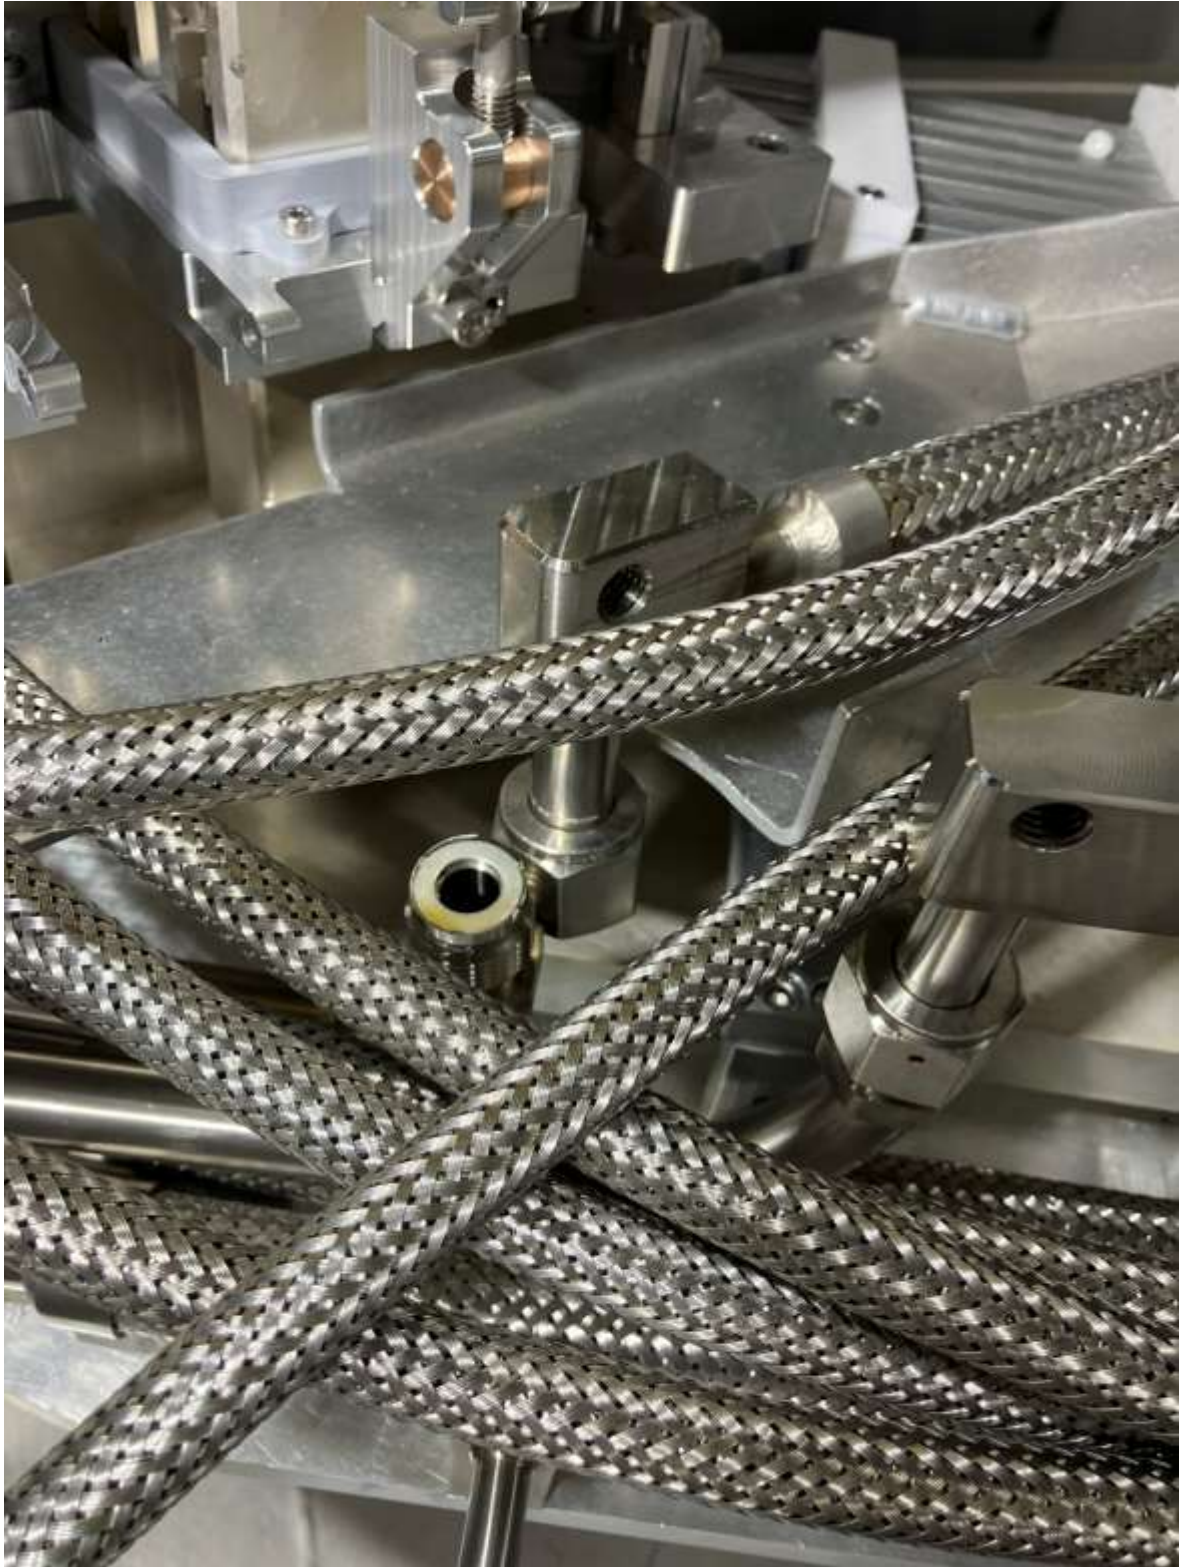
Illustration of VCR gasket on male side

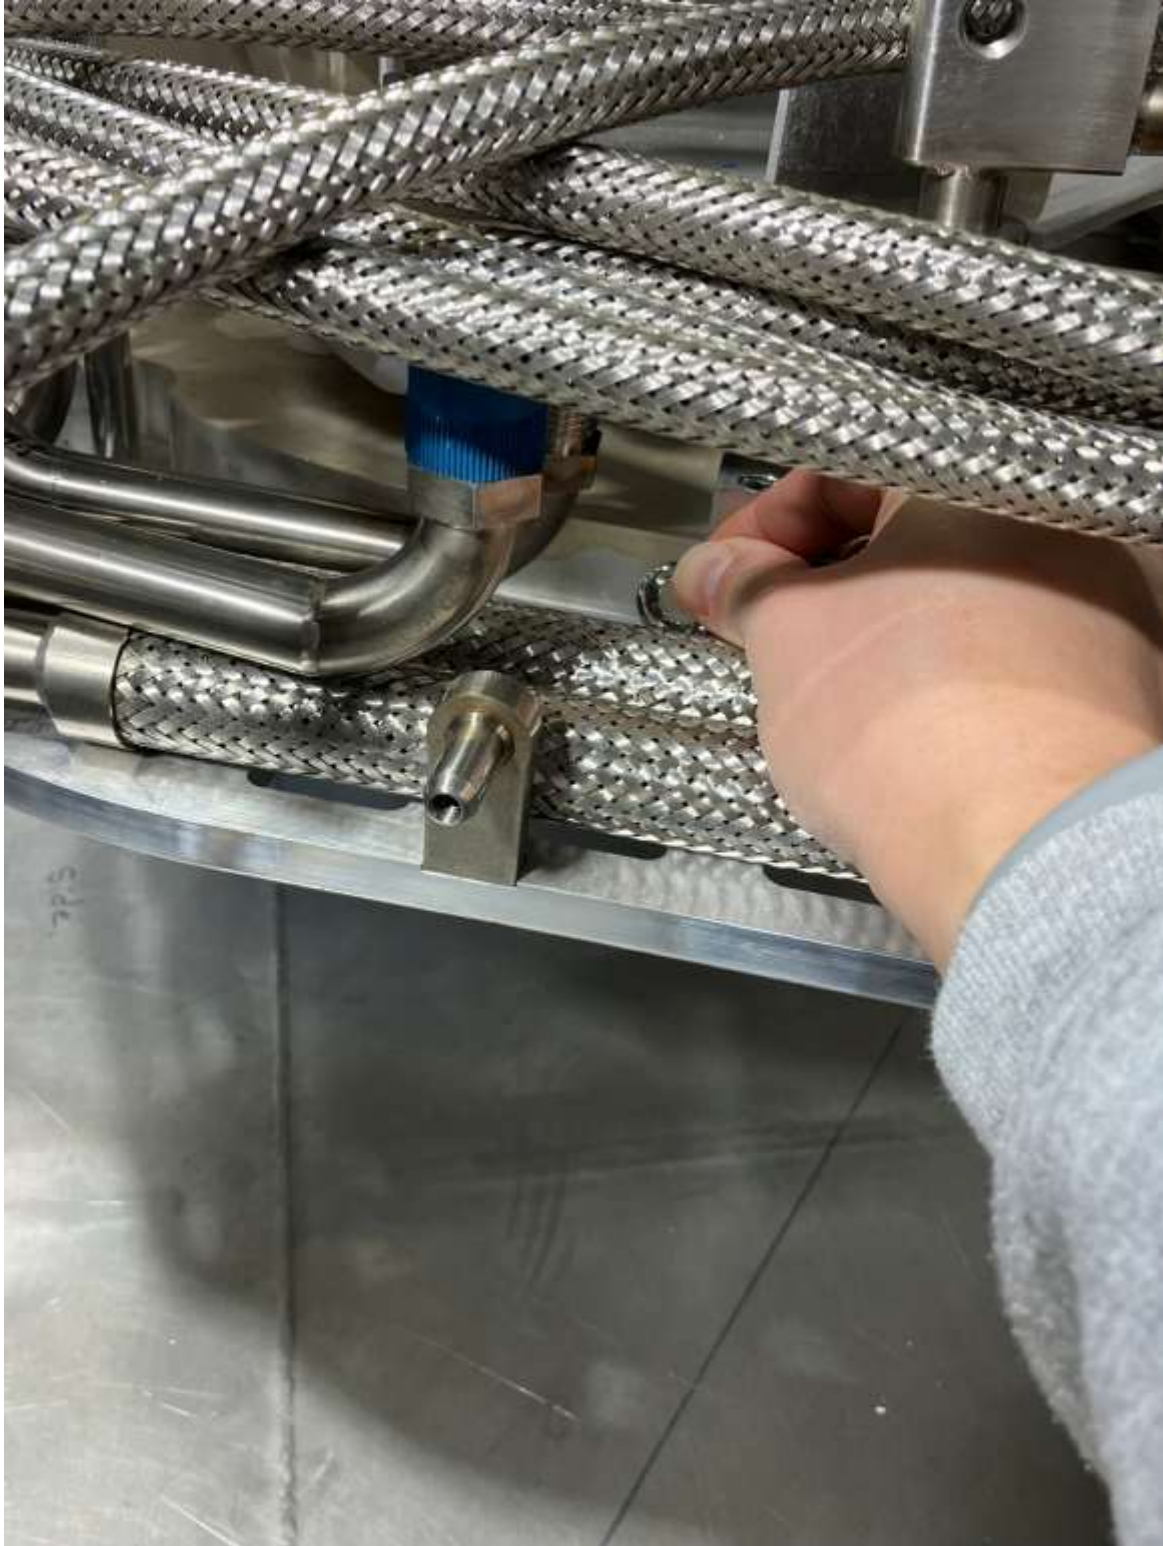
If dropped behind the lines, VCR gasket will be difficult to retrieve.

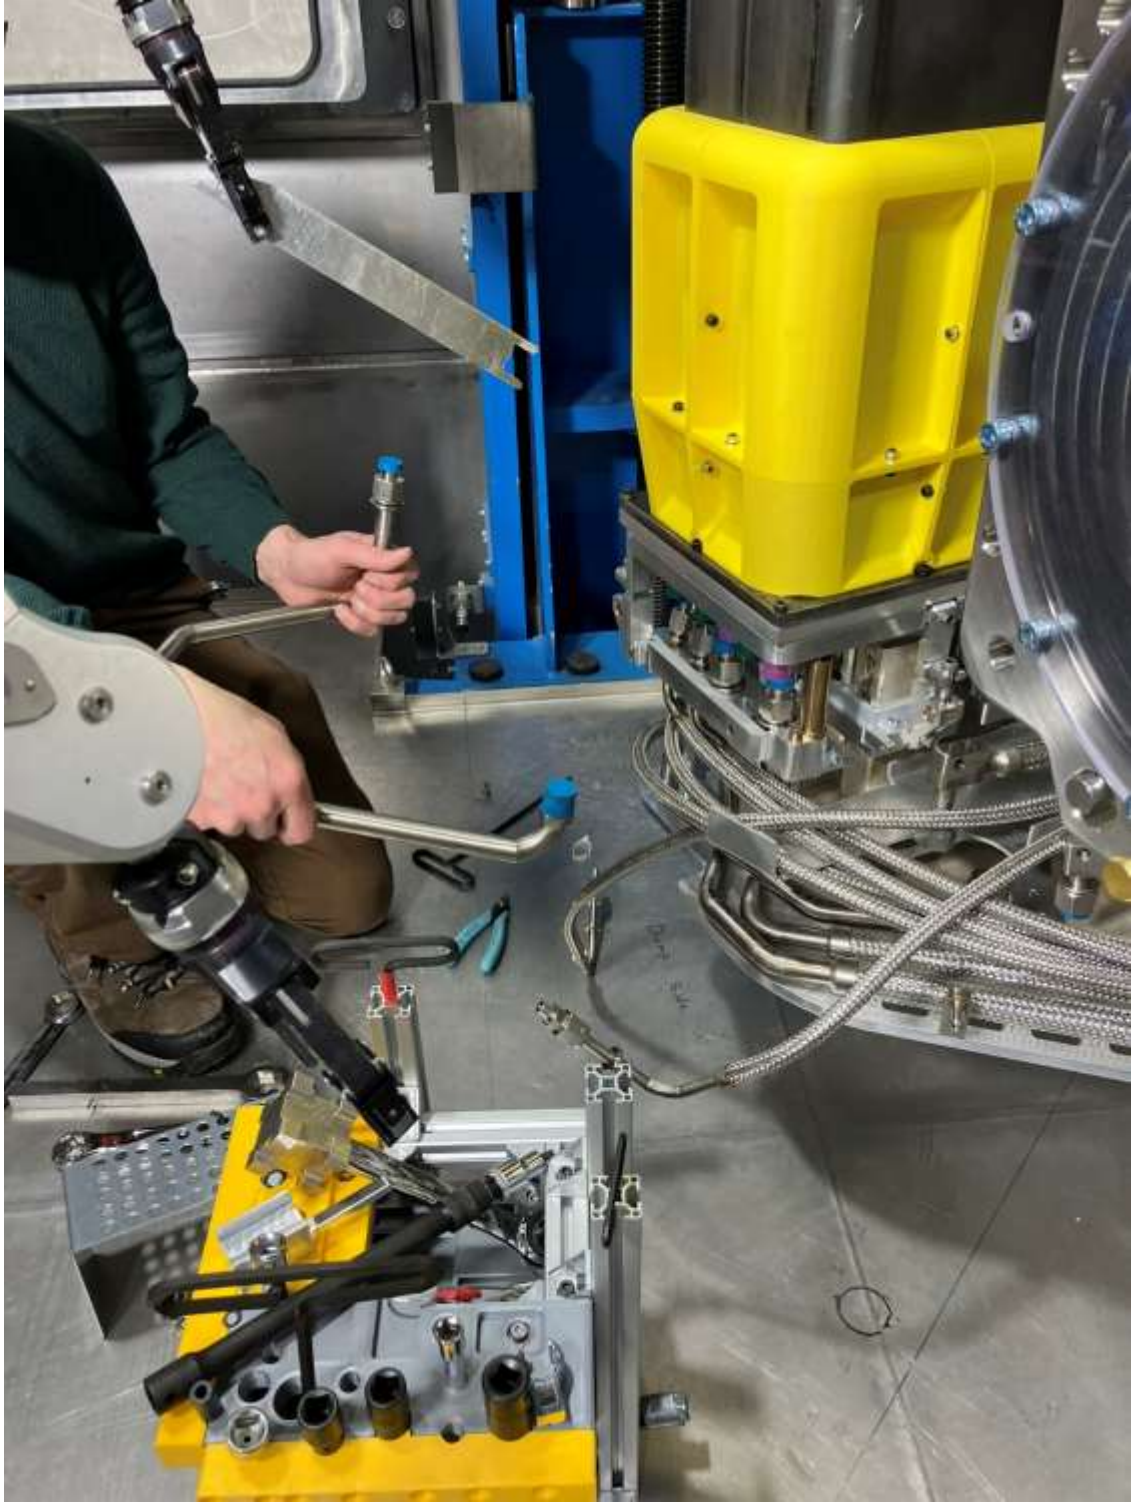
Hard line tube section looks like it can be removed without issue, tested by hand.

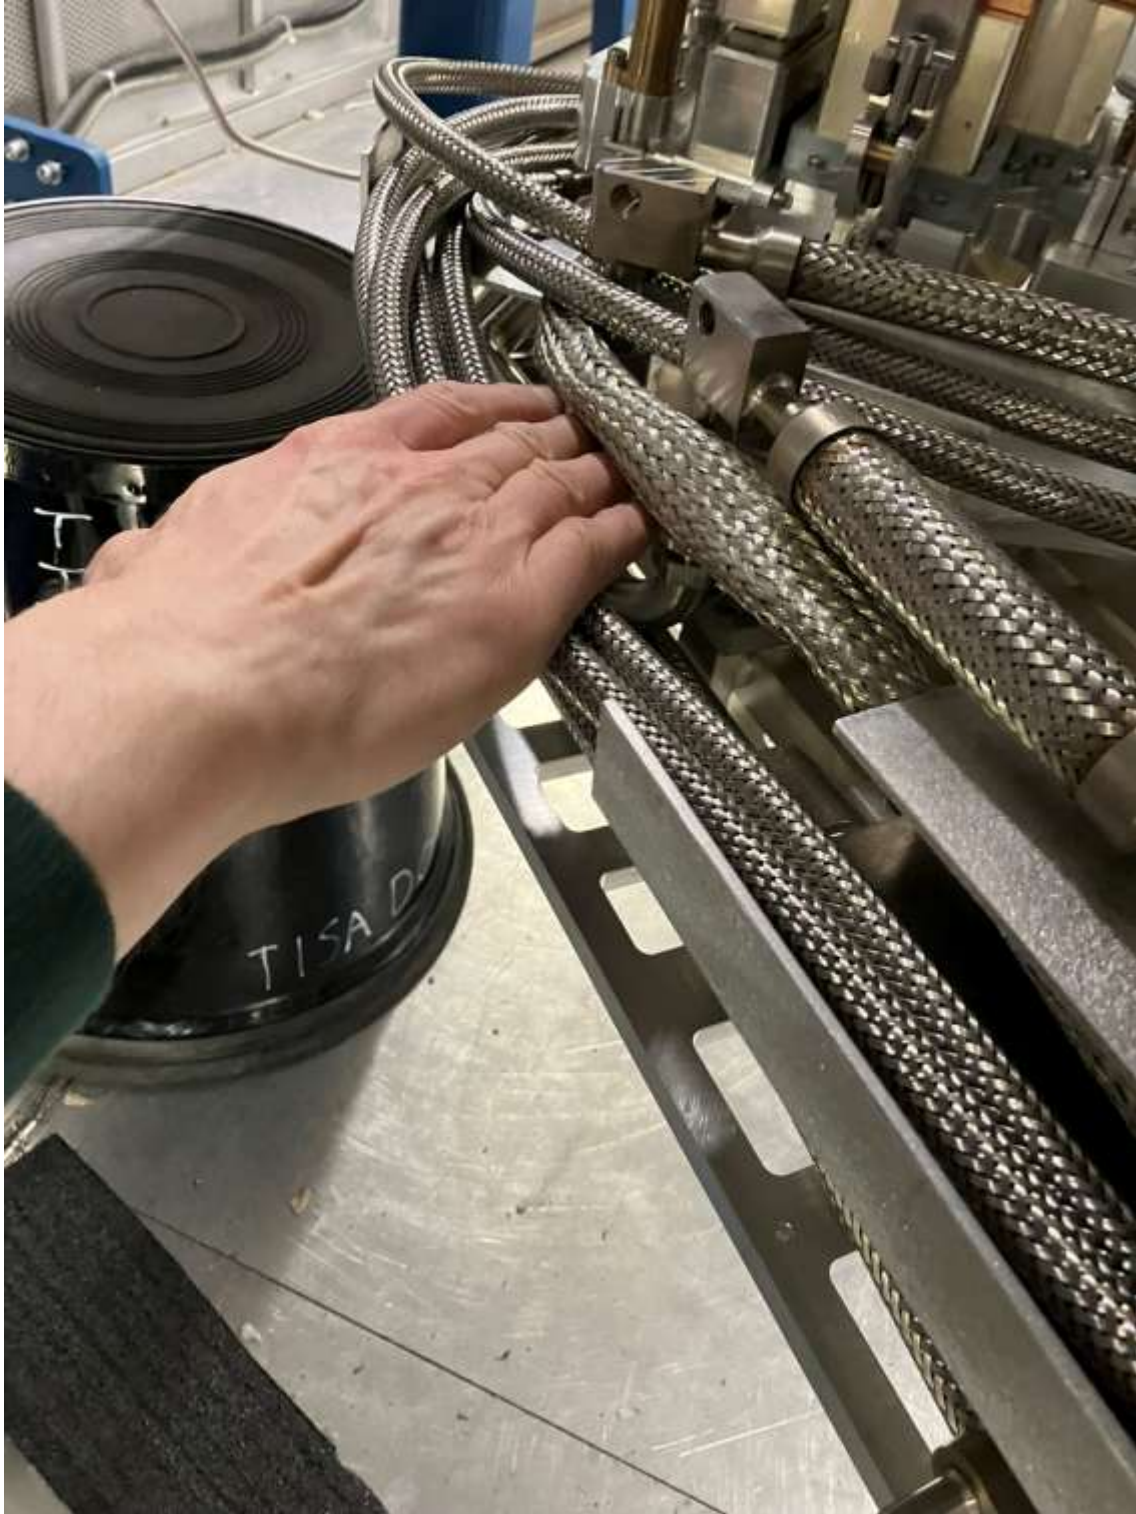
Multi-pin bundle line on AETE in TISA room interferes with access to intermediate VCR joints.

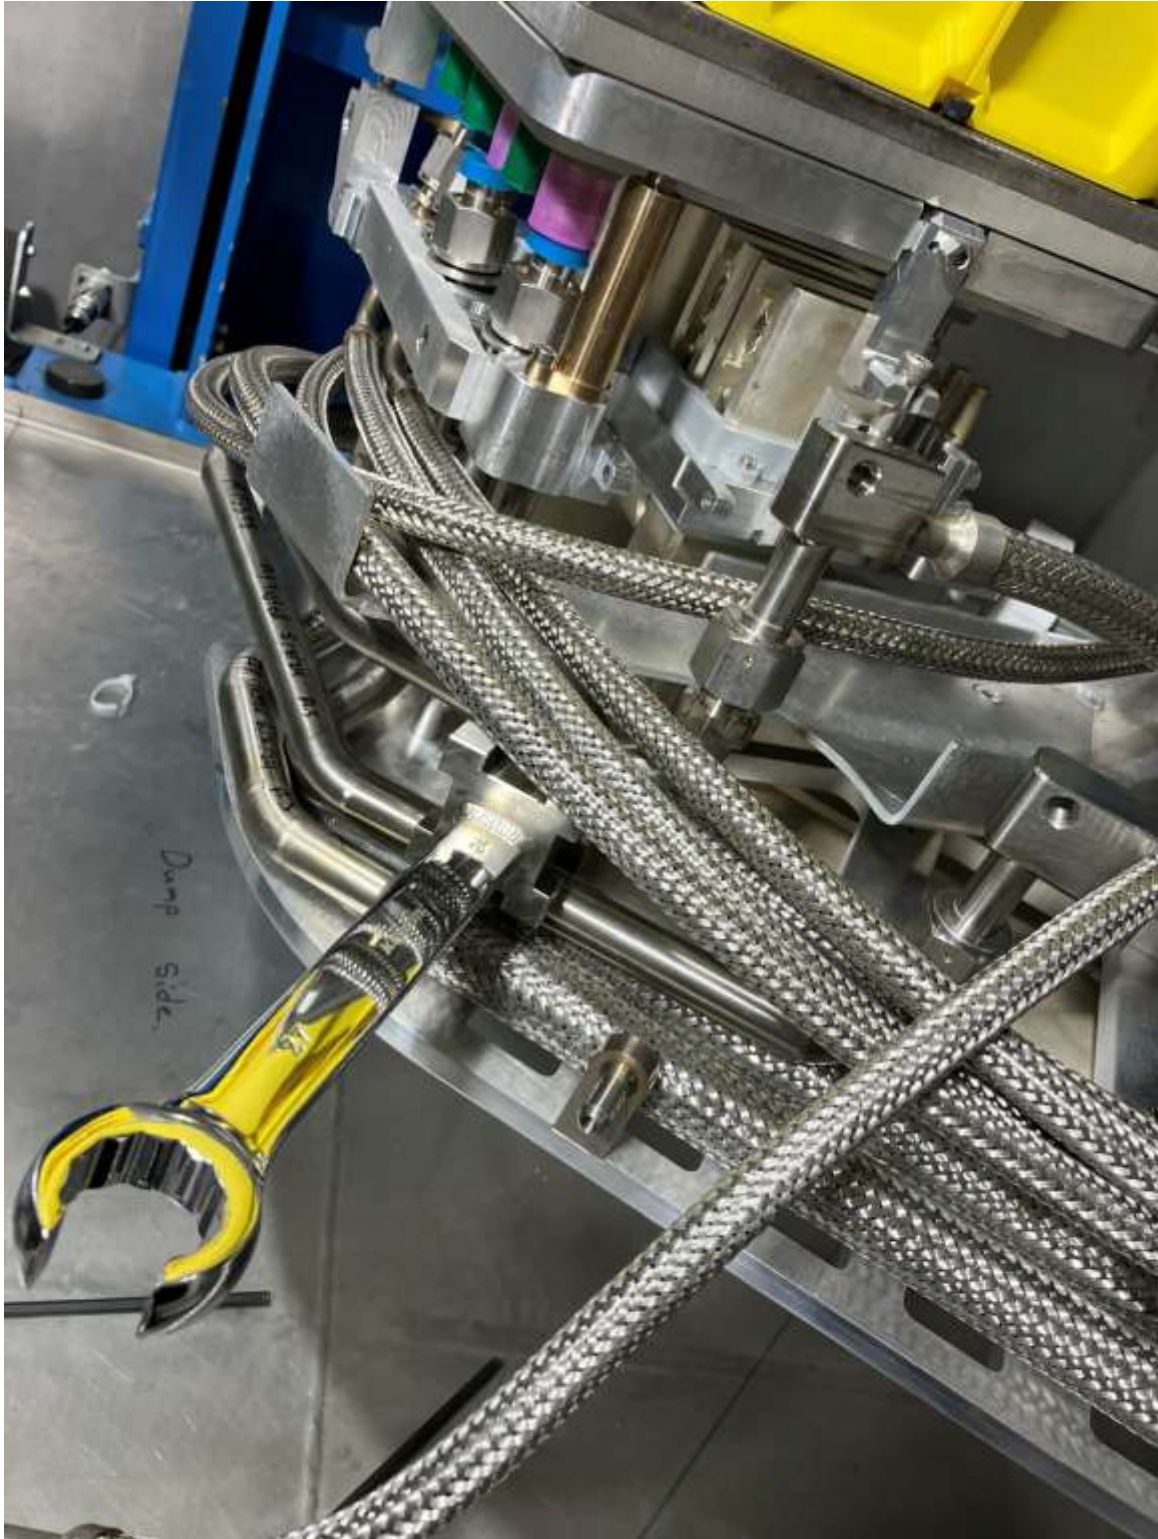
Using big handle wrench worked well to prop up the welded tube section for access to redo the joints.

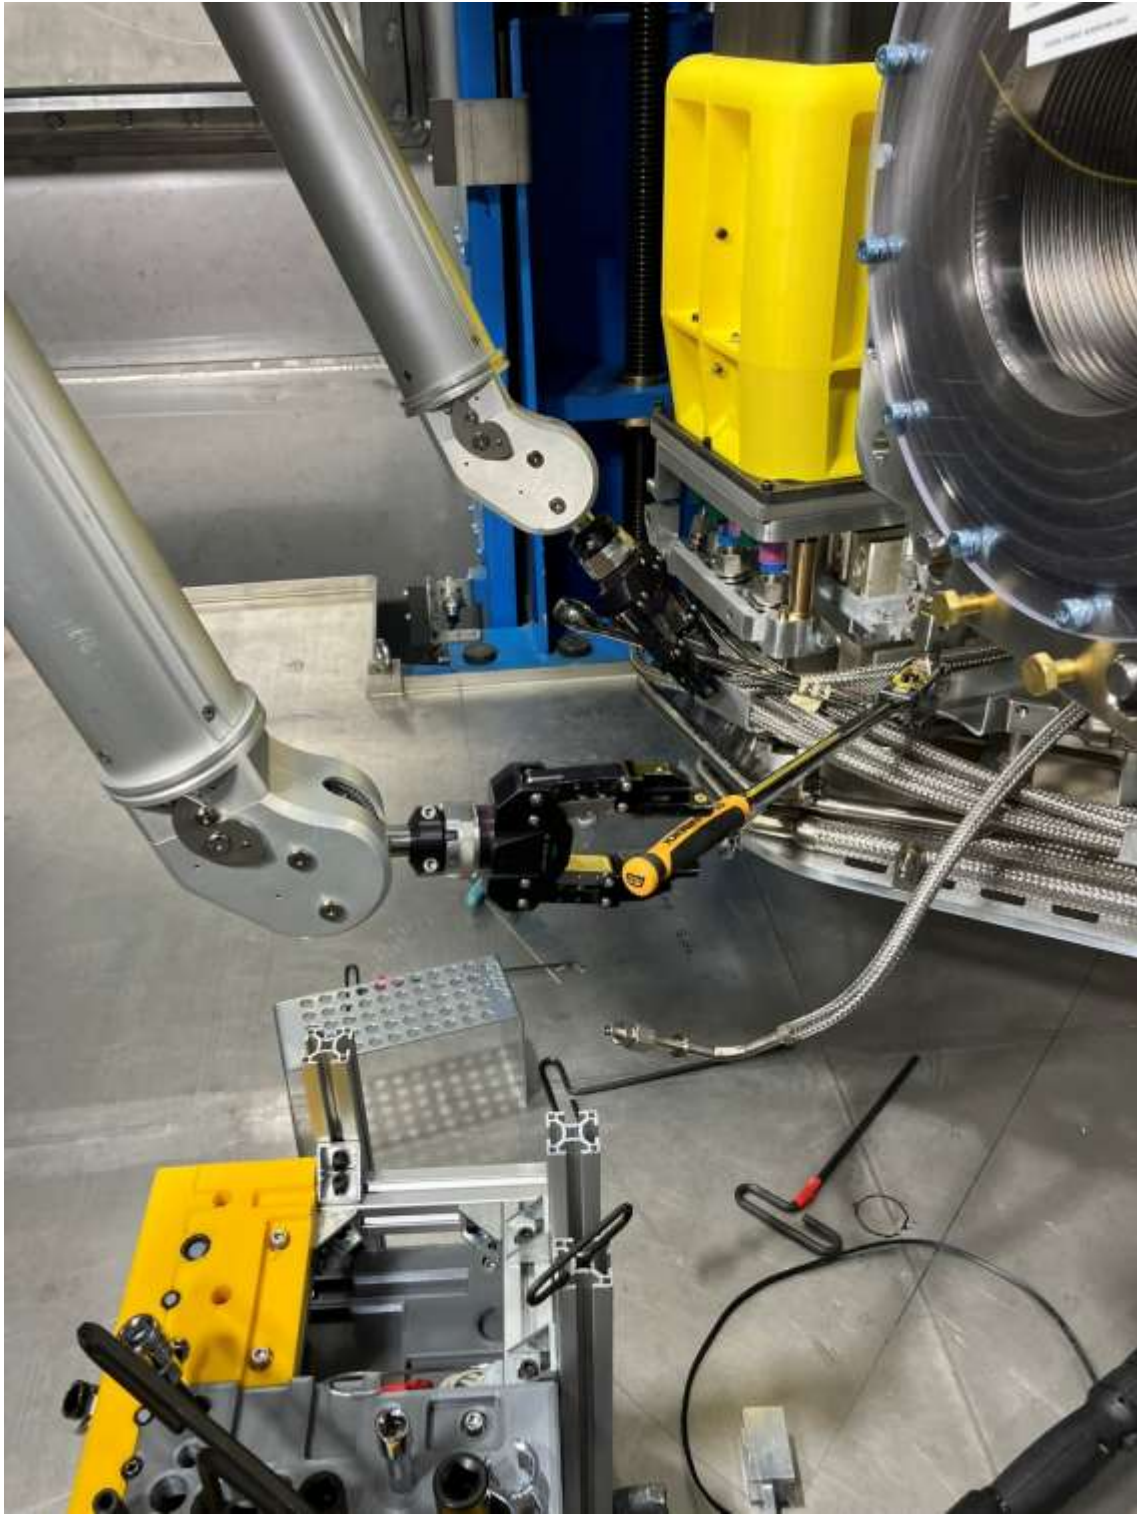
Setup for successful re-establishment of joint. Crows' feet and extra length ratchet used.

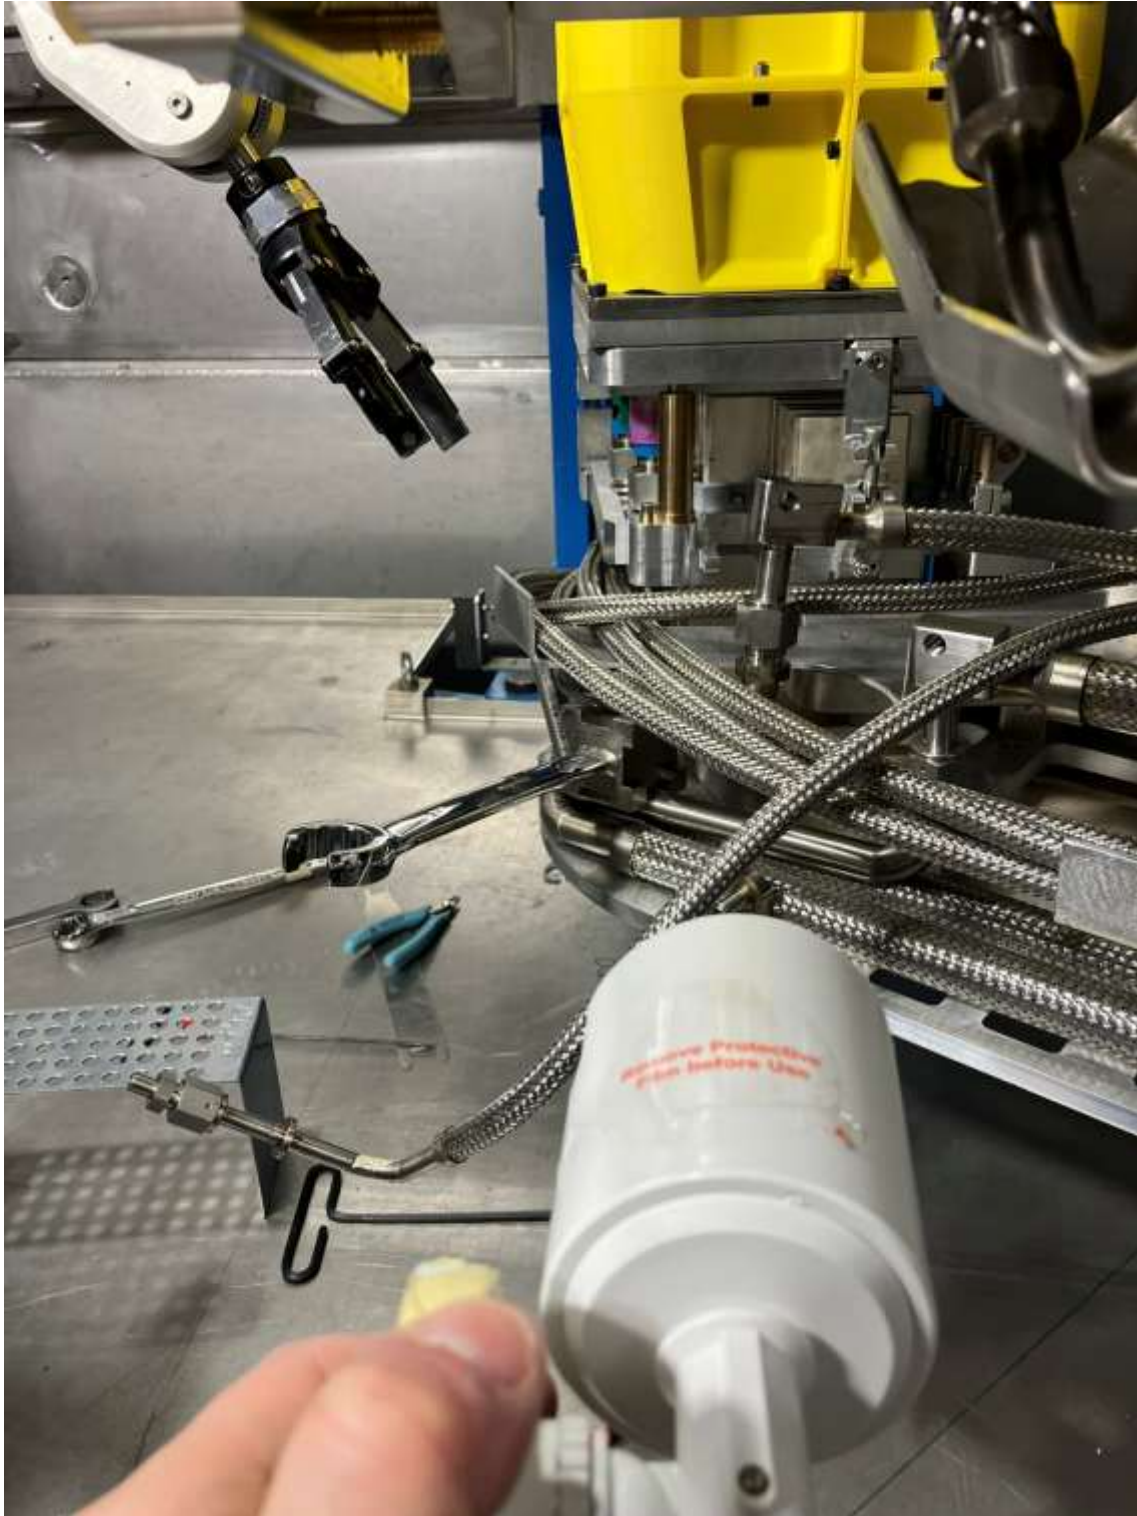
Misalignment not perceived from hot cell window, illustration of possible useful cross-view camera placement.

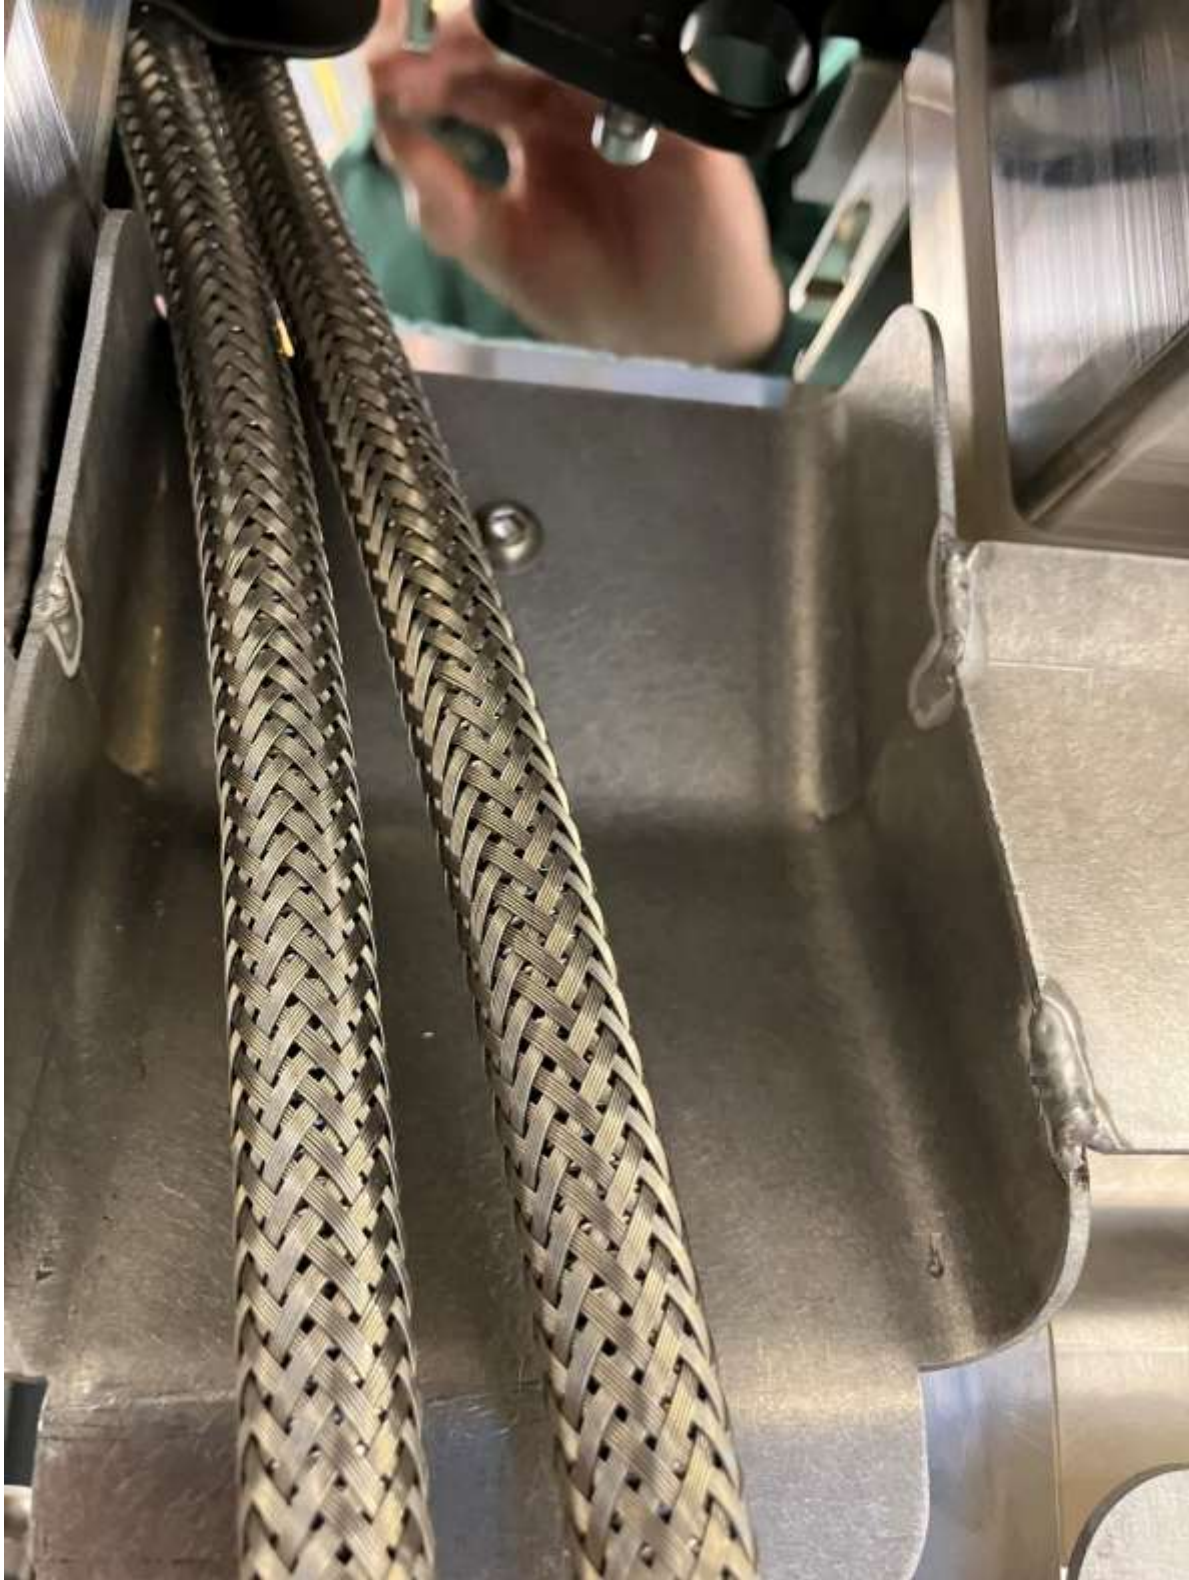
The full length of gas lines could be 'fished out' from this opening on the FE services plate.

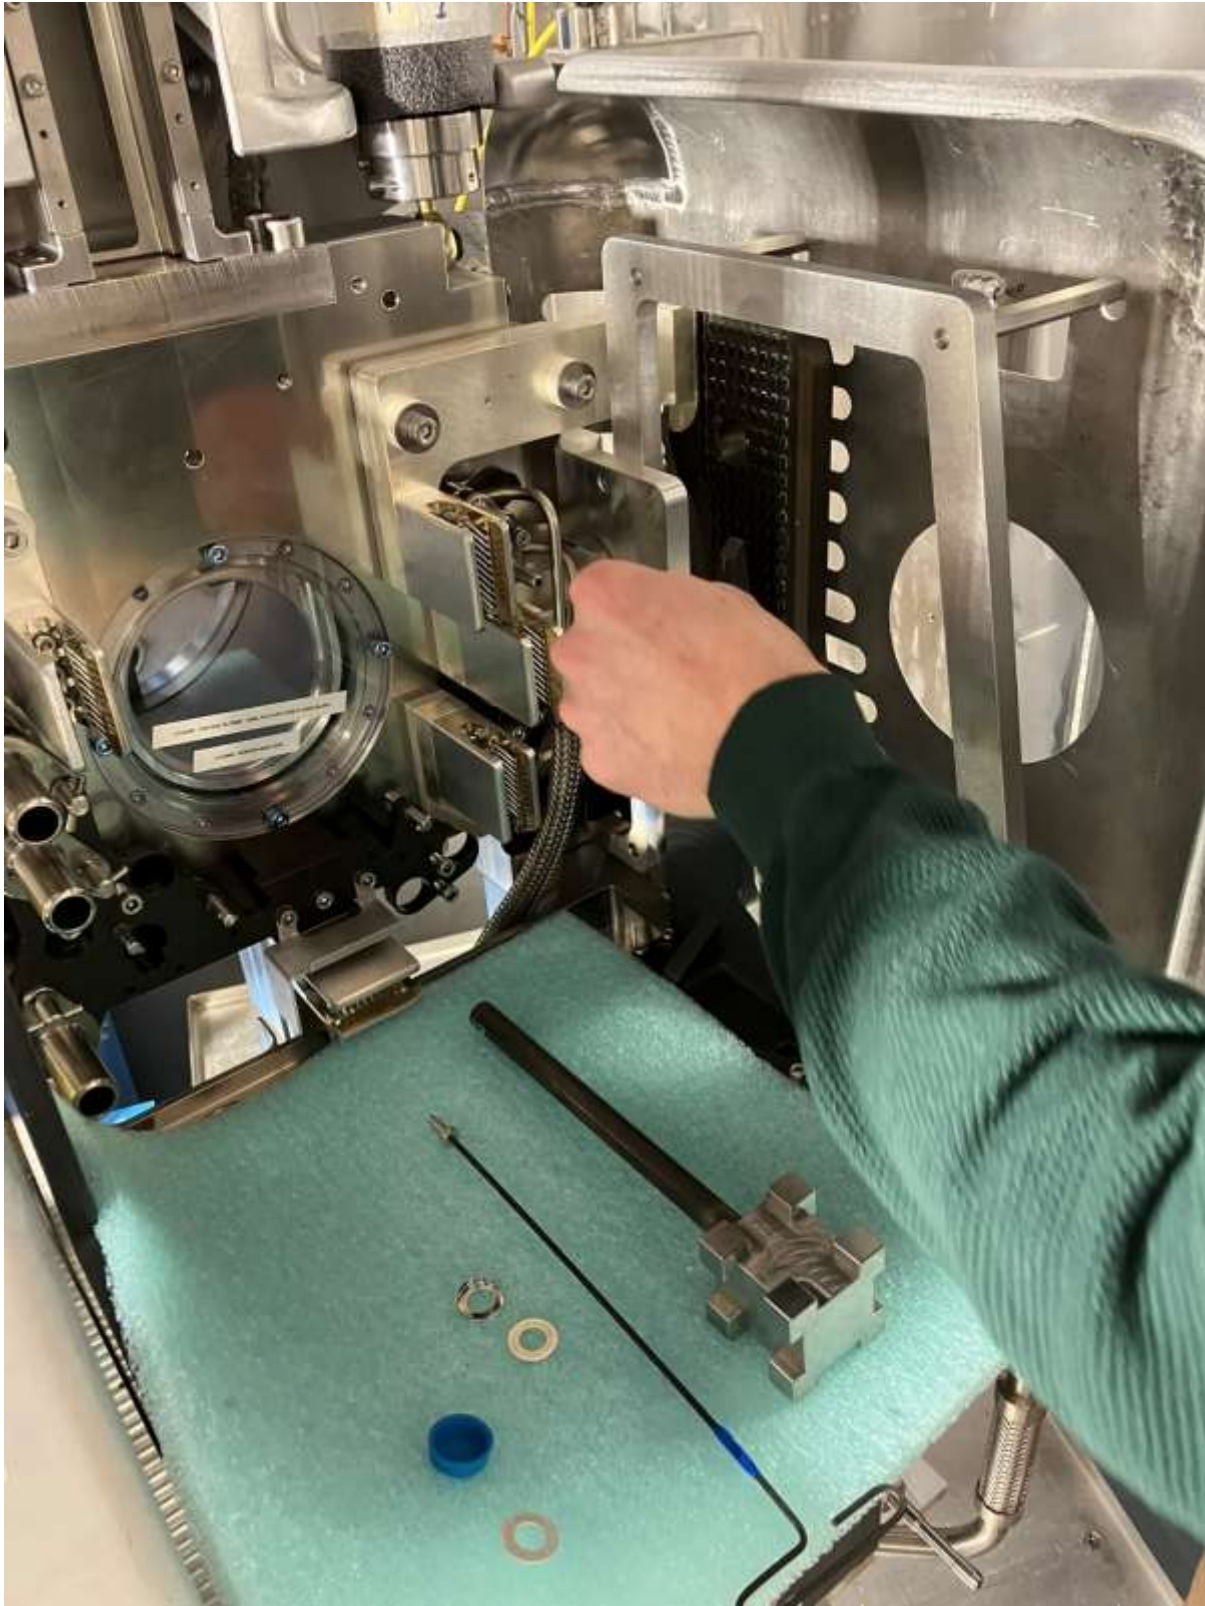
Gas line bracket and screws tested by hand, confident can do if tool is made to grab onto the sealing tube ends without damaging.
