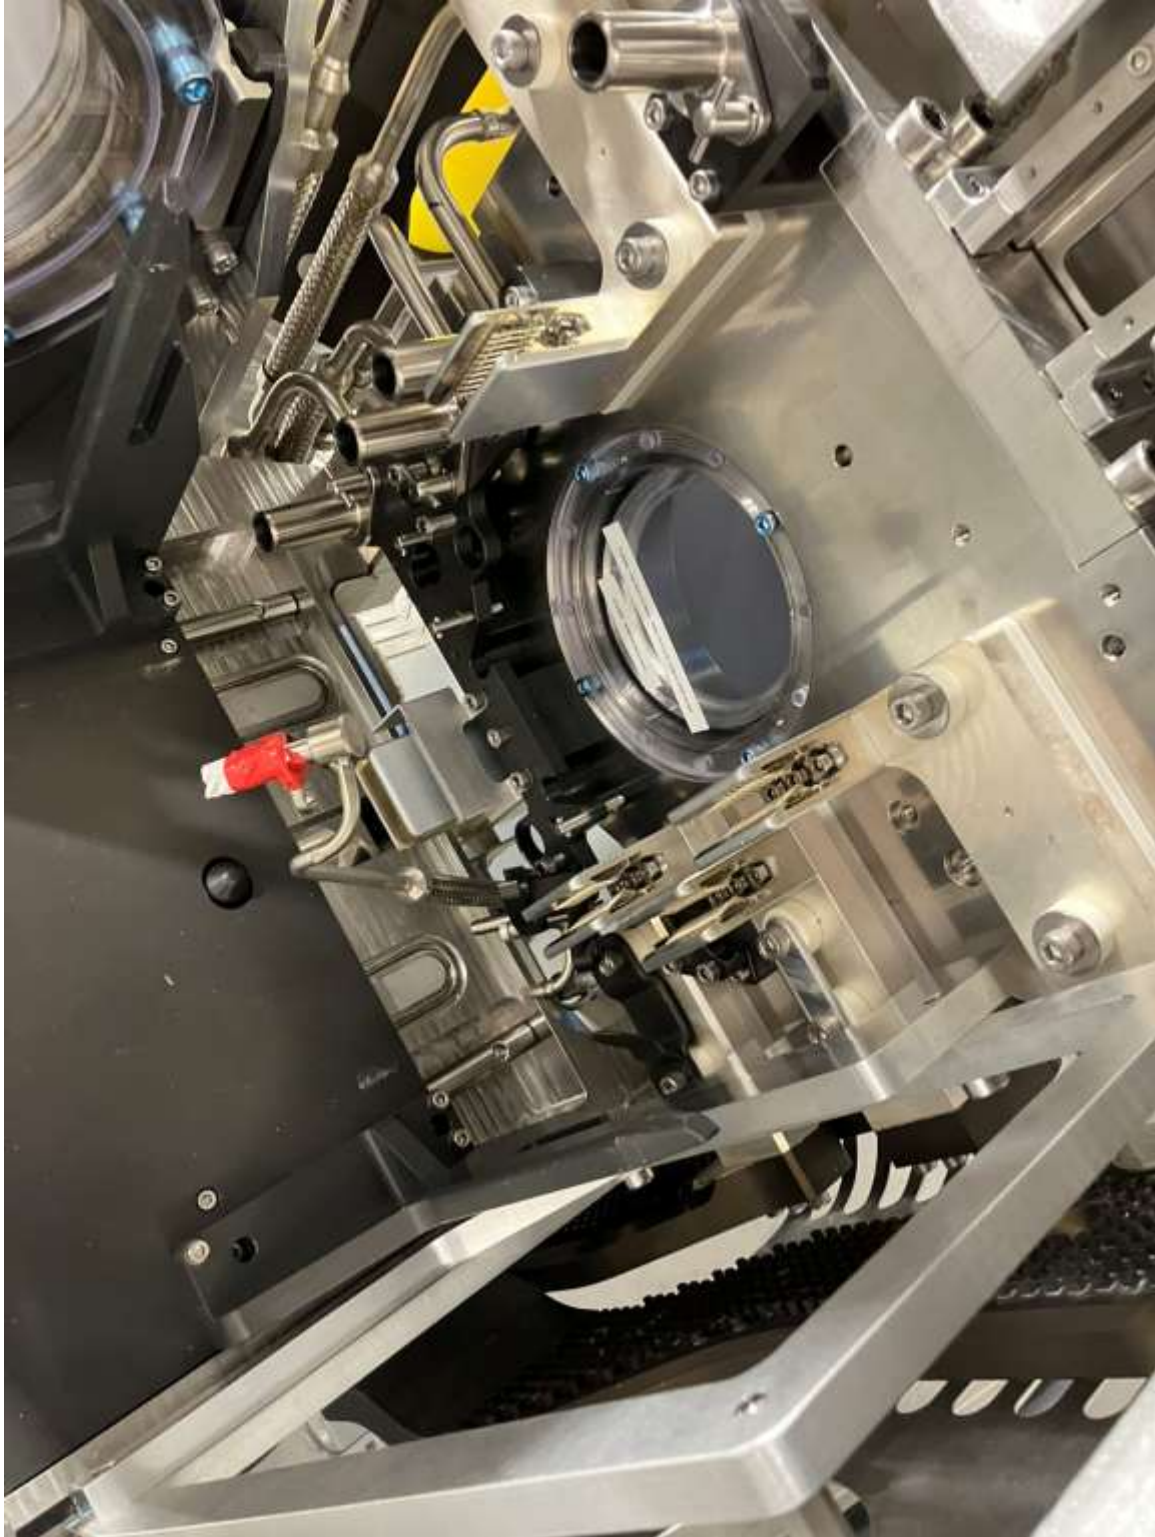
Taped sealing face on gas line tube, checked that it can be fished out from opening, electrical connectors not present at the time but confident it won't affect the outcome.
