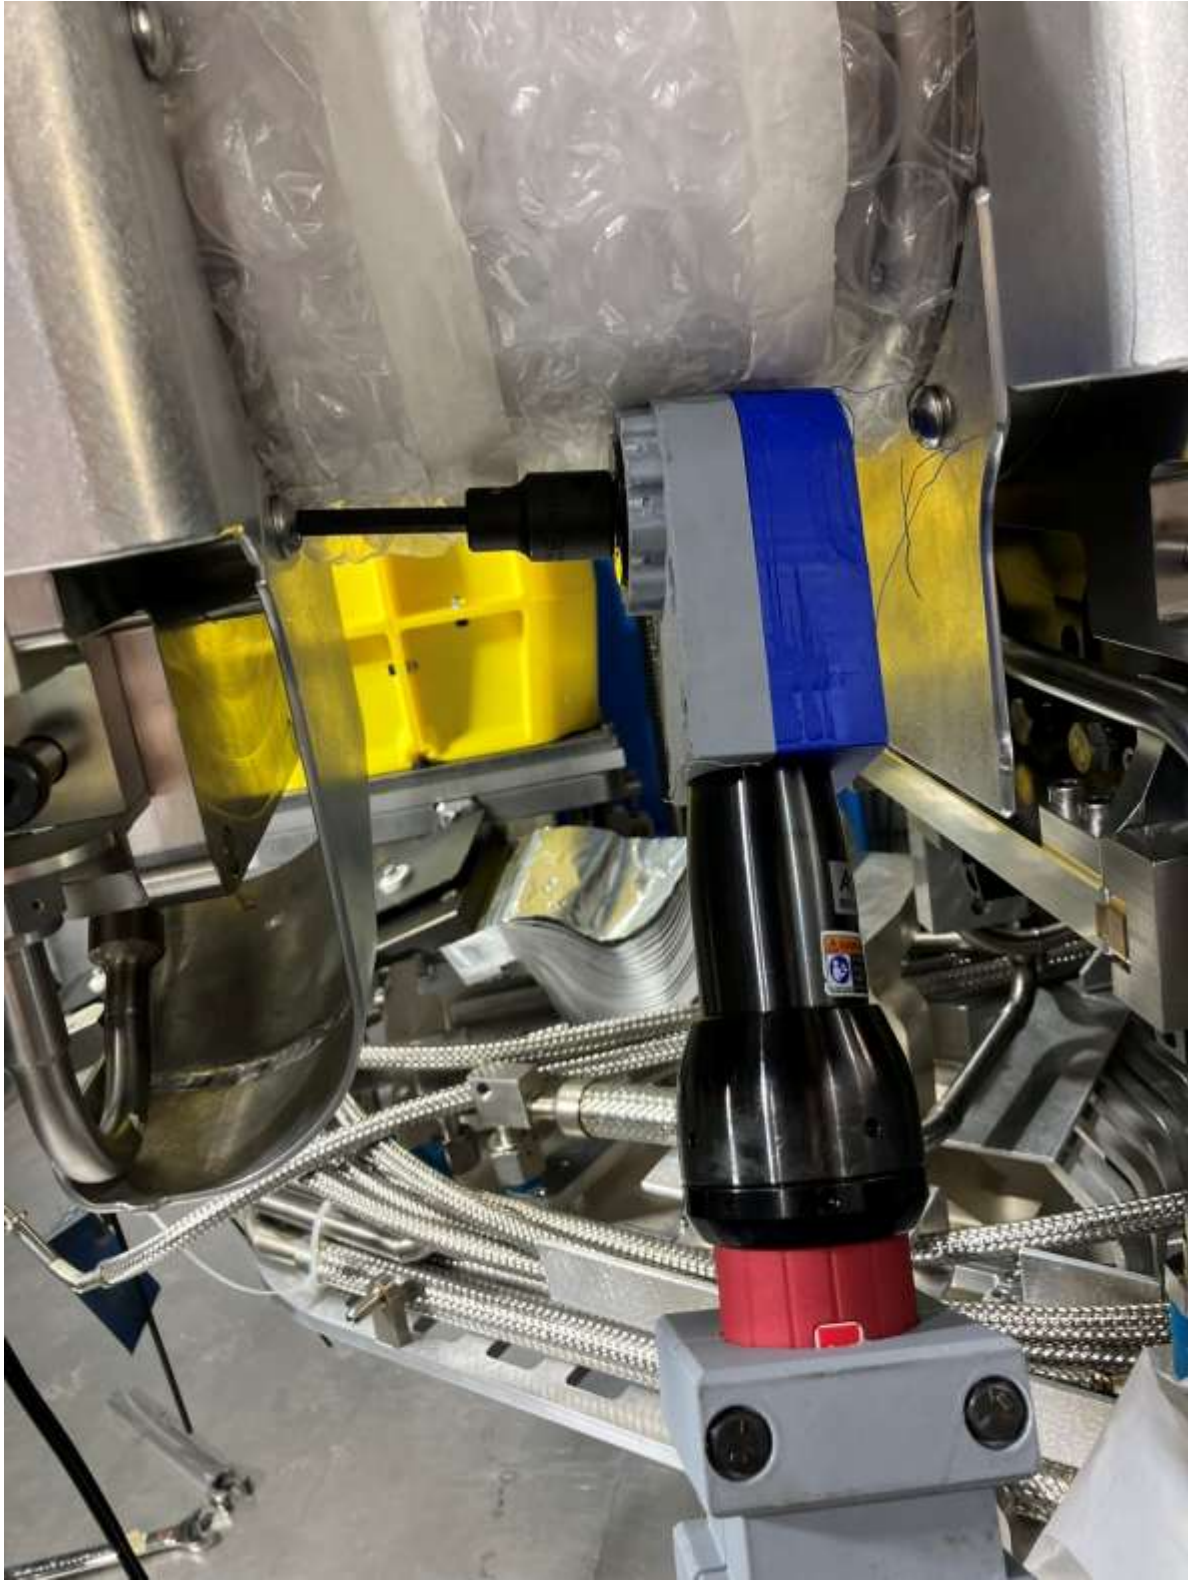
Torque tool interference when accessing HV shielding for this hanging VCR joint.

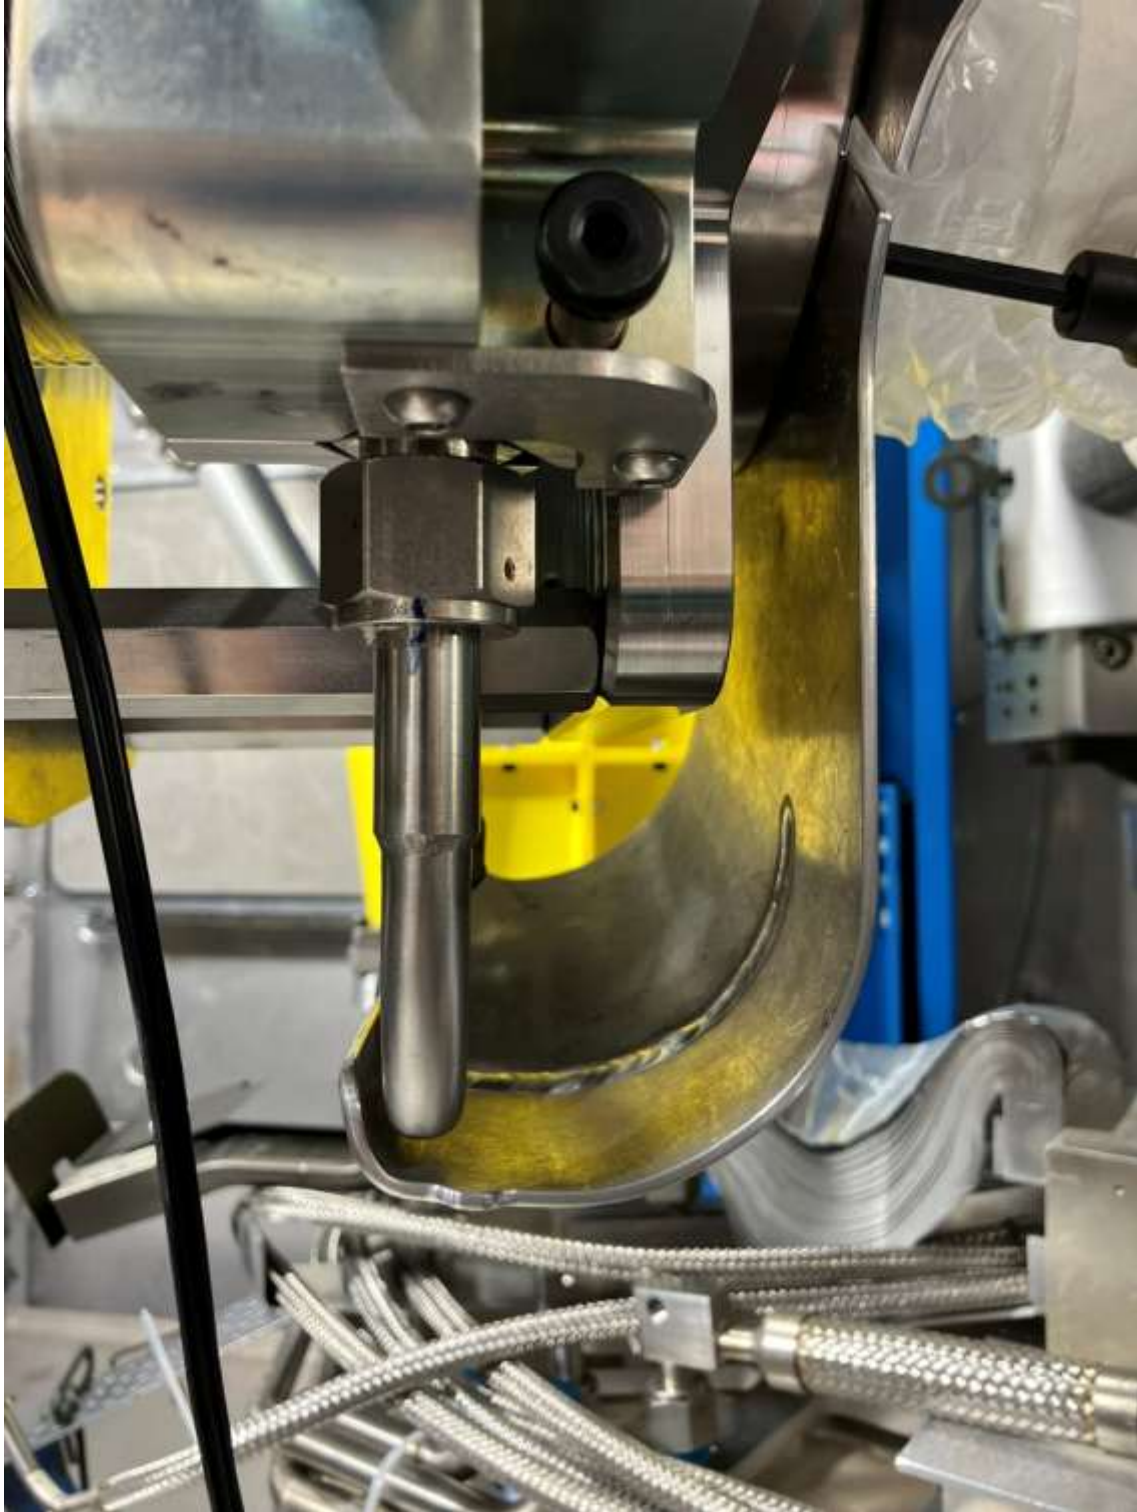
Joint successfully re-done by hand, no need for manipulator testing.

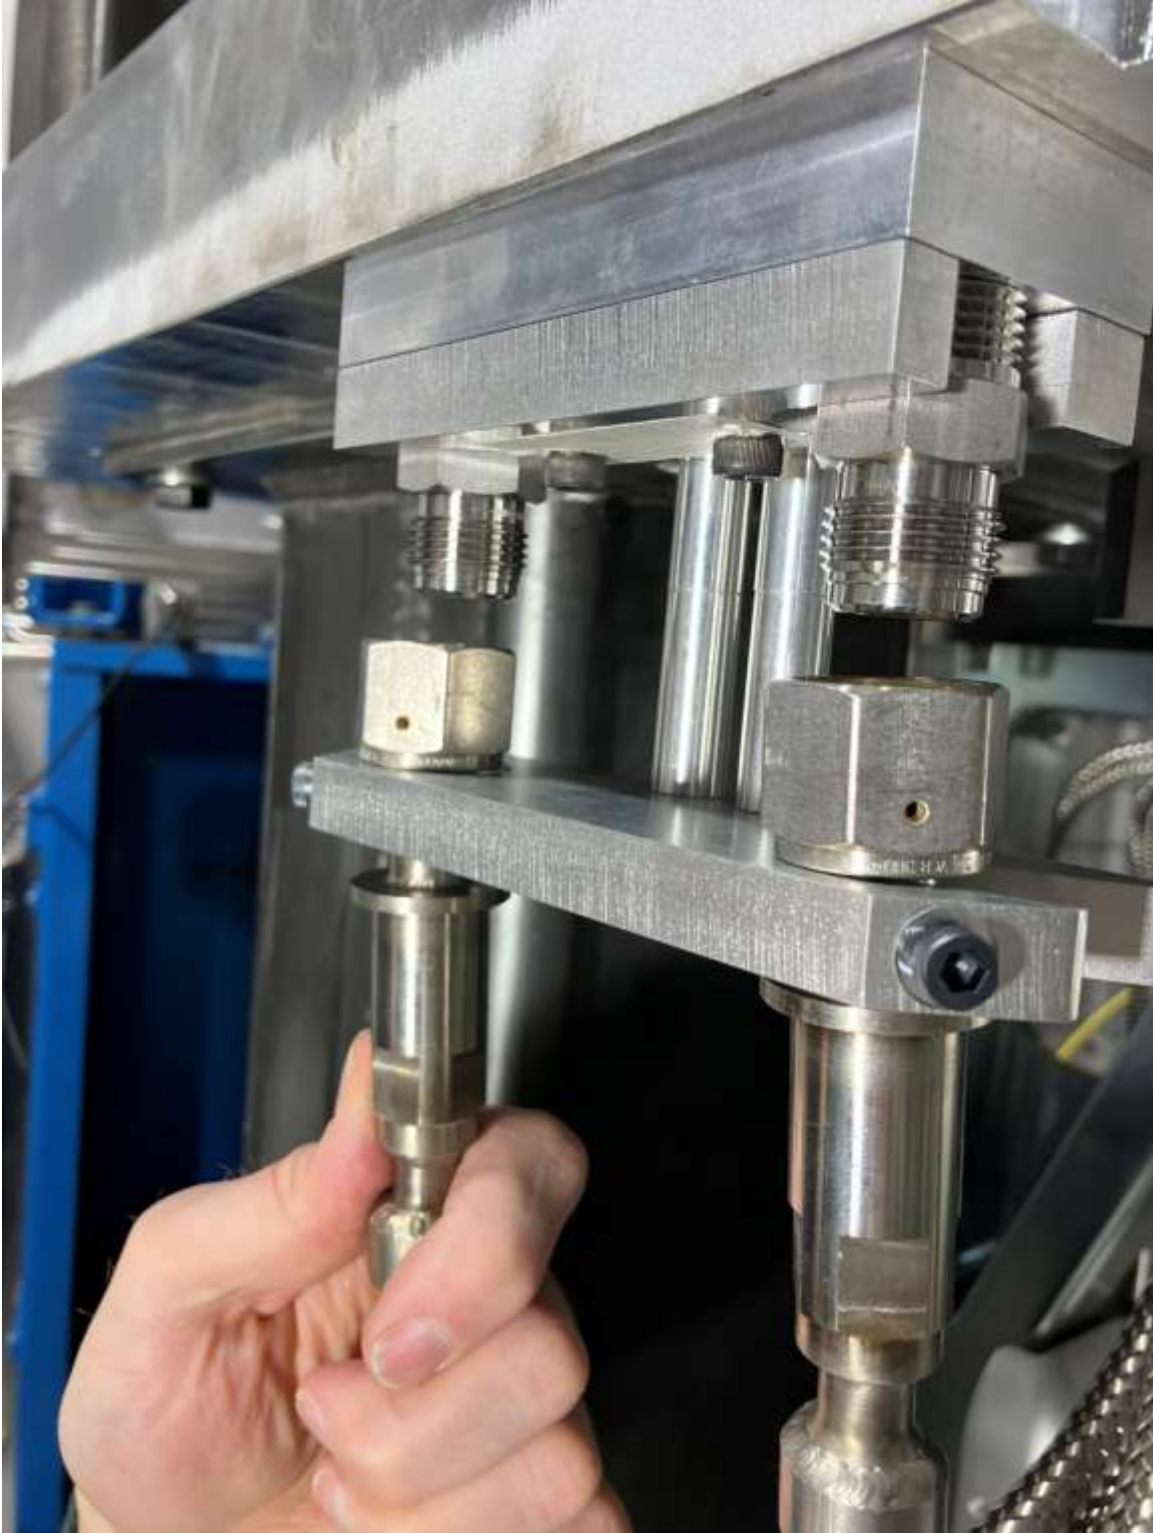
Bracket issue requires improper mounting of the female VCR side.

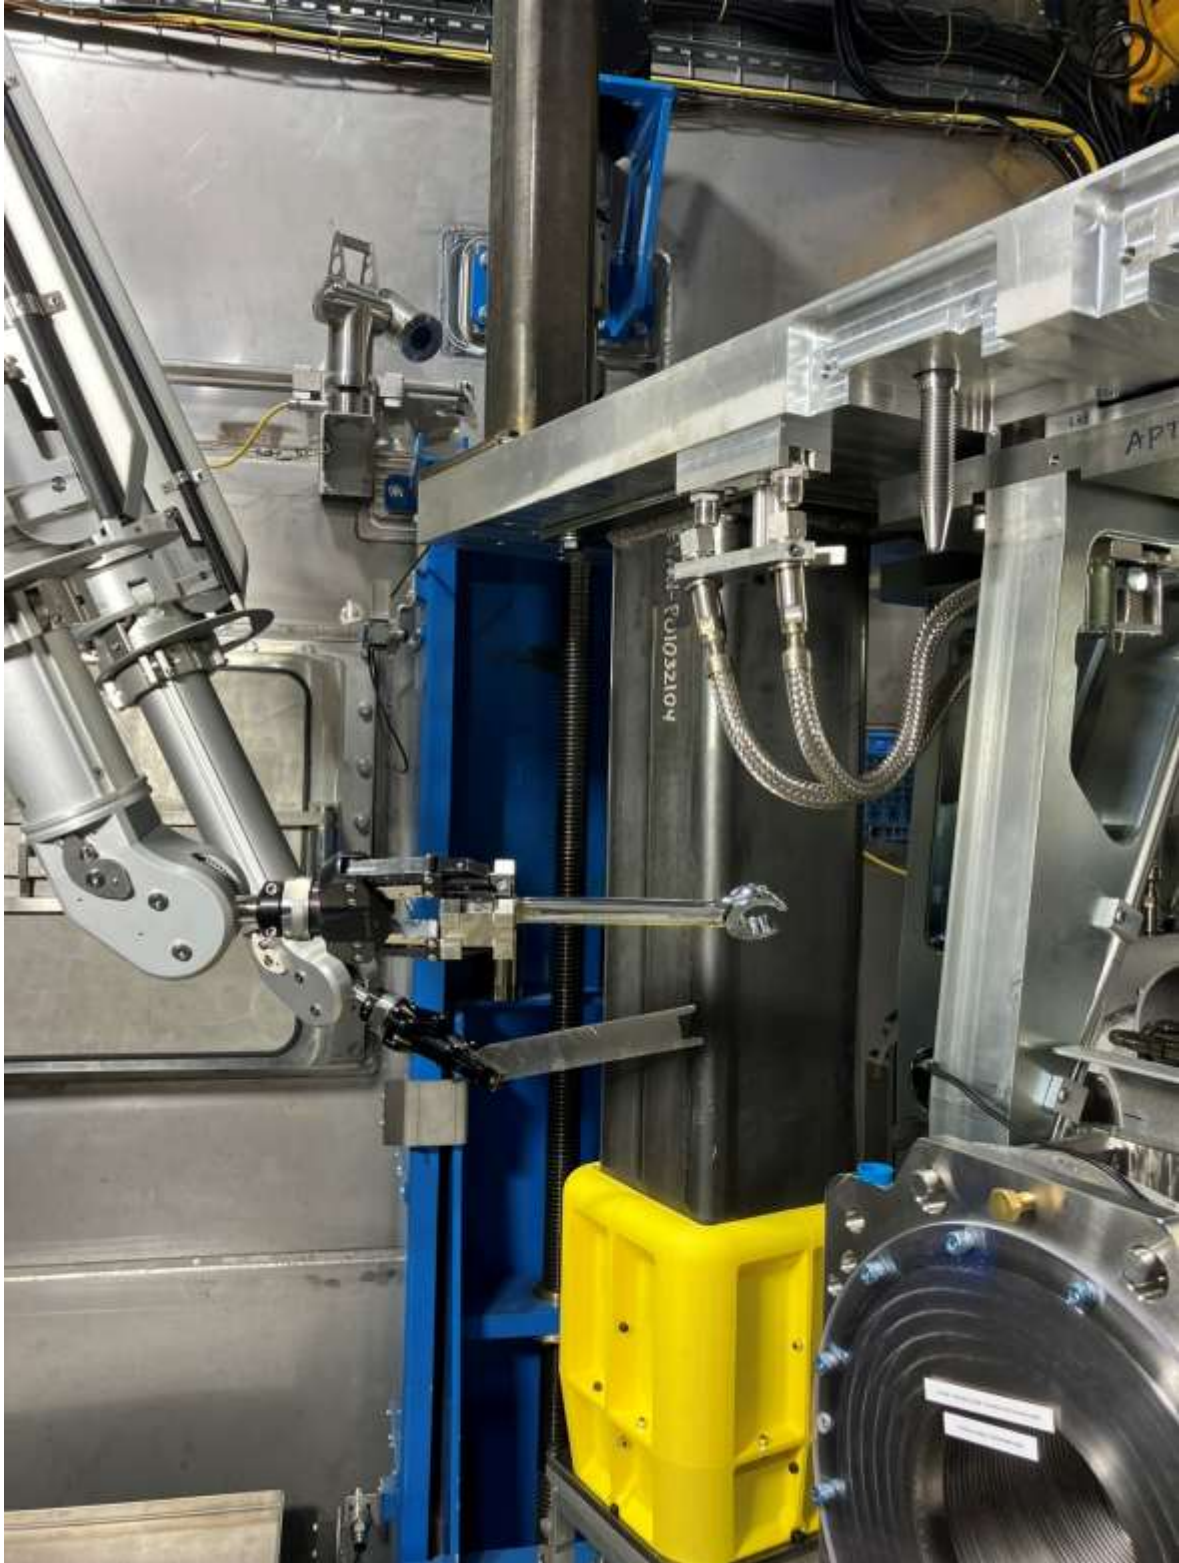
Successful positioning of the flexible lines on the upper driver side with manipulators into bracket.
