T2 M9 Alignment

Monday, February 06, 2017
3:56 PM

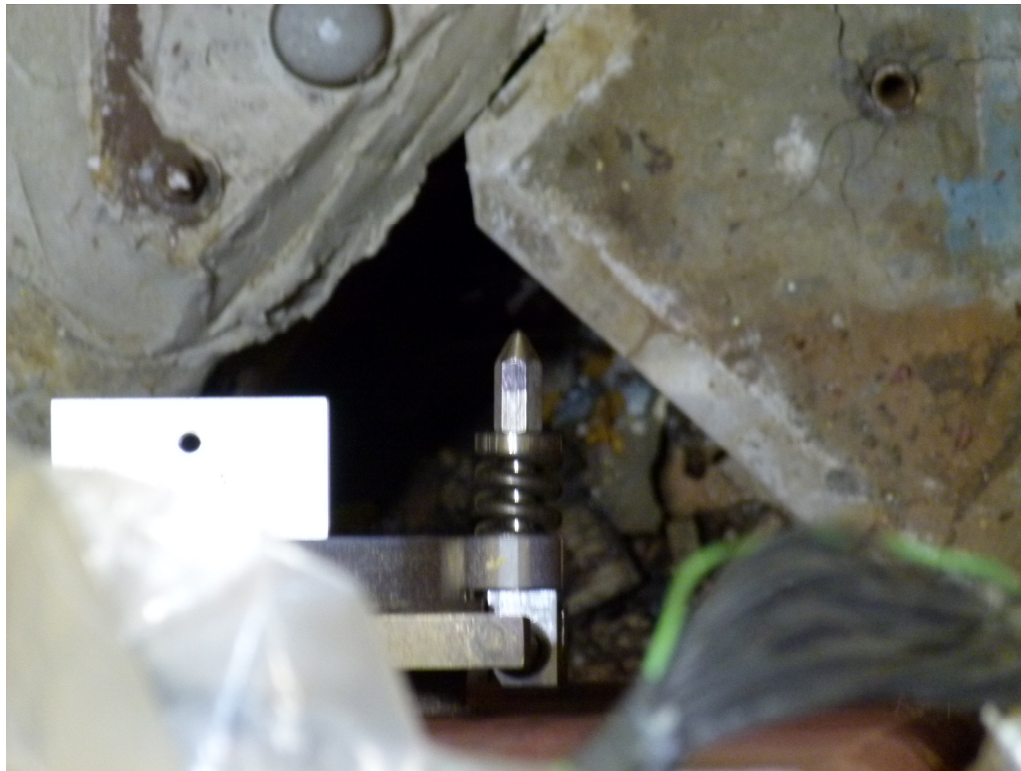
East eye before removal

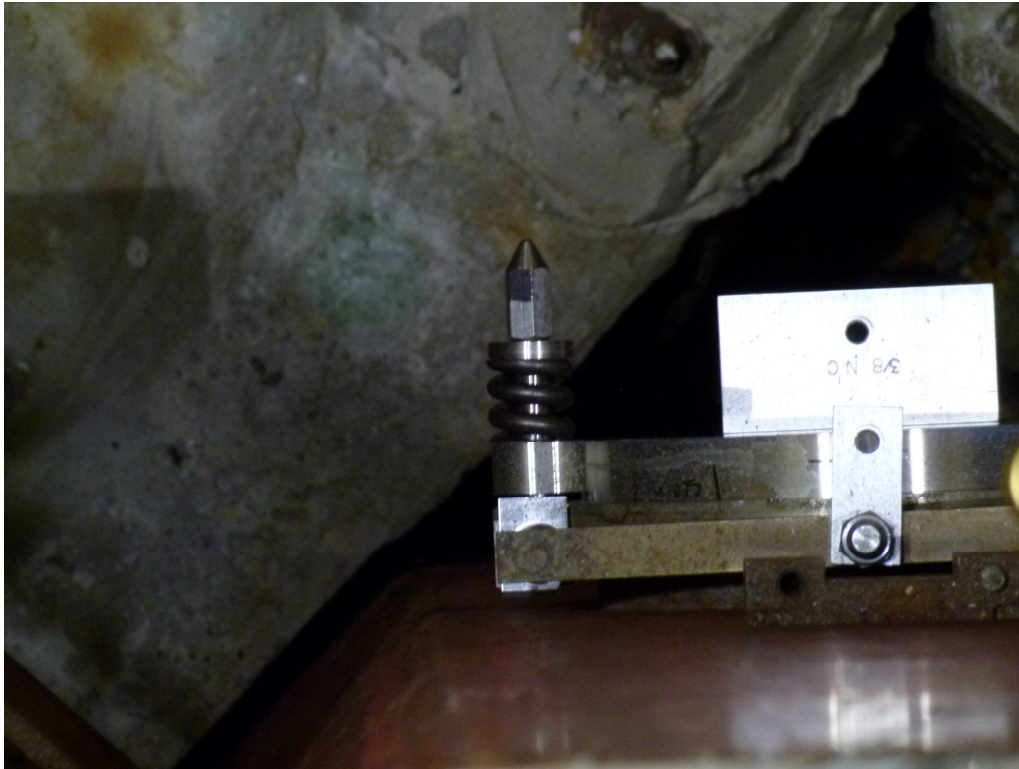
West eye before removal

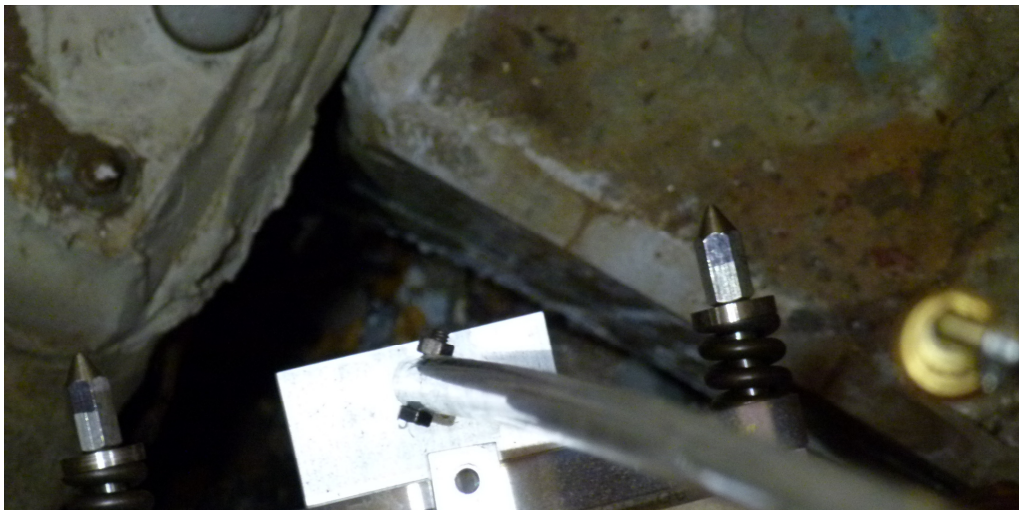
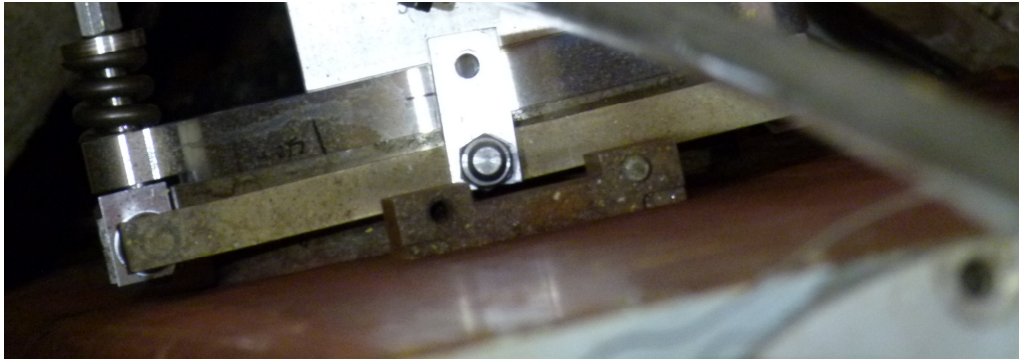
- Removed blank off from t2 m9 port, had to pry off with screw driver via spring ears. Clean removal it seems.
- Blank off is 200 uSv @ .5 m, 5000 CPM above bg.
- looks like 2 knife steps all around with oozing on the left and right, 0 and 180 deg positions. 0 and 180 look like 2.5 steps. Looks like it took one turn to remove/loosen blank off.
- Junk indium at bottom of exit port still present, indium knife edge seems clean. Ribbon stayed in blank off.

- Blank off just before removal

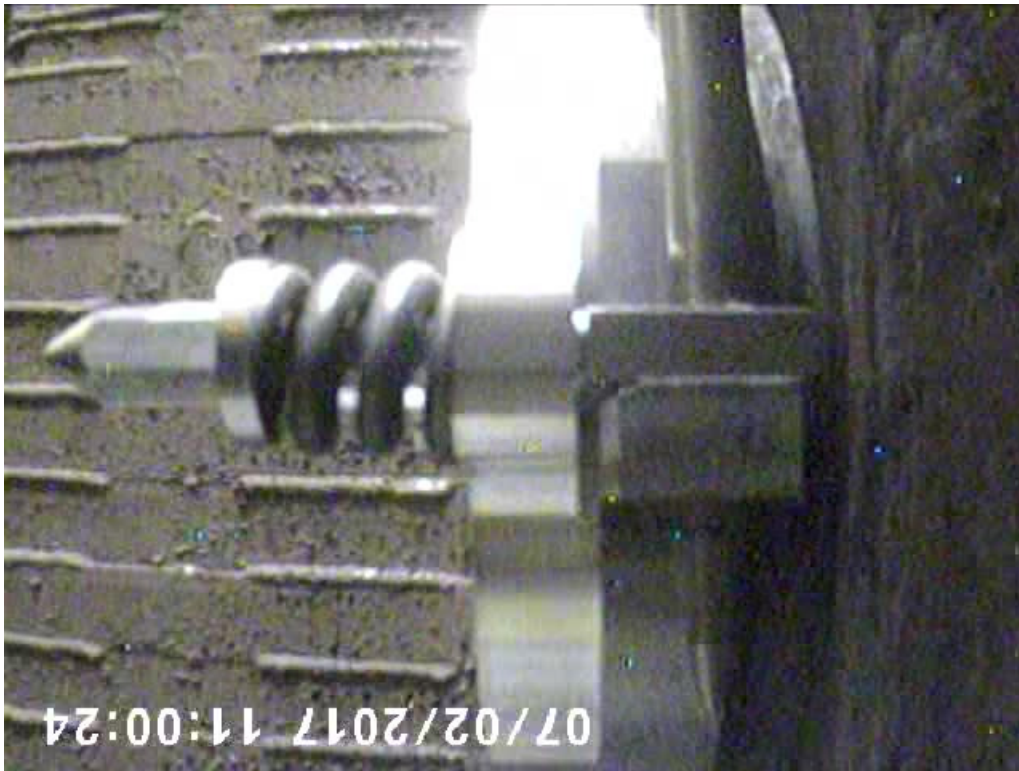
East spring ,looking west.

Spring eyes from side before removal, images flipped because camera is mounted upside down:

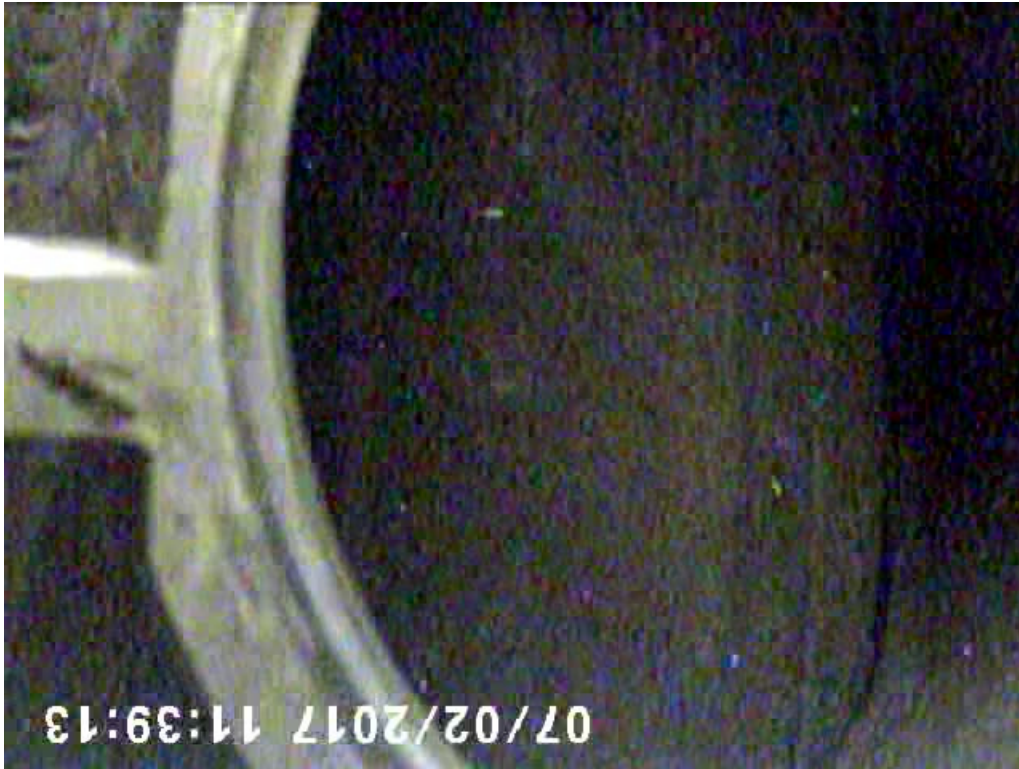
Flange initial inspection, images flipped due to camera mounting.

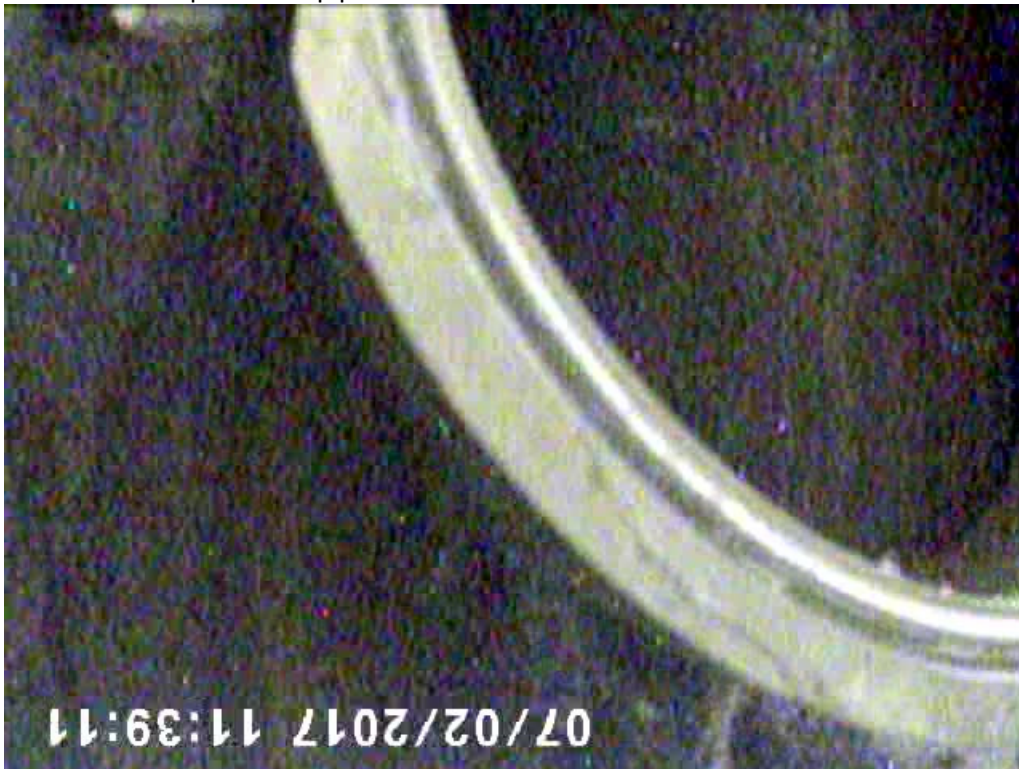
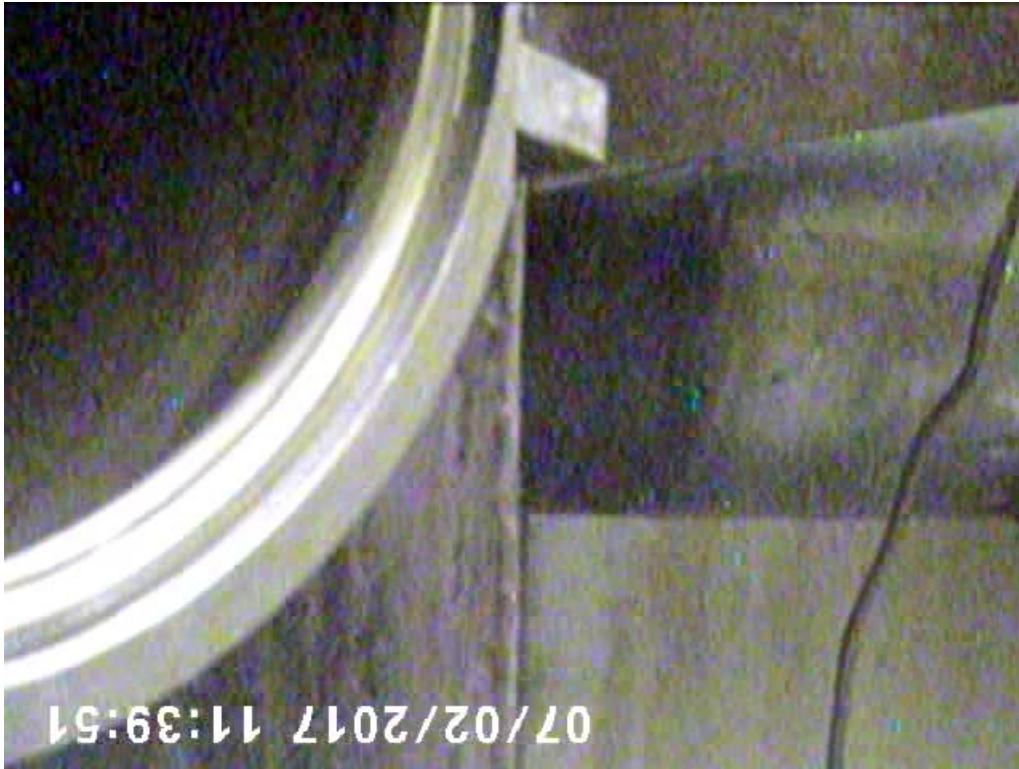
Old indium still present in pipe floor.

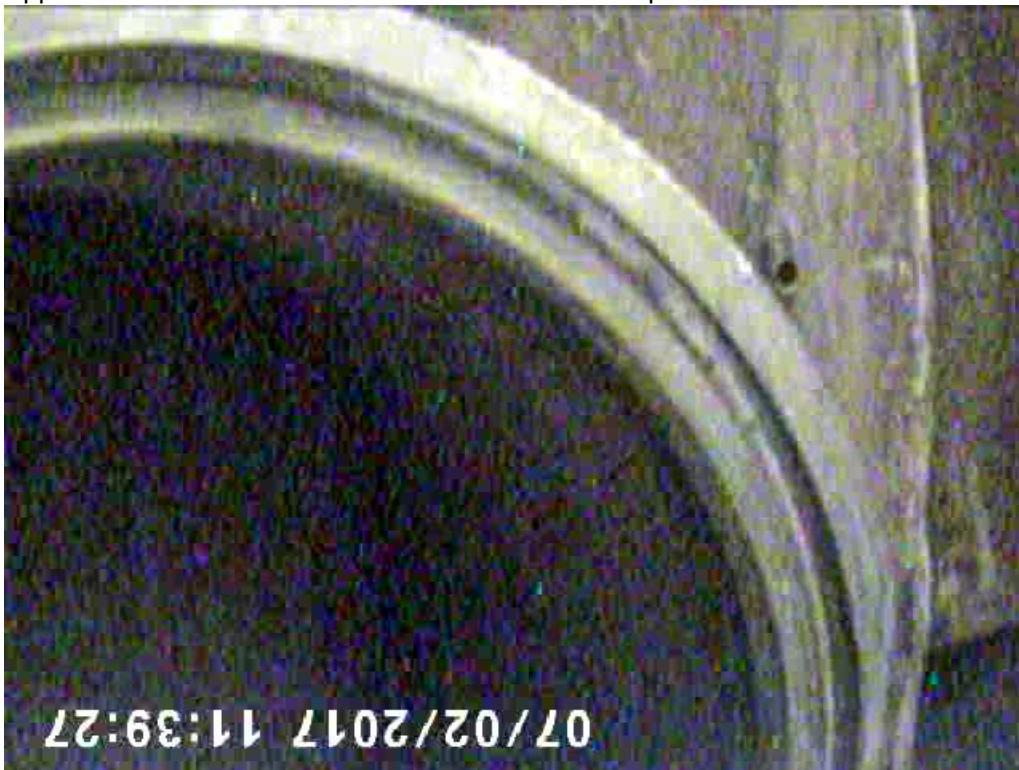
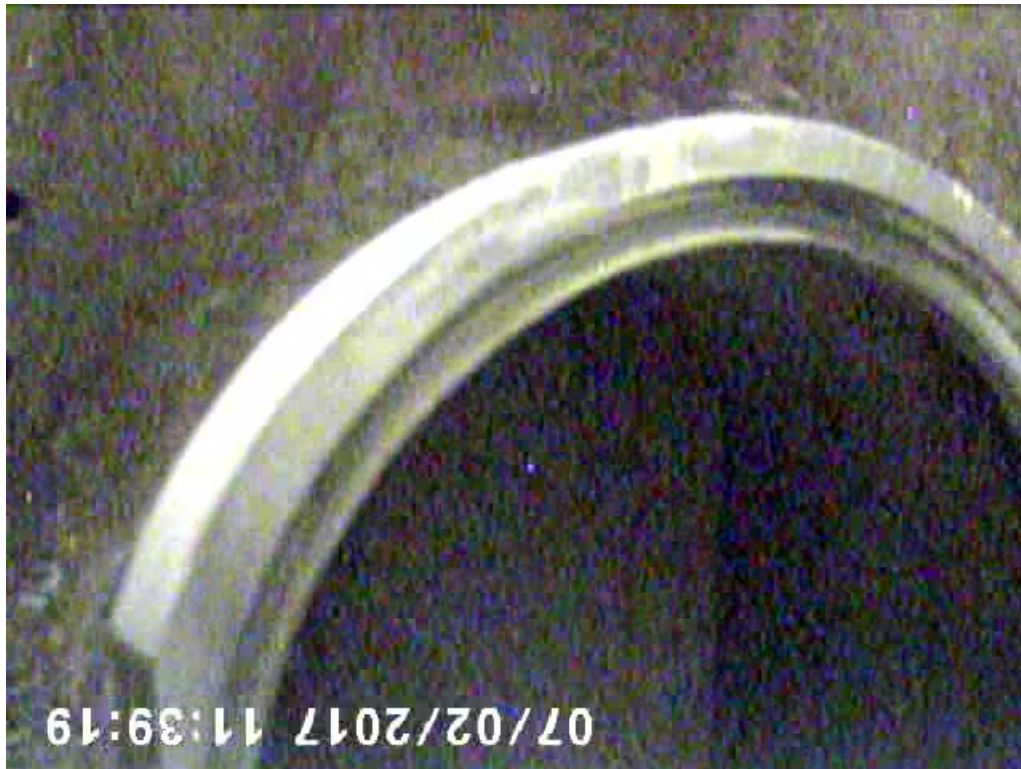
Upper east corner indium counter bore remnants still present.
