TM2 2017-09-21

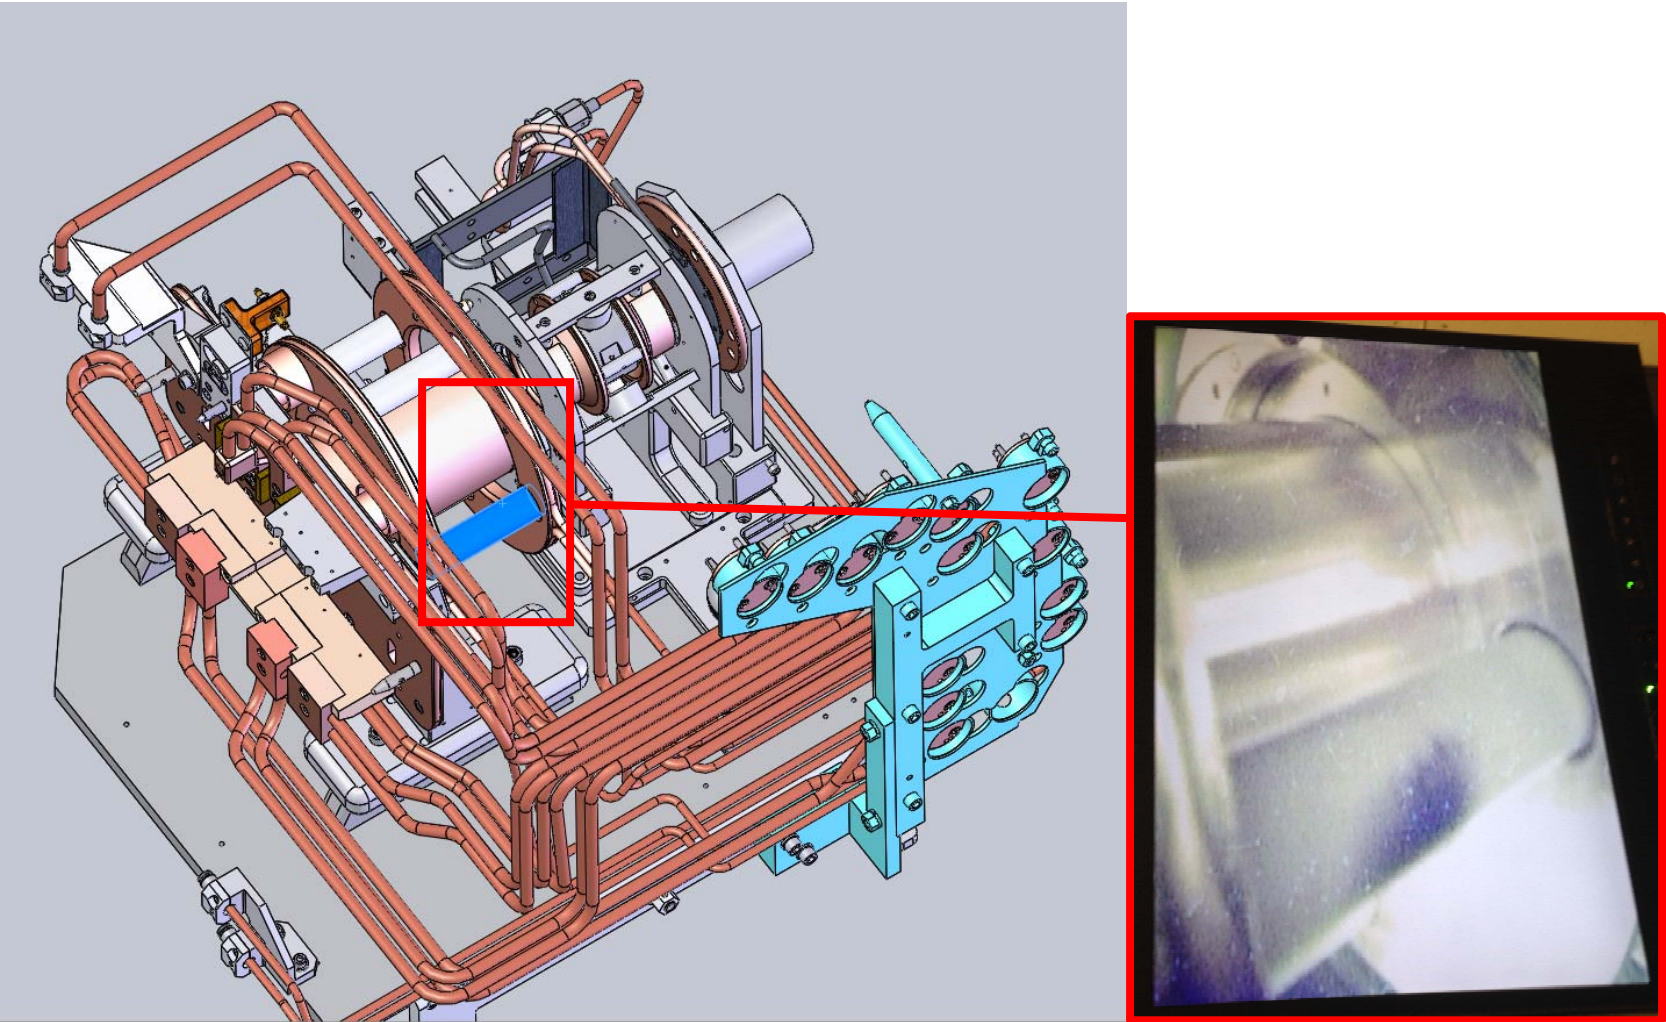
Discoloration / burn mark on insulator between Extraction Electrode and Ground Electrode

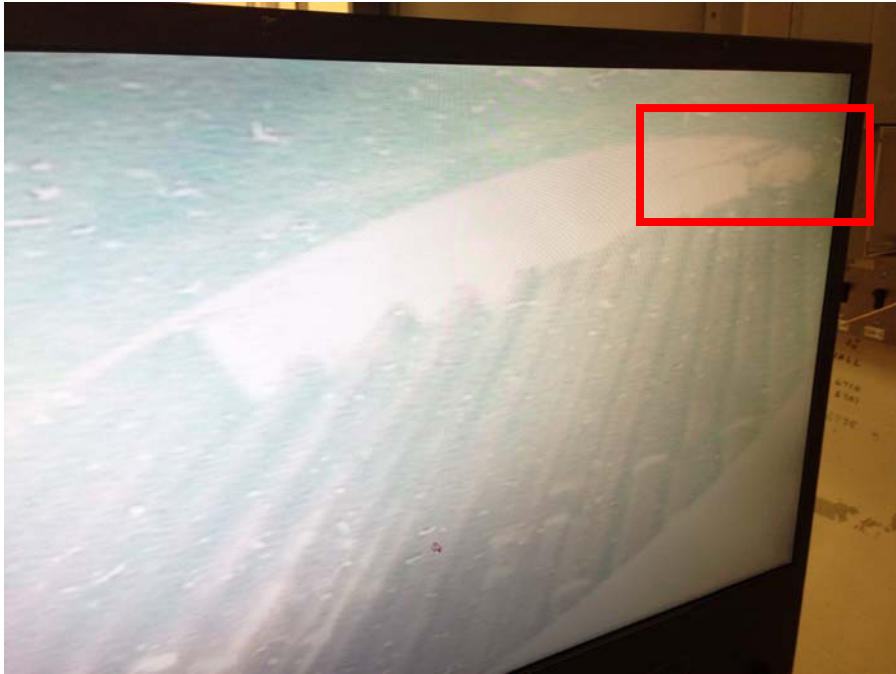
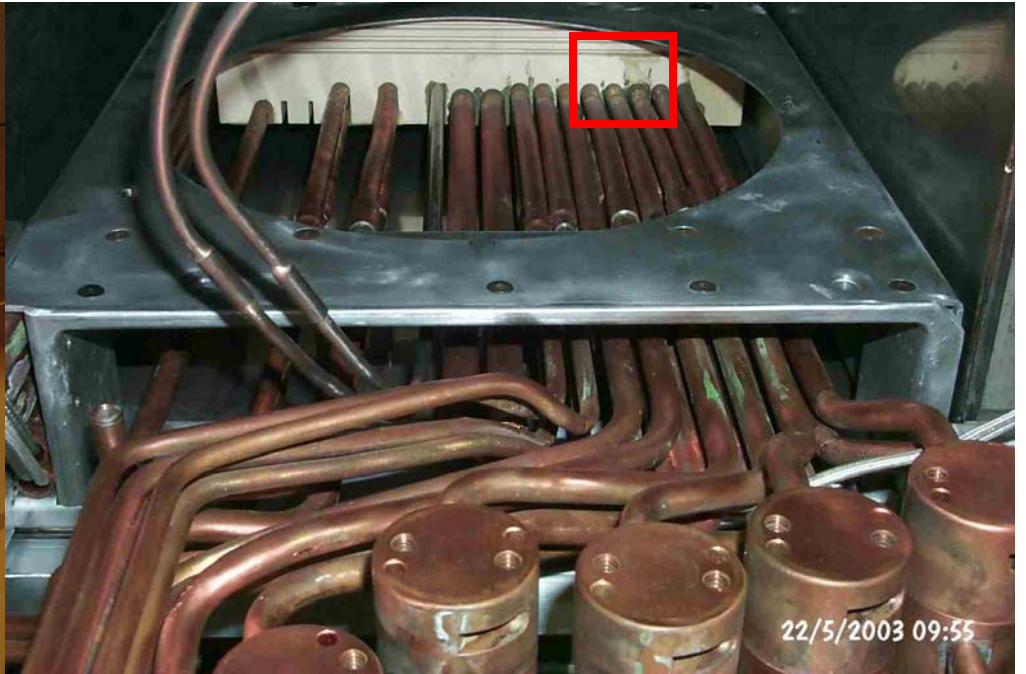
Dirt / epoxy on insulator in service tray as built
