Used Parker FS251-4FP No-spill Coupling Inspection

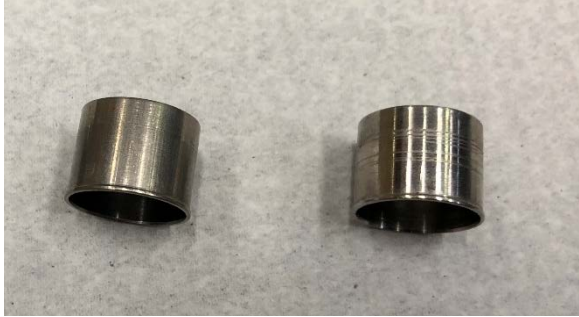
- O-rings intact and no damage observed
- PTFE backing ring brittle causing it to brake during removal
- Damage or wear observed on one of the Face Sleeves
- Deposited material observed on Valve Assembly and Valve Retainer (material could be removed)
- Face sleeve not moving smoothly over springs on one of the couplings (same as with damaged Face Sleeve)

Figure 2: Wear on Face Sleeve (right)

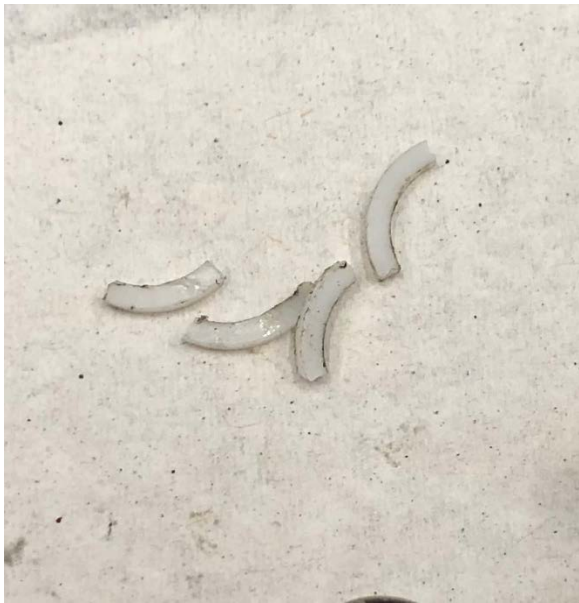
Figure 3: Broken (upon disassembly) PTFE Backup Ring. The material properties have changed to make the PTFE material brittle and possibly worn.

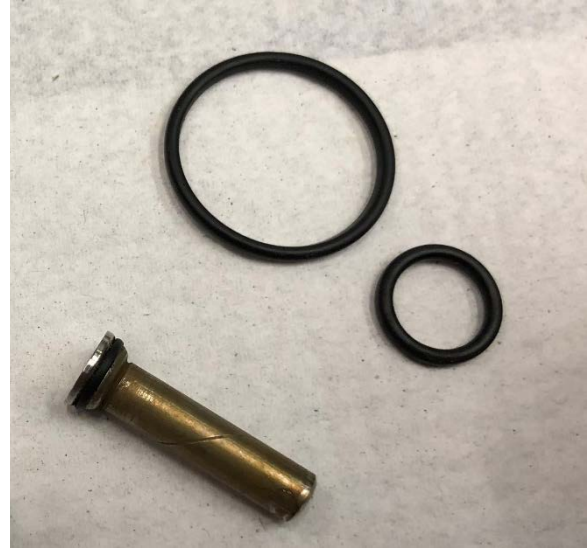
Figure 4: O-rings and valve assembly with O-ring. Valve assembly coated with deposit.

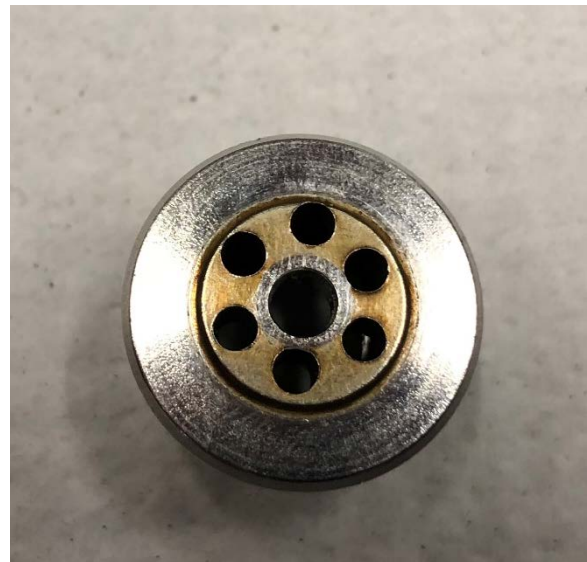
Figure 5: Valve Retainer with material deposit
