Report on Inspection of Pail 211 (Ta #58) in F-308 Flask #20

Date: Sept. 14, 2023

Author: Adam Newsome – TRIUMF Remote Handling

Location: Meson Hall Warm Cell

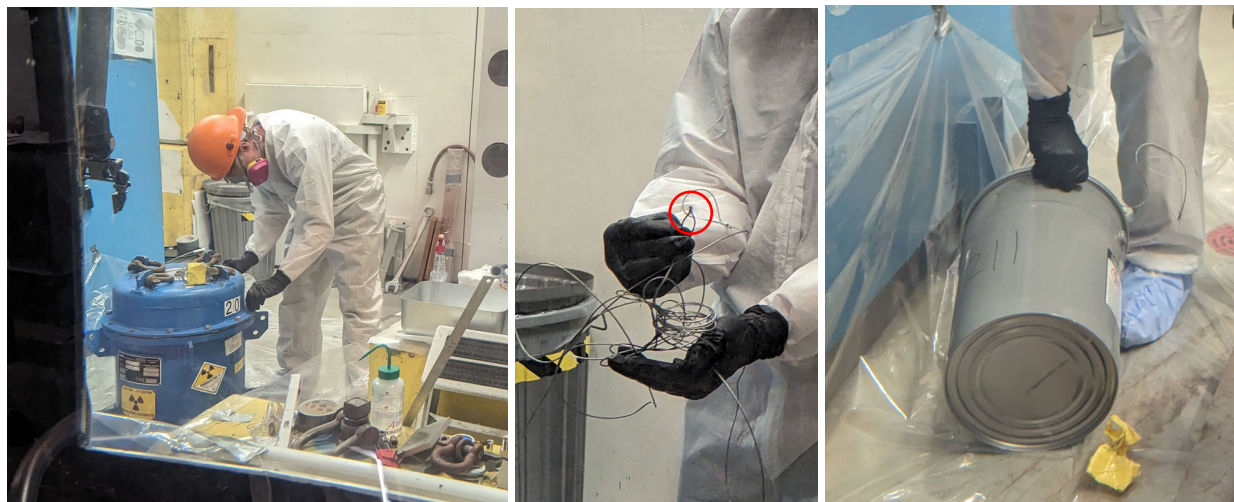
- The lifting cable was significantly tangled and kinked – there were multiple instances of kinks and tangles observed (see image below with red circle).
- The pail itself appeared to be undamaged upon visual inspection; no punctures were present and the lid was secured. There were no obvious issues with it.
- The pail was contamination-free.
- The interior of the F-308 was contamination-free.

- It is suspected (but not confirmed for certain) that the issue CNL observed during lowering was due to the cable kinks/tangles – the kinking would have prevented the pail from being lowered as the cable would get caught in the small hole in the lid of the F-308.

- It is unclear whether the lifting cable's kinks were caused during original packing at TRIUMF, during shipping, during CNL's lowering into the tile hole, or during CNL's recovery and re-coiling. It is impossible to tell at which stage this occurred from visual inspection. At this time, CNL has not offered any description or photographs of what occurred at their facility which would aid in the investigation. Investigation is inconclusive.

- The contents of the pail shall be re-packaged into a new pail due to both the concern associated with the distance this pail will have traveled in total during multiple shipping events, as well as the need for the lifting cable attached to the lid to be re-fabricated.
- TRIUMF will perform the pail re-packaging into another pail in the near future, and then place this pail into a different F-308 as the existing one's certification will have expired this time.
- TRIUMF will advise CNL on the new pail number, and it will most likely be shipped back to CNL in the next batch that is shipped.
