Day 1 (2024-04-22)

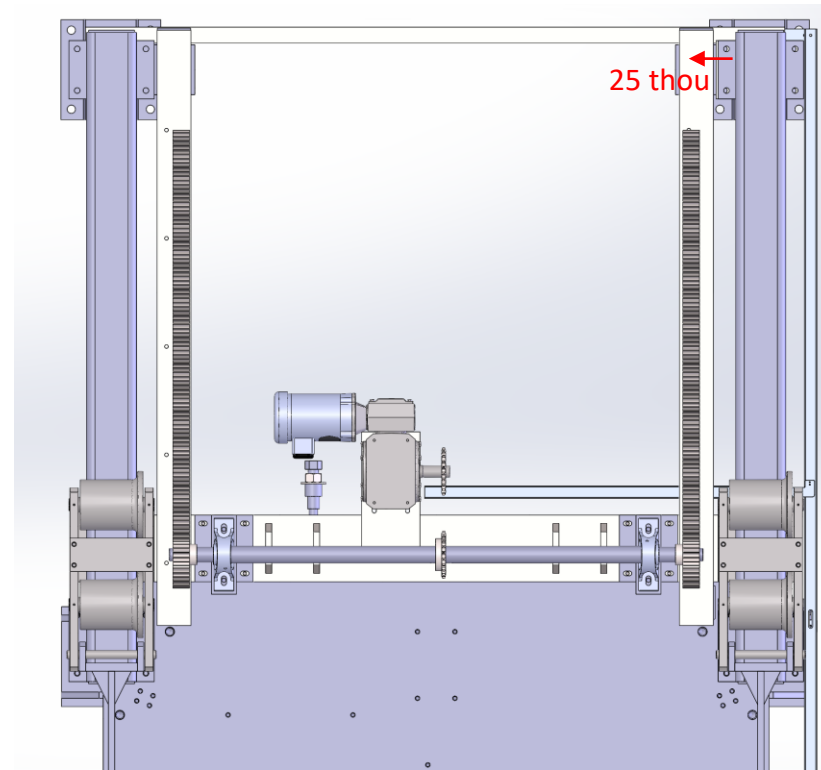
- An attempt was made to correct misalignment by moving this structural beam inward slightly, approx. 25 thou.
- The vault was remotely opened and closed while monitoring the dial indicator. Prior to this test, the dial indicator moved 185 thou when the door was fully opened. During this test, the same result was observed. This means the adjustment made no difference, however it is likely attributed to the fact that the roller car “bottoms out” on the structural tube so the measurement is actually saturated and maxed out.

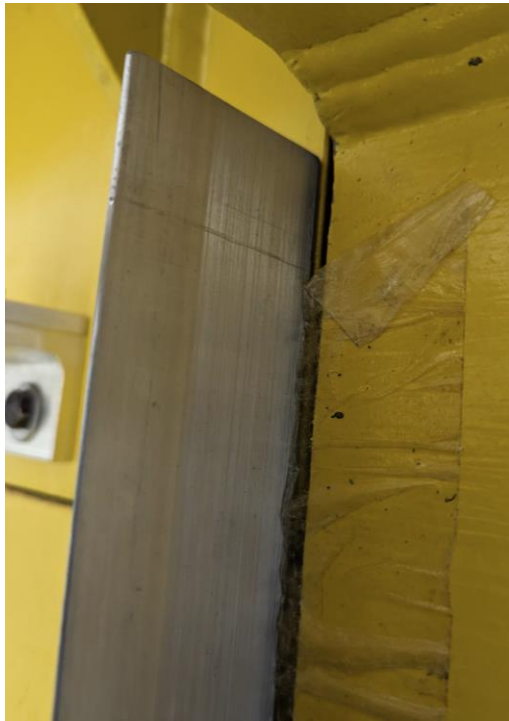
Left side (facing head-on)
(difficult to see but there is slight overlap)

1. It was noticed that when looking at the vault head-on, there is a lateral shift which is approx. $\frac{1}{4}$ " , as evident from both sides of the vault:

1. We need to revert back to normal state (before 2024-04-22) adjustment.
2. Lift door slightly and translate it to ensure the door is centred laterally with respect to the vault (do this by checking the sides – the obvious gap on one side should reduce in half). In order to lift the door, the drive shaft will need to come off which is important for the next step.
3. When putting the door back in place, push it so it is flush up against the vault to correct the rotational misalignment. With it properly in place, the bearings and shaft assembly can be reinstalled and set to maintain this position. Furthermore, the pinions should be loosed at this point so they can be clocked in at the same position, and also centred laterally in their racks.

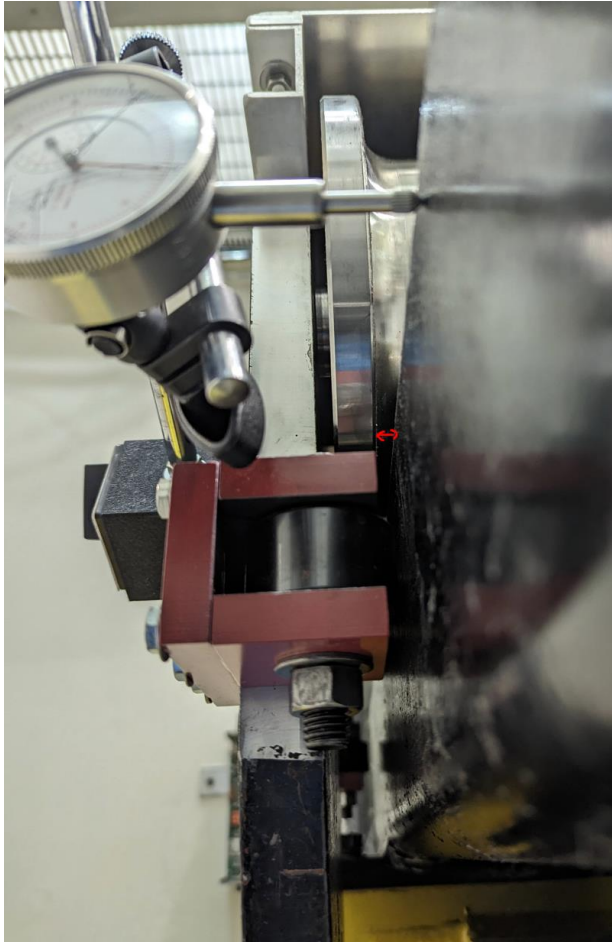
Left side (facing head-on)

2. It was also noticed that the large rollers (and smaller rollers) exhibit a similar lateral shift:

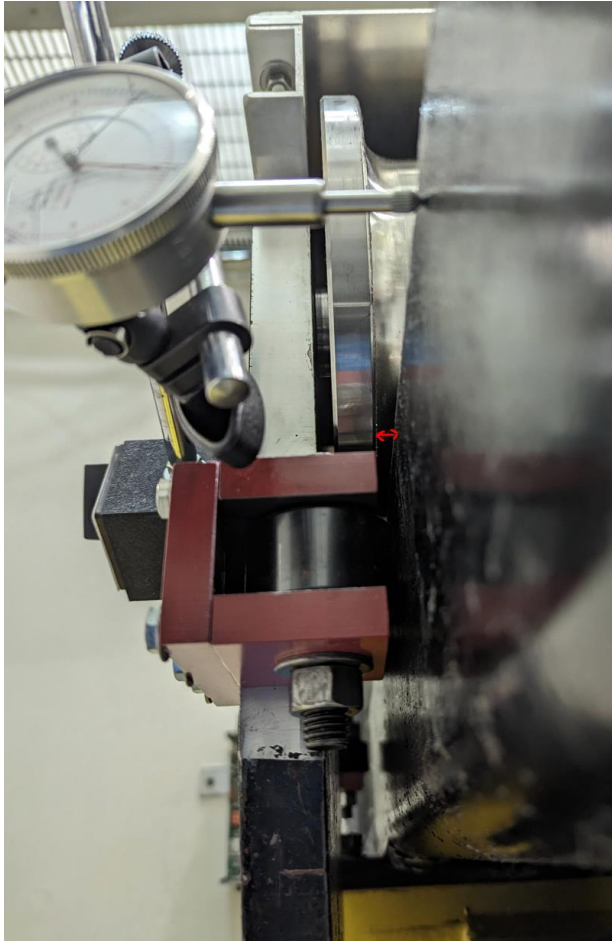
Left side (facing head-on)

2. It was also noticed that the large rollers (and smaller rollers) exhibit a similar lateral shift:

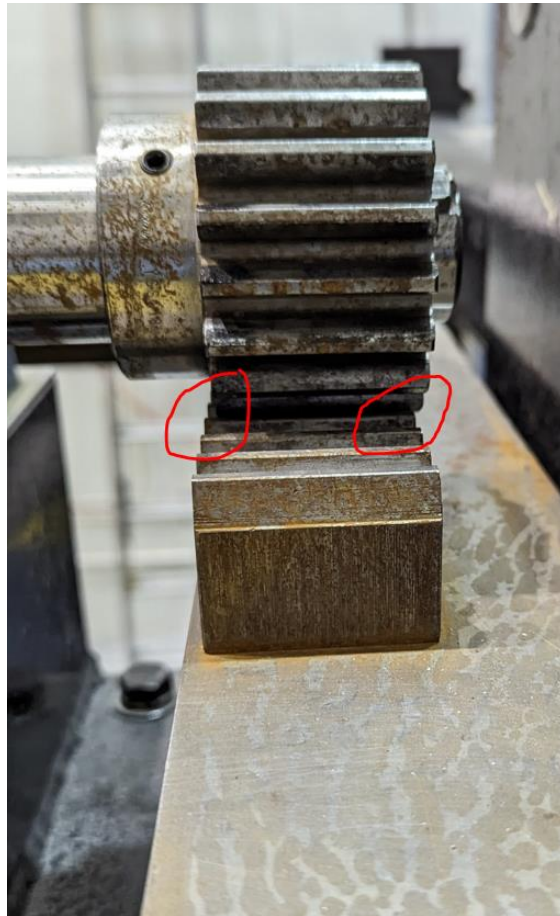
3. This shift is also slightly noticeable in the rack and pinion assembly:

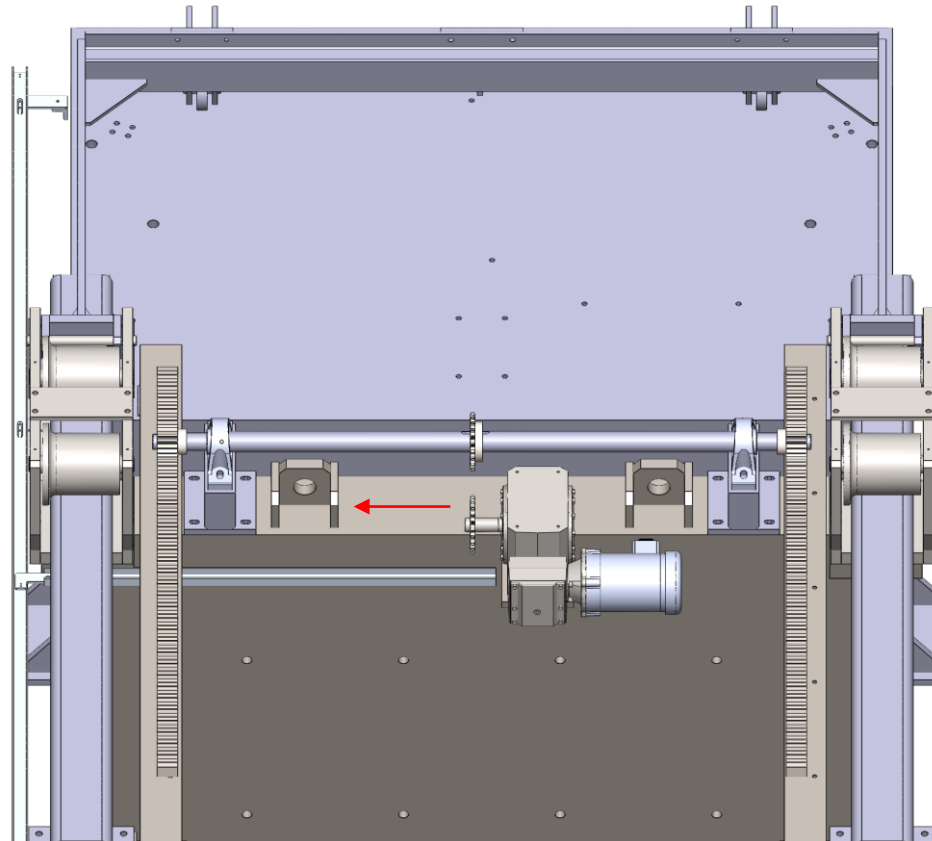
It seems that the entire door assembly is slightly laterally shifted, half of the approximately $\frac{1}{4}$ " gap observed, and should therefore be moved approx. $\frac{1}{8}$ " to the right in the image below (looking head-on) [note: measure to confirm the amount]

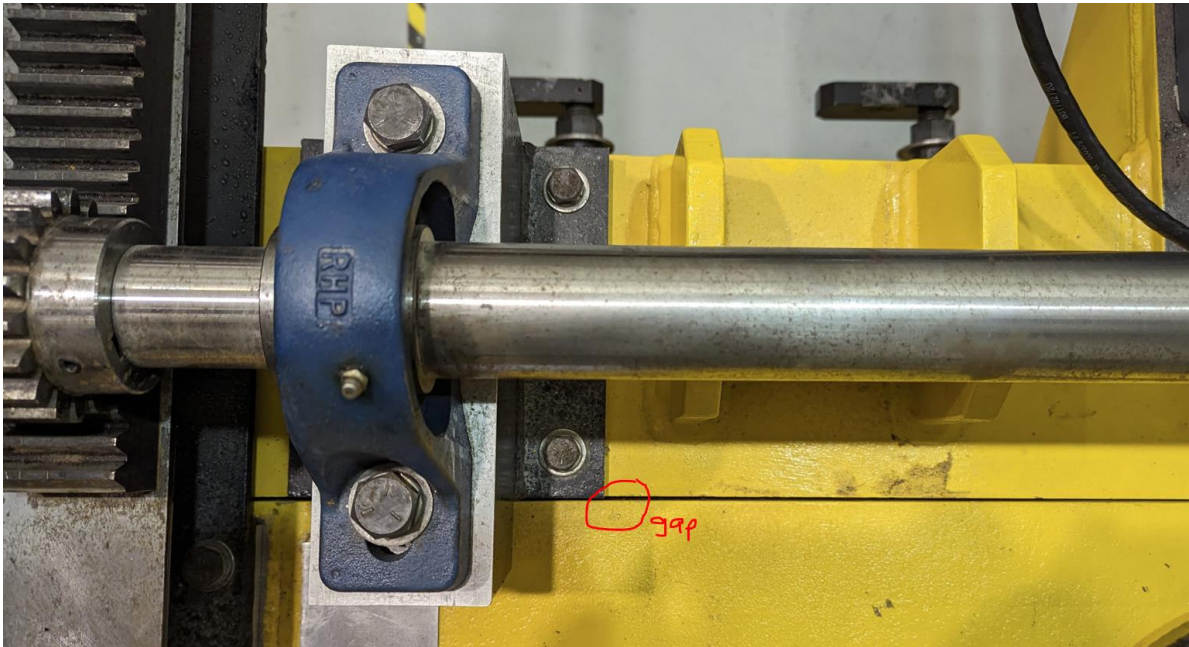
Left side (from above)

4. It was also noticed that, when viewing from above, there's a gap between door and vault on the left side, but *not* on the right side.

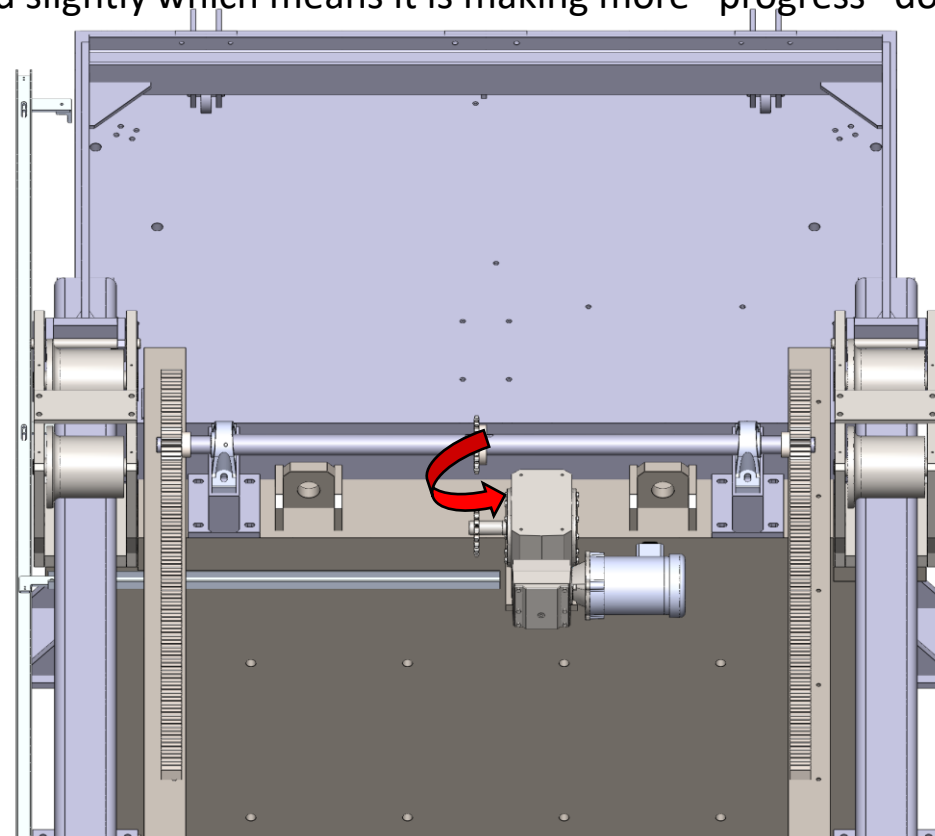
It seems that the entire door assembly is also slightly rotated, which could be a result of one of the bearings (which holds the shaft assembly) being incorrectly positioned. If this is correct, it is possible that this is the explanation for the door skewing as it opens up – if one pinion is more constantly loaded than the other, it can pull the entire assembly over. It is suspected that the “clocking” of the pinions with respect to each other may be slightly off as well, which could also cause this (in other words, one of them is rotated slightly which means it is making more “progress” down the length of the track).

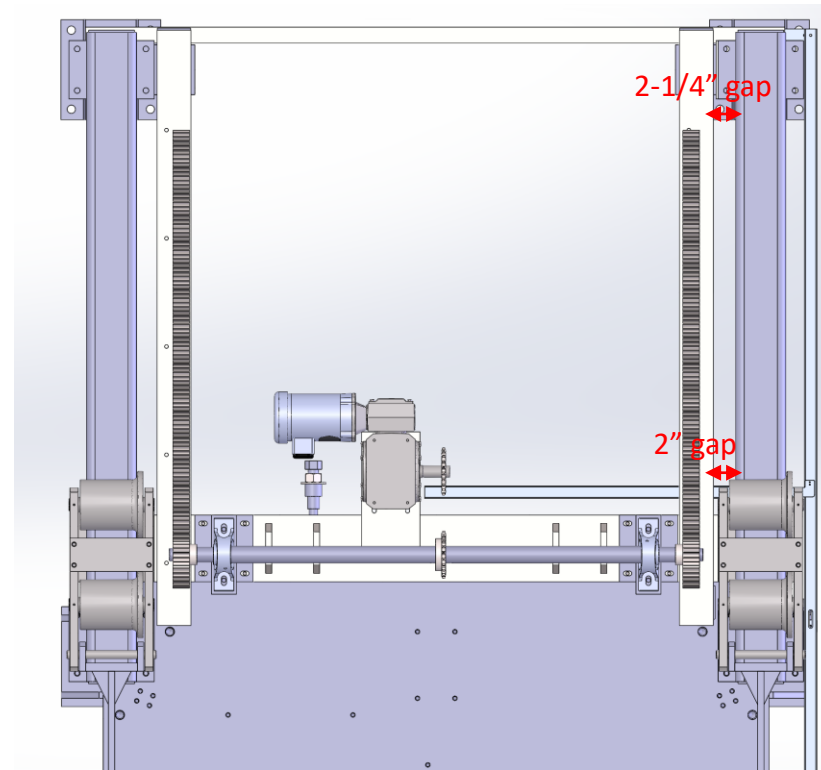
- Started off making measurements... the following was observed:
- The two structural members were essentially parallel w.r.t. each other
- The two pinion supports were essentially parallel w.r.t. each other
- Gap was measured between pinion support and structural beam on both side... the following was found:

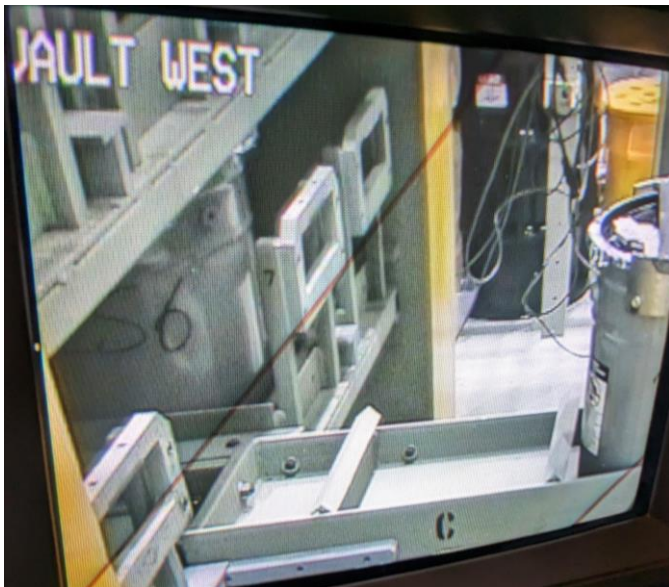
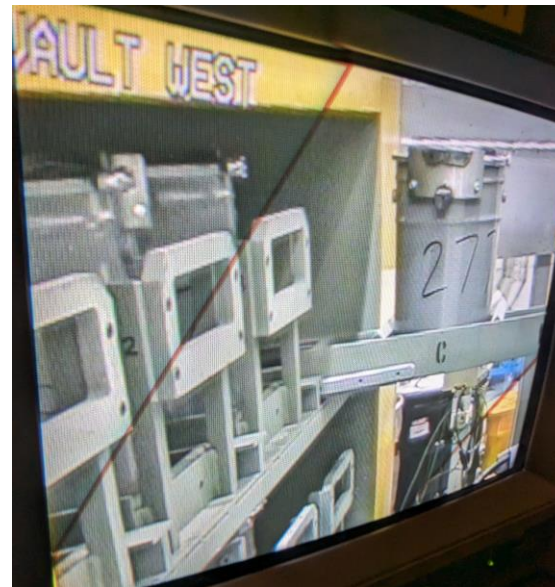
- Open and close vault door with trays 4 and 6 engaged
 - Door fully opens to allow for access to all pails... perhaps even more than before but this is acceptable and considered an improvement. We looked around with camera and there's no major concern.
 - Door closes correctly.
 - No interferences observed during travel.
- Open door with the two trays engaged still, and emergency close
 - The door successfully closes using emergency override mechanism
 - Confirmed closed via camera views
 - **(NOTE: before vault is used again, the emergency mechanism must be reset! Hopefully we can do this tomorrow)**
