## **Report on Inspection of Pail 275 (SiC #44) in F-308 Flask #22**

**Date:** Oct. 3, 2024

**Author:** Adam Newsome, P. Eng. – TRIUMF Remote Handling Group Leader

**Location:** Meson Hall Warm Cell

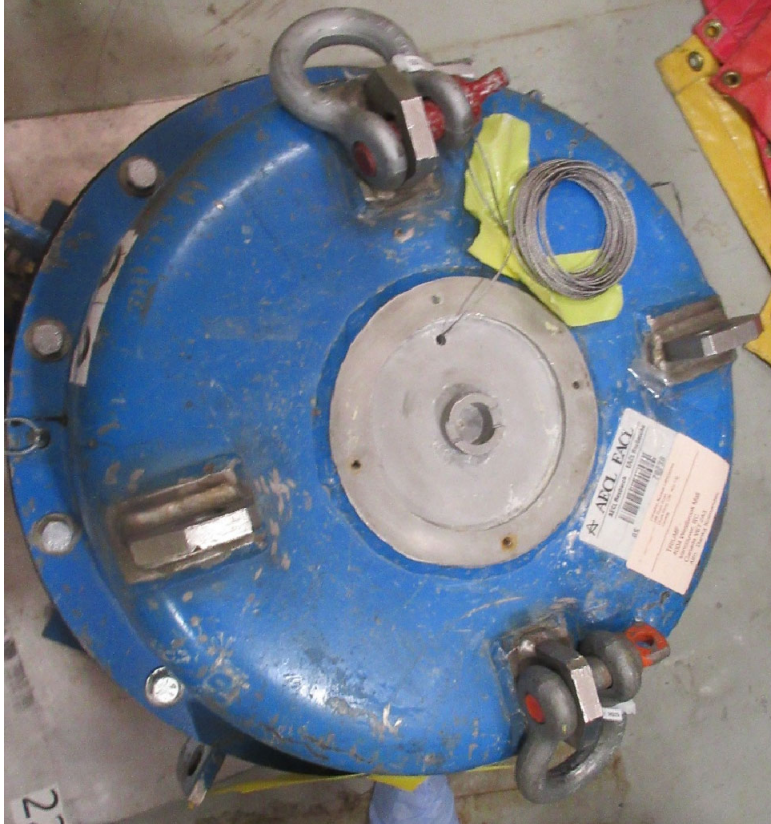
- No major obvious issues were observed in the portion of the cable that was coiled underneath the top cap. See Figure 1.
- The pail itself appeared to be undamaged upon visual inspection; no punctures were present and the lid was secured. There were no obvious issues with it.
- Upon removing the F-308 lid to expose the pail, it was observed that the cable was originally incorrectly routed such that it was exiting the lid of the pail improperly, and furthermore was caught underneath the sheet metal "cable keeper" part. In other words, it was routed "backwards" through the attachment block on the pail lid such that the crimped loop butt up against the cutout where the cable should exit, rather than the flat surface of the attachment block. See Figures 2 – 4.

Figure 1: Small lid cap removed from F-308 exposing coiled cable - no obvious issues observed

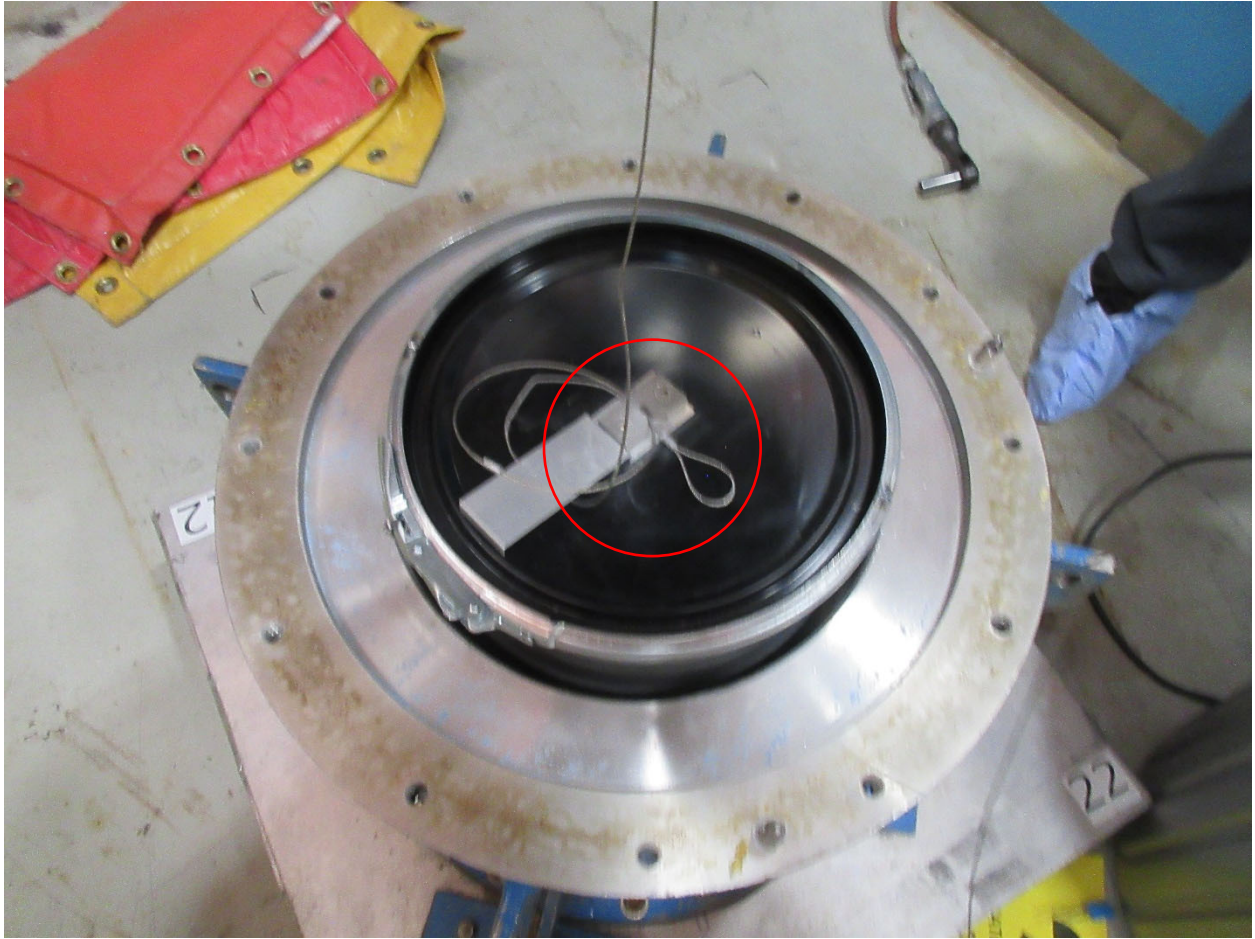
*Figure 2: View of top of pail, showing crimped loop on wrong side of attachment block, and cable routed underneath "coil keeper" part*

- The improperly routed cable on top of the pail's lid is undoubtedly responsible for the issue observed by CNL (failed pull-test prior to emplacement).

- When the cable is incorrectly routed as described, it causes excessive lateral loading in the cable assembly. The result is that the cable does not enter through the hole in the underside of the F-308's lid correctly. Because of this, when the pull-test is attempted, it causes additional friction and a kink in the cable which prevents it from being fed smoothly through the hole, and therefore feels as if it is stuck.

- It is clear that the root cause of this issue was a pail assembly oversight. This error was an easy one to make and could have been made by an inexperienced person assembling the pail, or someone who was in a rush. Furthermore, the error is a very difficult one to catch because at first glance, it appears to be correctly routed, and because any personnel handling the pail directly are doing so with haste to reduce radiation dose.

- **Prevention of this issue in the future:**
  - This pail was originally fabricated in the summer of 2022. At that time, documentation on pail assembly, including quality control checks, was deficient. Based on recent requests from CNL, TRIUMF has authored a design note (TRI-DN-23-10) which contains a formalized procedure for assembly and quality control checks for the lifting-related aspects of the pail. It is expected that this improved documentation, which includes an updated assembly drawing and step-by-step photos, will reduce the probability of such an error.

It is recommended to update procedures related to the above tasks to include a check for this issue, as well as a general check to ensure there are no other obvious problems with the pail assembly (i.e. fasteners appear present and tightened, cable is not kinked, etc.).

- **Dealing with the existing waste (contents of Pail 275):**
  - The contents of the pail shall be re-packaged into a new pail due to both the concern associated with the distance this pail will have traveled in total during multiple shipping events, as well as the need for the lifting cable attached to the lid to be re-fabricated.

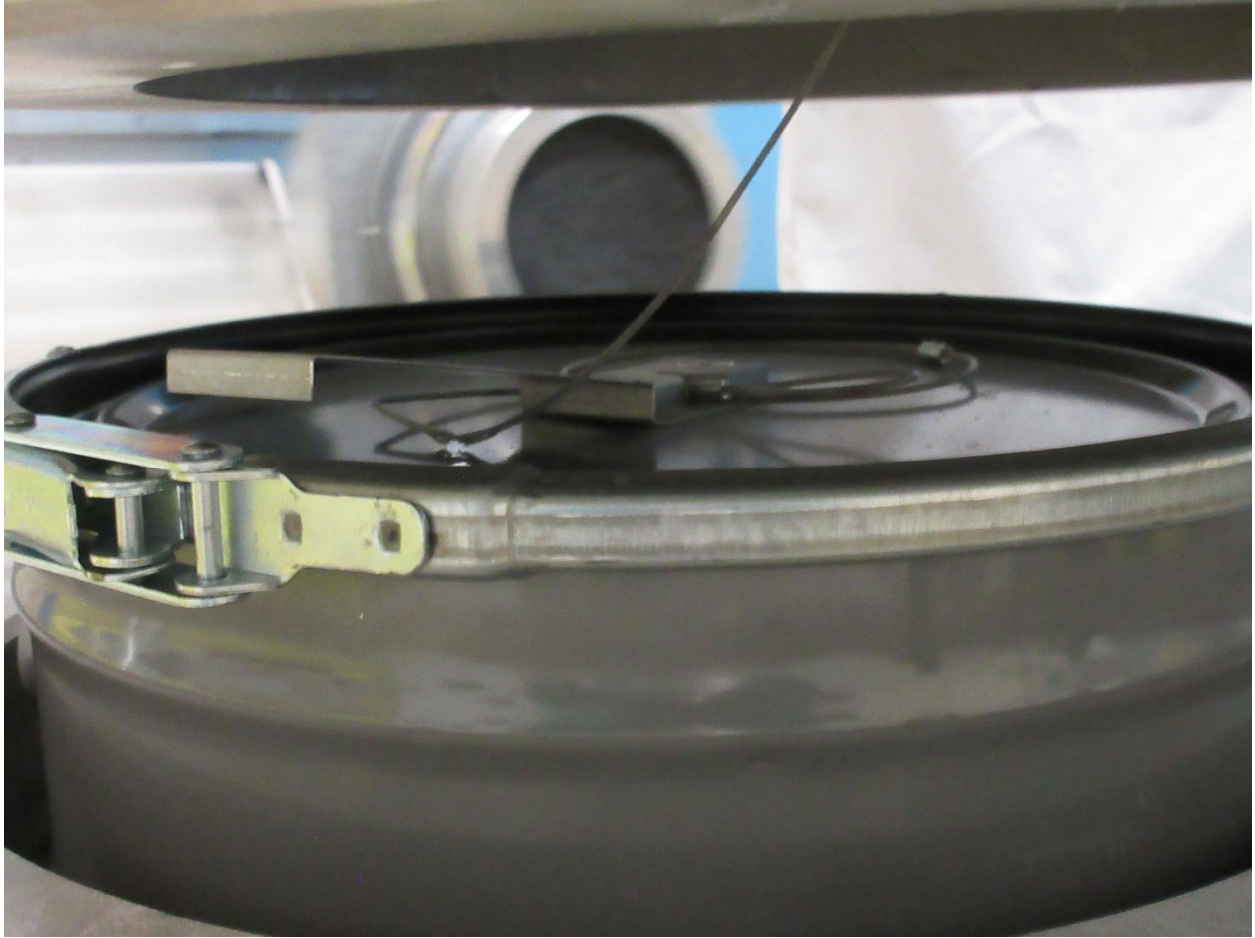
Figure 3: Side view of same items of interest as Figure 2

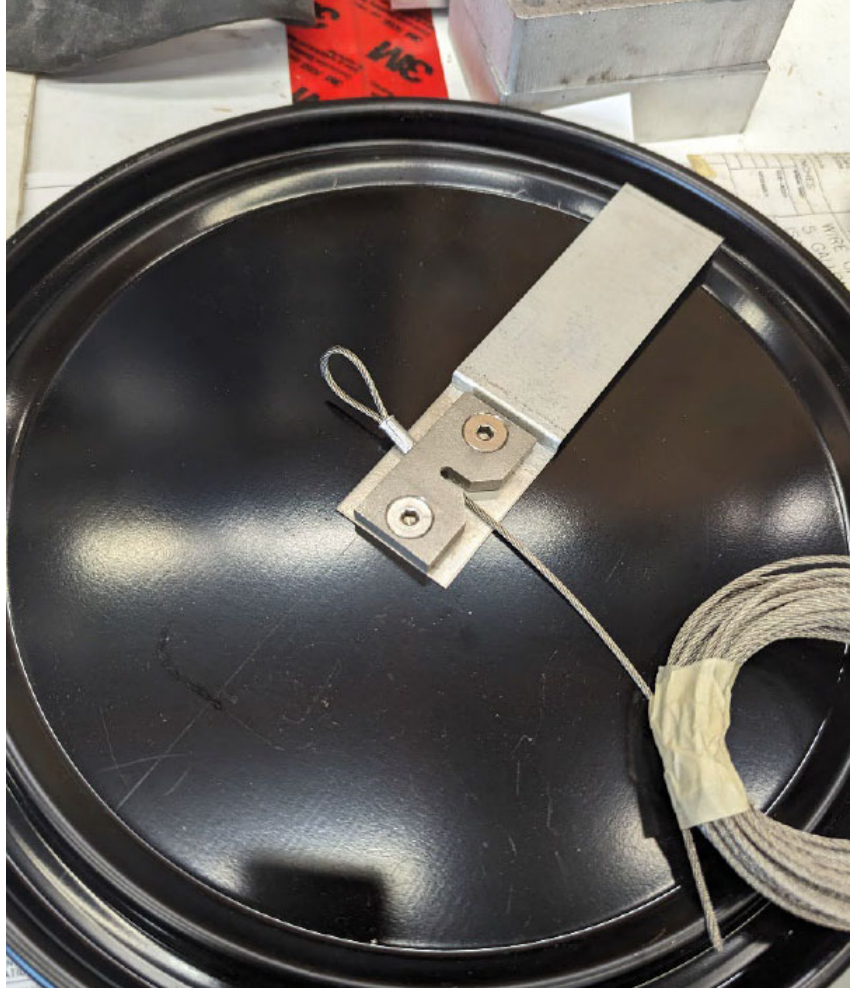
*Figure 4: Correct way for cable to be routed through attachment block (example image from TRI-DN-23-10 assembly instructions). For Pail 275, the cable was routed through the block the opposite way.*
