Mar 22, 2013

TI-MKI LEAK CHECK

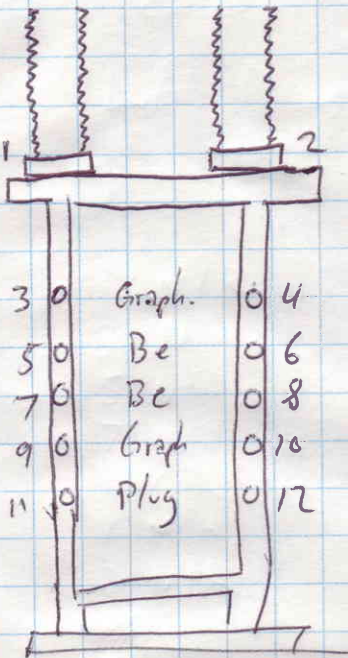
Facing Ladder

Left Bellows: N/R
Right Bellows: N/R

Pos'n 1: N/R

2: N/R

3: N/R

4: N/R

5: N/R

6: N/R

7: N/R (when angled upwards)

8: N/R

9: Up to 40 on x50 scale

10: N/R

11: Up to 69, N/R after tightening

12: Up to 32 N/R after tightening #11

Position #9 (Graphite Target) did not improve after tightening once.

After tightening further, baseline dropped to 10 on 10X scale. Pos'n #9 up to 38 on 10X scale when re-tested.
