2017 Jul 10 T2 Solenoid Valve Replacement

CYCLOTRON Fault 10119
Summary: T2 target cooling system flow lost To Group: Targets Issued by:
Robin Swanson
Priority: immediate response
Preventive Request: 0
Details:
At 19:17 T2 target cooling system flow on the Cu-ALCW side of the heat
exchanger went to zero. Confirmed that target system had in fact lost flow
to heat exchanger when water package temps began to rise.

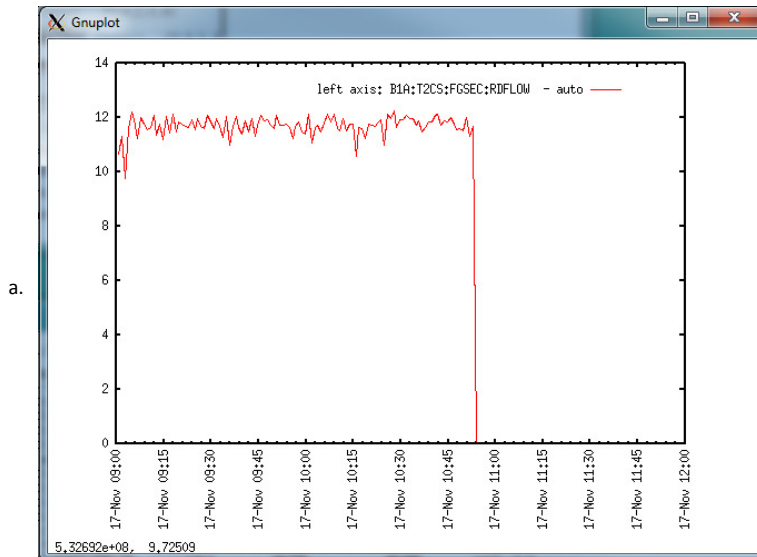
1. Plot of previous known failure of suspected valve, plot of B1A:T2CS:FGSEC:RDFLOW, flow meter downstream of heat exchanger secondary side.

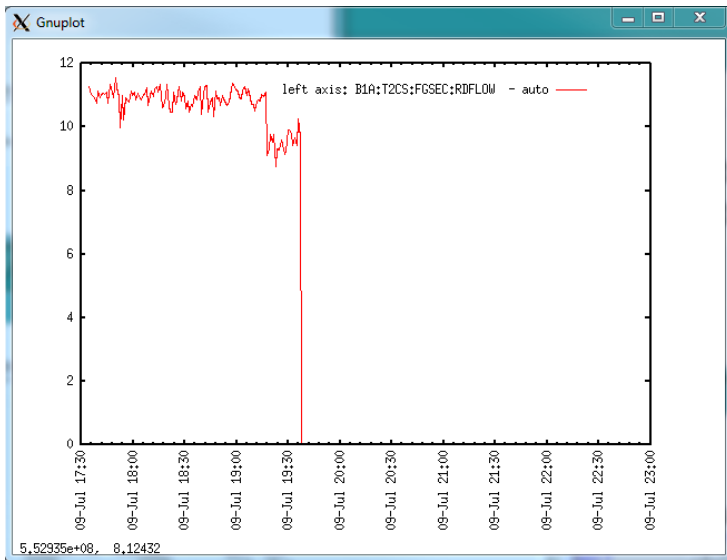
2. Plot of 2017 Jul 10 valve failure, plot is of flow to B1A:T2CS:FGSEC:RDFLOW

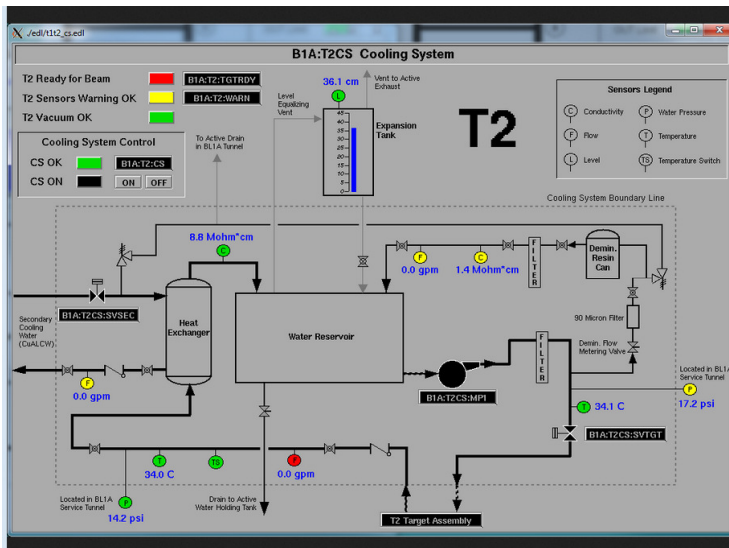
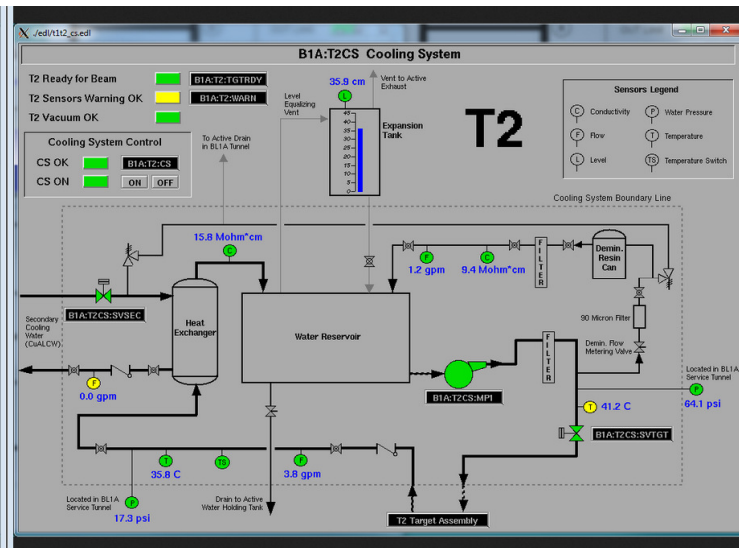
3. Ops elog dated 2017-07-09 21:55:45 showing restart of water package, turned off vs turned on.

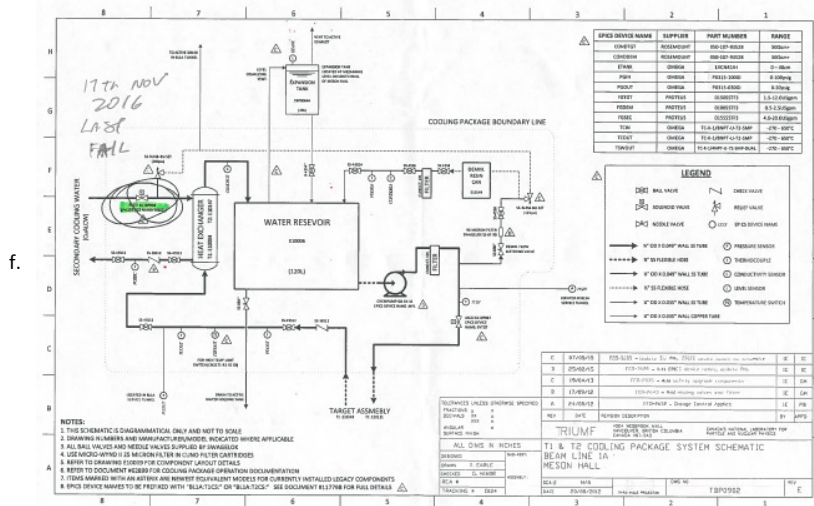
- a. Valve shows green in epics
- b. No flow in down stream flow meter
 - i. Could possibly be bad flow meter or bad valve, but more likely the latter (proven not the case, see below)
- c. Indirect evidence it was a valve failure and not a flow sensor failure from ops was when the package was restarted the target water temperature was still climbing.
- d. Same kind of valve as failure as one in 2016 Nov 16 to 17 (confirmed after blocks removed).
- e. Drawing of water schematic, failed valve highlighted:

8. Did actual repair with MDV:
 - a. Disconnected old valve via the swagelock fittings, lower fitting seems galled or something. Use the "drip pan" to hold the water that came out of the heat exchanger. Pan with water was left behind and covered after job.

- a. Disconnecting old valve some black debris fell into drain pan, unsure if debris was already there or not.
- b. Connected new valve to multipin, had Controls (Tony) remote fire it, works, confirmed by Doug.
- c. MDV removed fittings from failed valve, taped pipe joints, reattached swagelok couplings to valve.

- d. Valve replaced on to water package.
 - e. Total job time replacing valve proper, est 30 mins.
9. Once valve connected, had ops restart water system.
- a. Heard solenoid fire, ops reported low flow but then back to normal after 5-10 minutes, likely from the heat exchanger being drained from removing the valve. MDV heard cavitation, but went away. Visually checked for leaks at the joints, none were seen. Pressure may not have been high enough to spot slow leaks at the joints however.
 - b. Flow meter was showing normal flow, Doug and Ops ok to re cover blocks
 - c. Doses: MDV .04 mSv, Doug P. .007mSv , KCN .019 mSv; 0.066 mSv Total, does not include plant group uncovering blocks.
10. Work done by 15:15.
11. Post mortem:
- a. Valve has failed about two times in the same way in the last year.
