T1 & T2 Target Ladder Water Flush and Leak Check Procedure Document: 46600 Release Date: 2024-02-26 Release No. 3 Leak test date: April 02, 2005 | time 2 fine 305 | time 60 Bellows, fittings, welds, joints (position ladder toward hot cell window - Fig.16): Leak rate Leak rate Loc. (Torr-Delay\* Delay\* (Torr-Loc. ID (sec) Vsec) (sec) ID Vsec) 1a 1b HAME IS 2a 2b A Wadned За part of 4a\*\* 4b\*\* the long deby LAy 5a 5011005 register g 6a 7a 7b verporte duration. 8a Baseline leak rate: 00 c-1016 \*Duration since He release to when the leak rate is first He dose (psi & sec): 3 y 0,55 detected (if detected). Notes: mitrolly bottom and "These joints may be welded in some target ladders. No check necessary if so. @ 3e-3 Fair and 2. Se-817-1/s after some framering Target welded/brazed joints (position ladder toward hot cell window - Fig.16): Leak rate (Torr-l/sec) / total duration (sec) at: Tgt. left-side left beam right beam right-side pos. joint(s) window window joint(s) 5 4 3 2

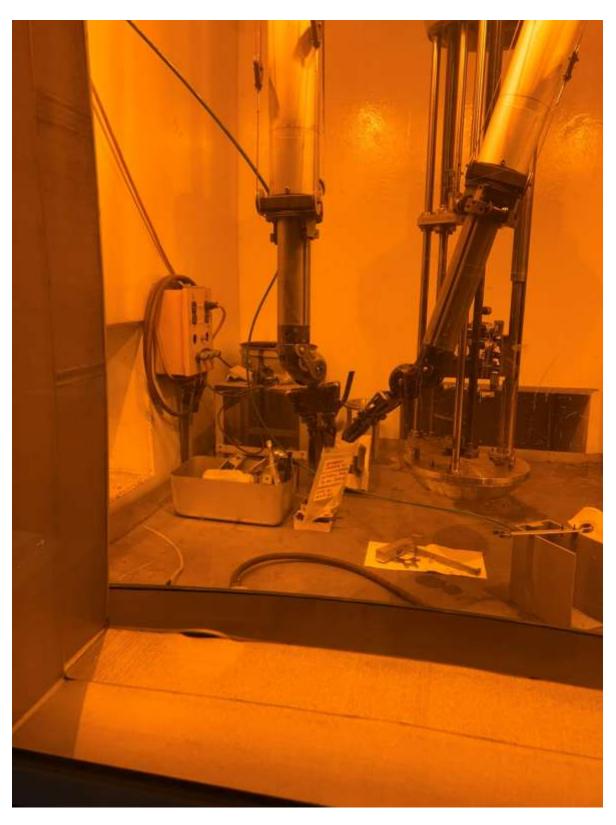
Bagging the graphite chips.

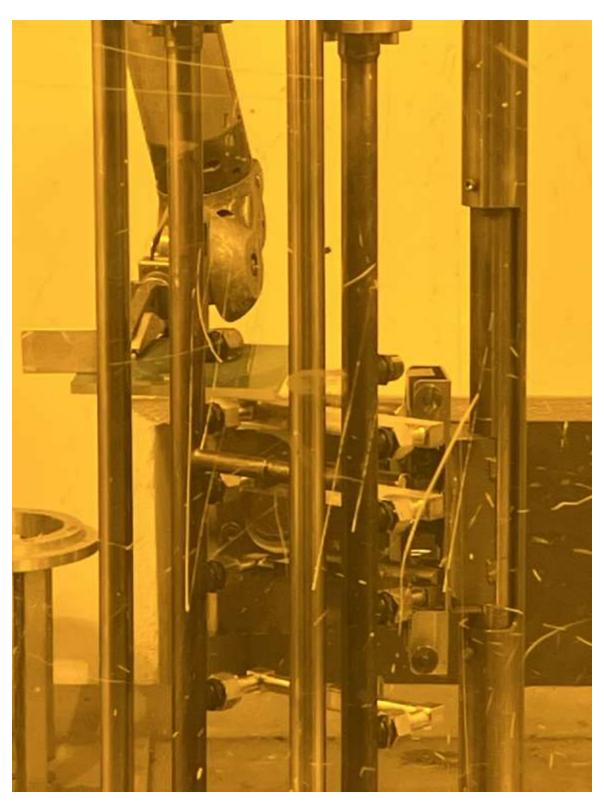
Use random plate to catch Swagelok plug and prevent damage to profile monitor.

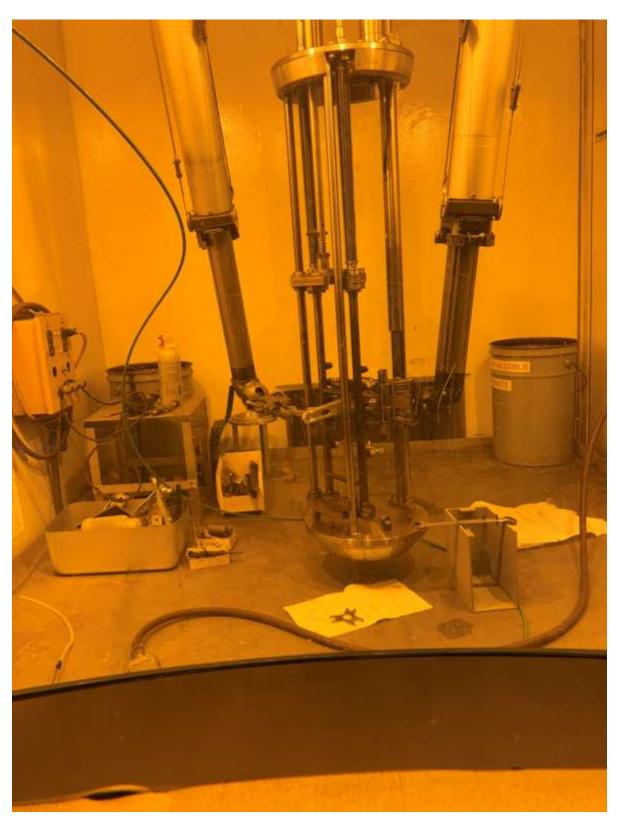
Gently hammering out target in position 3 (SER#301) on T2-MK1

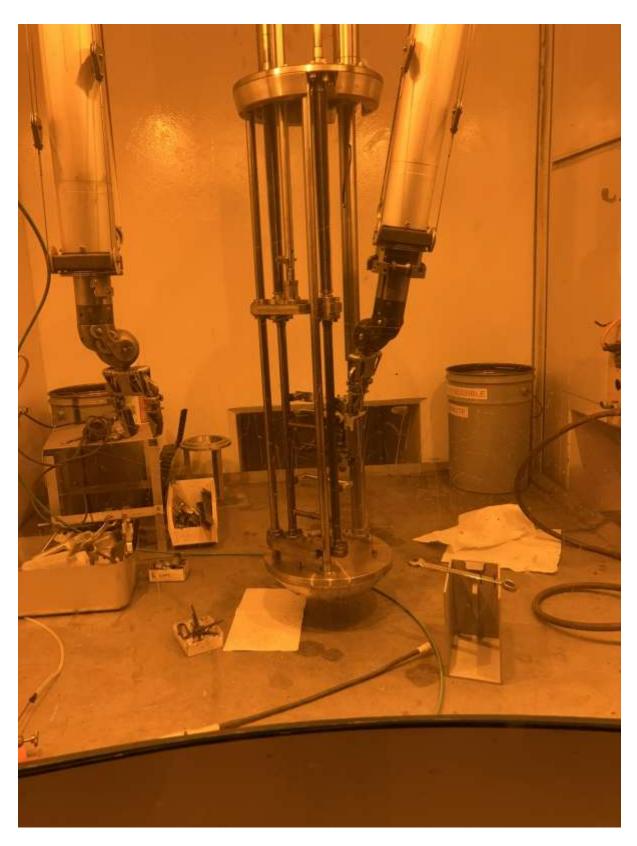
Checking Swagelok nut tightening with gap inspection gauge.

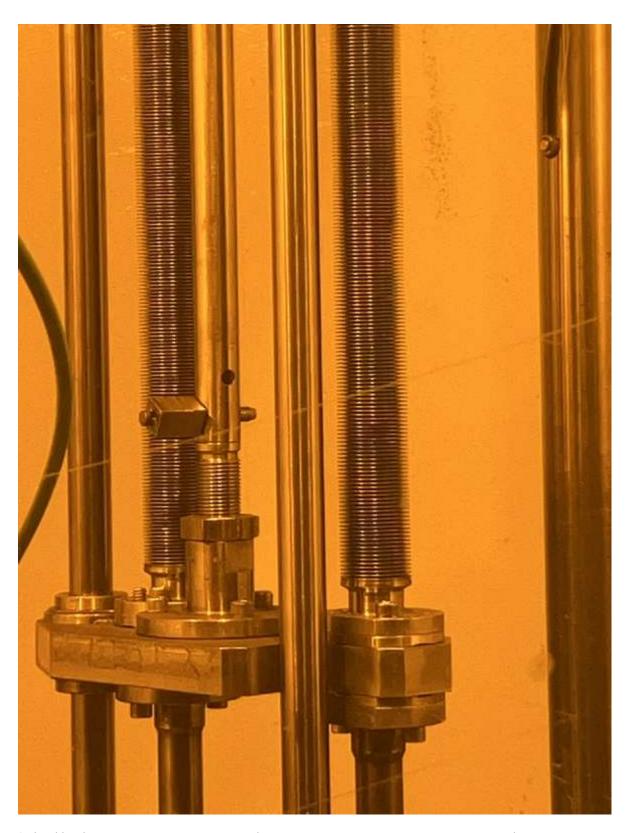
'Ding' in right bellows when ladder is rotated closer toward the hot cell window.
