## TM2 Source Tray Test in ISAC Test Stand April/May 2015

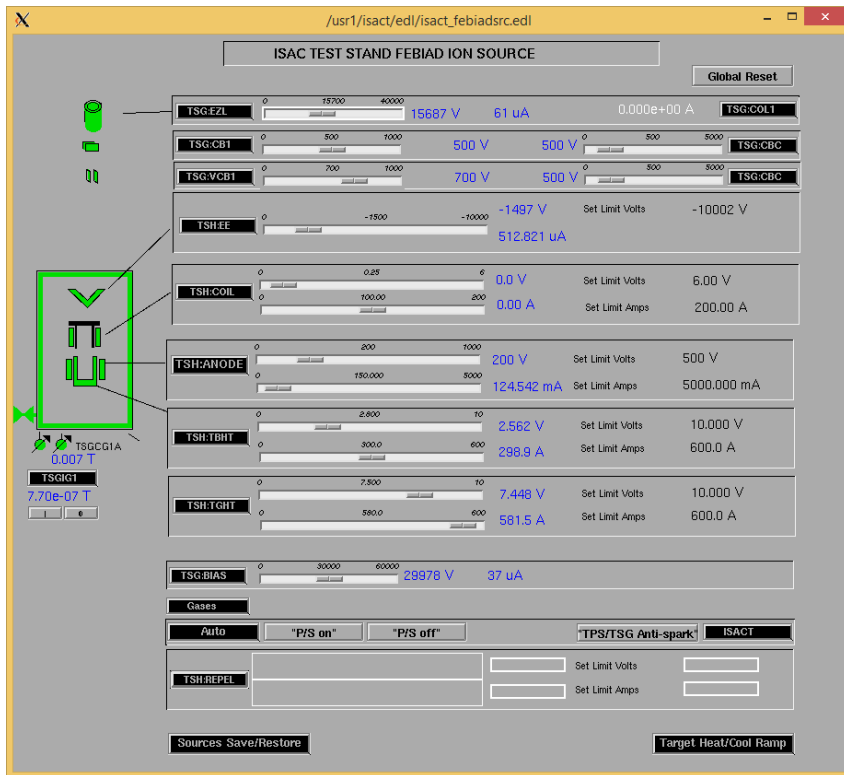
1. EZL was tuned to 15.7 kV at 30 kV BIAS. Required EZL voltage at 60 kV BIAS is expected to be 31.4 kV (5% more than the rated voltage for the cable used)
2. VCB1 steering required was 700 V (500 V CBC). A steering voltage of 1400 V could be required at 60 kV
3. TBHT and TGHT voltage was somewhat higher than expected. This could be explained by the thermal cycling of the target and the trips due to vacuum leaks.
4. Window cooling lines were installed but not connected to the water block nor the windows
5. The read back from the FEBIAD coil power supply stopped working during the test.

Figure 1: EZL voltage higher than for the Test Stand Source Tray, steering applied.

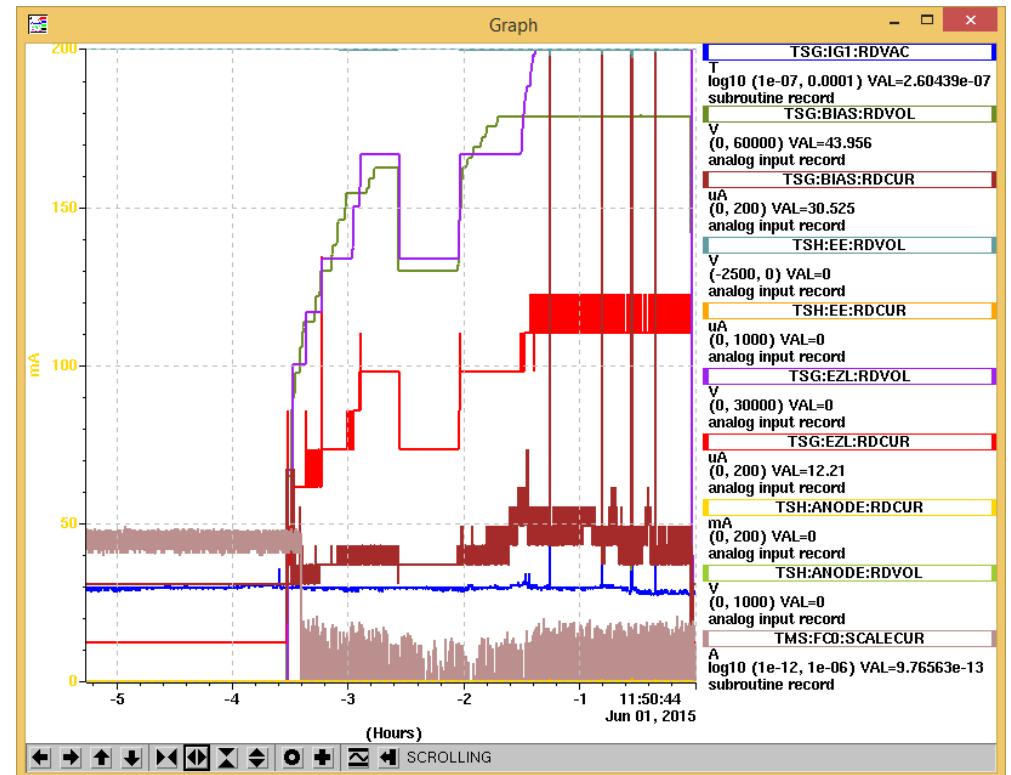
Figure 2: Final HV conditioning

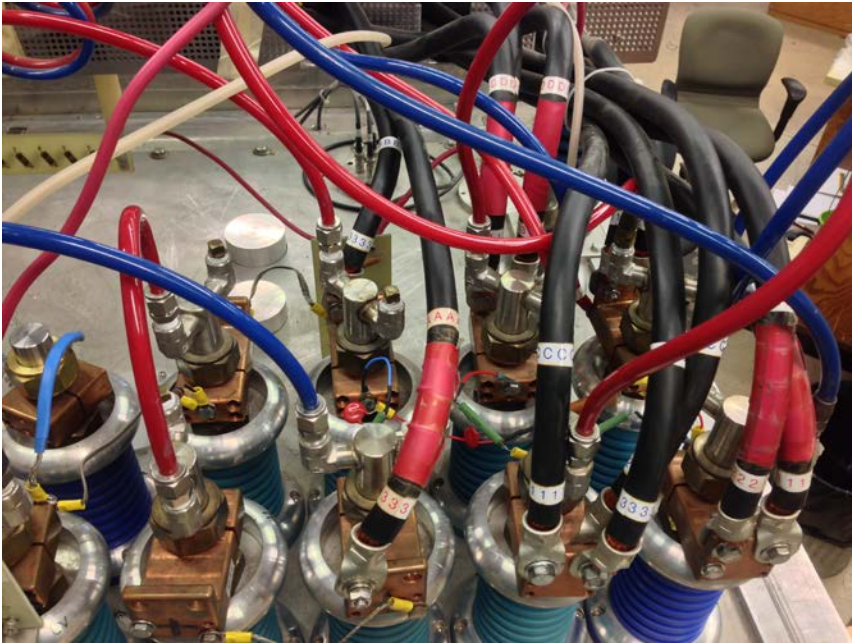
Figure 3: Test Stand coil configuration

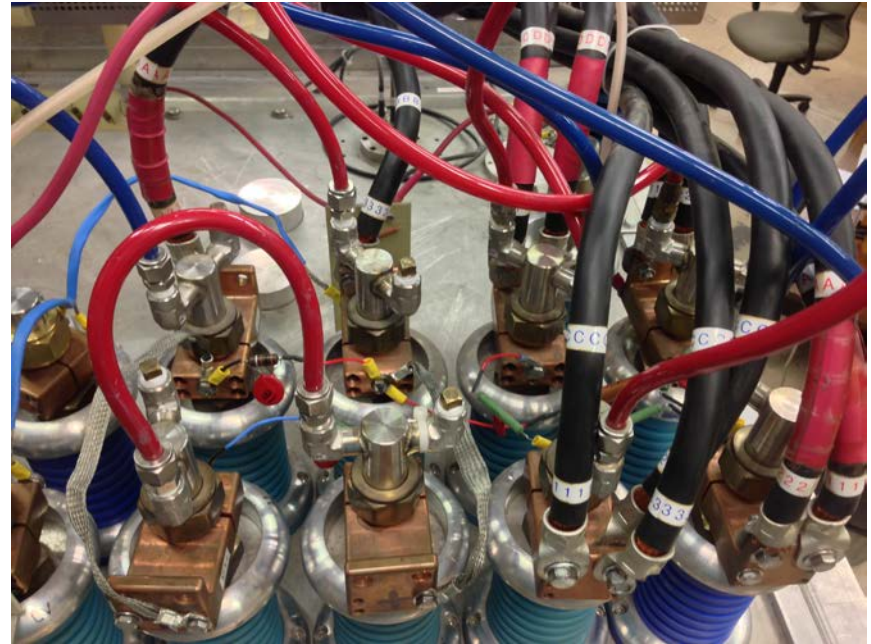
Figure 4: TM2 coil configuration

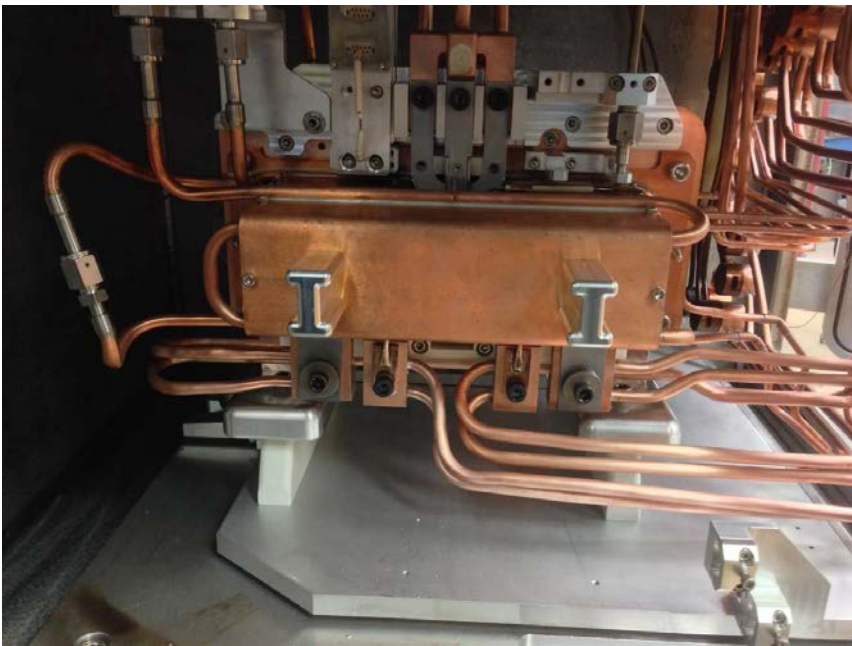
Leak developed at coil conductor block while target hot

Figure 5: Original coil connector blocks

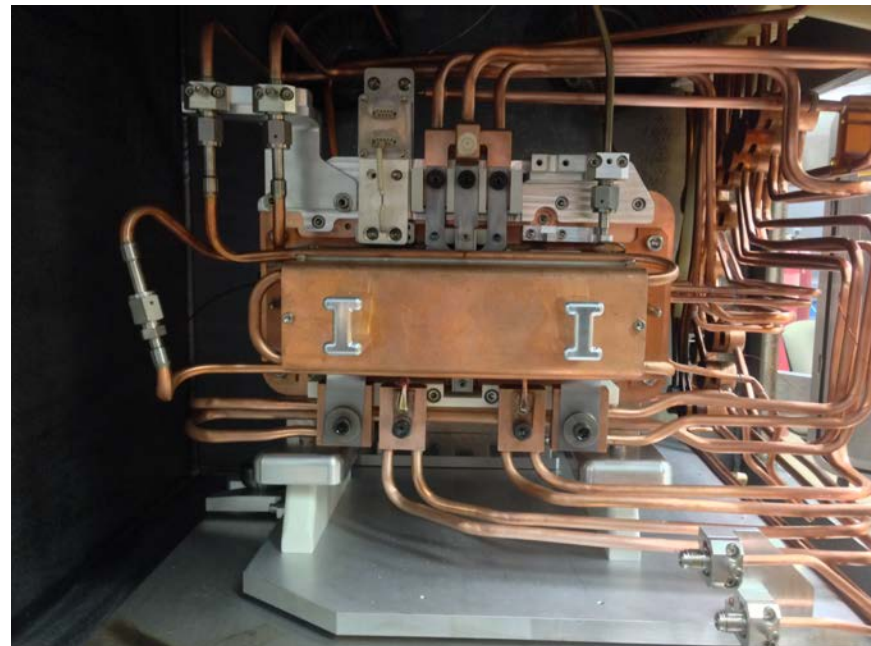
Test with redesigned coil conductor blocks – repeated leak at coil conductor block:

Leak developed at coil conductor block while target hot

Figure 6: New coil connector blocks
