Cleaning the flanges

2020-08-07

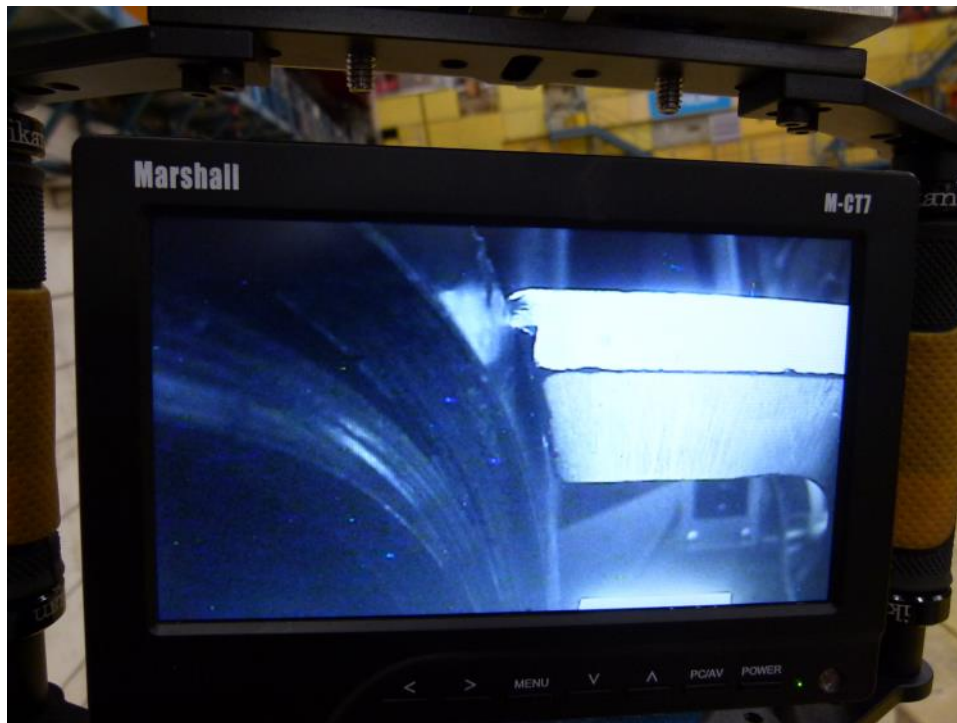
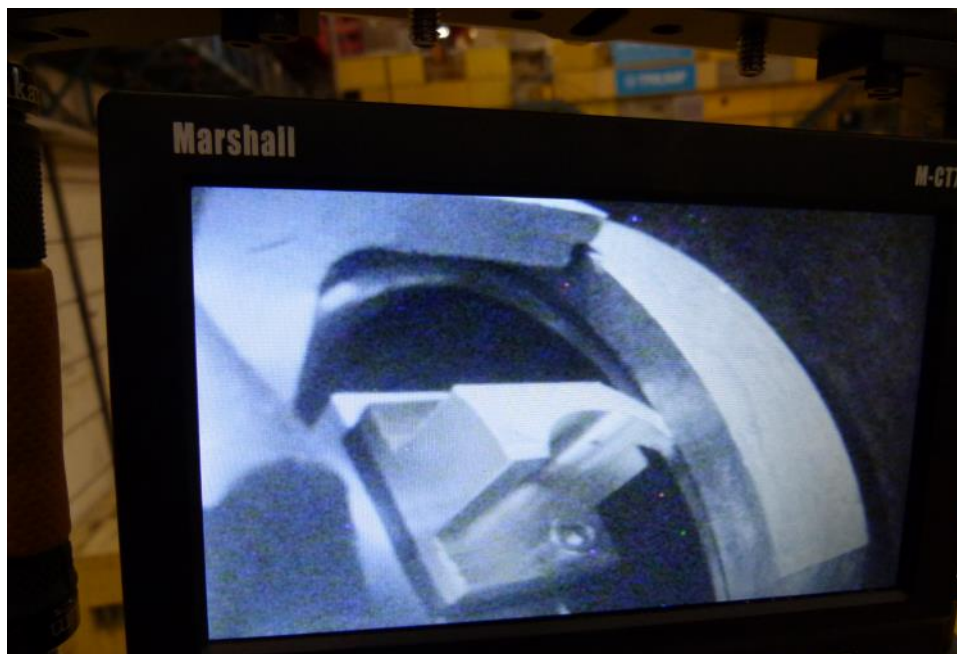
Photos of the indium scraper legs not seating on the OD of the T2 M9 flange. The mismatch is possible only 1/32" to 1/64" but enough to cause the scraping tool not to seat properly:

Attempted to scraped m9 flange with the open face indium scraper and new knife tools, scraper did not fit. In 2013 when we did this the scraper didn't fit also but we forced it on to the flange, it had to be pried off after. We abandoned scraping. 2013 elog is here: <https://elog.triumf.ca/TIS/RH-Beamlines/50>

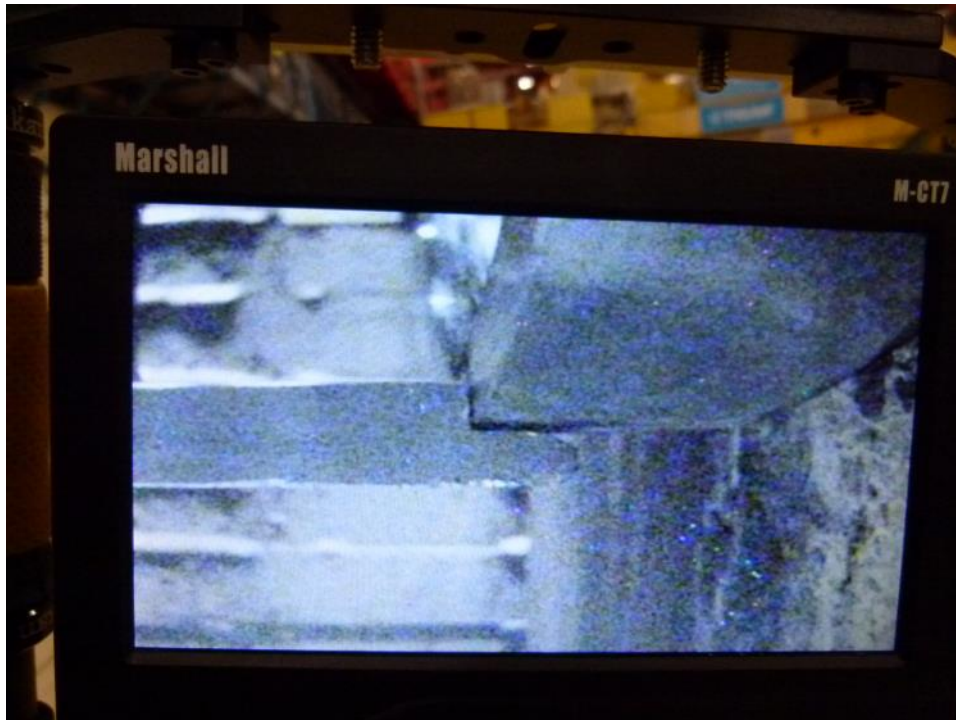
View of bottom positioning foot.

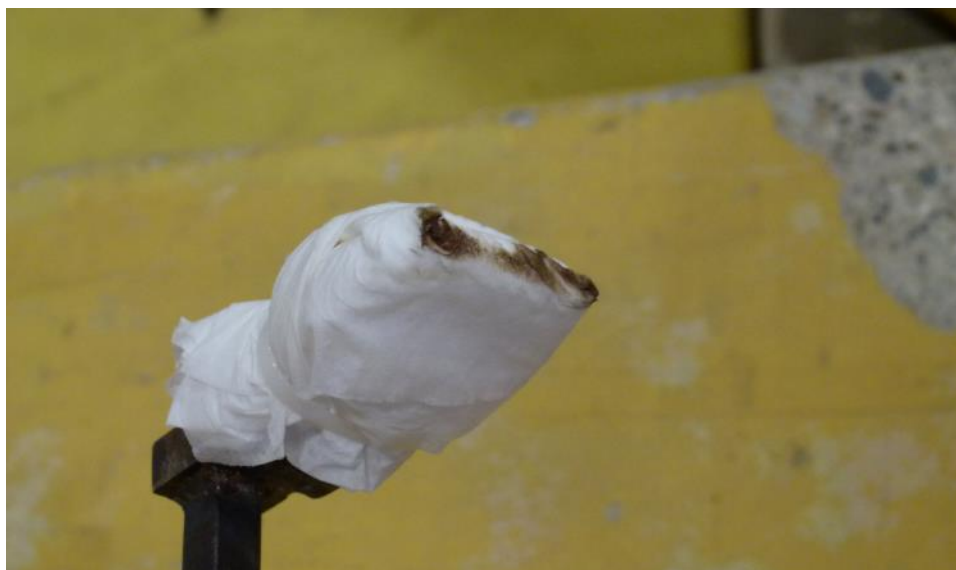
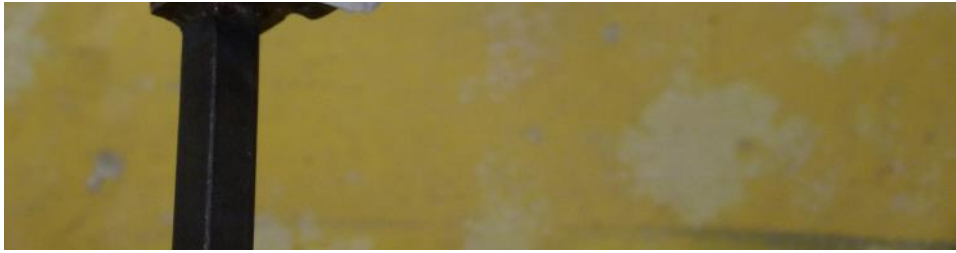
After first pass:

Spent rest of time cleaning the B1 flange manually with rags on poles and acetone and methanol. Acetone was also dribbled directly on the knife flange via a polyflow tube on a pole. Made three passes around the knife edge, it seems to be cleaner than before.
