TRIUMF – Pail Testing for ISAC Waste Shipment to CNL

Subject: Pail Testing (*current design*) Results

Date: 2023-06-09

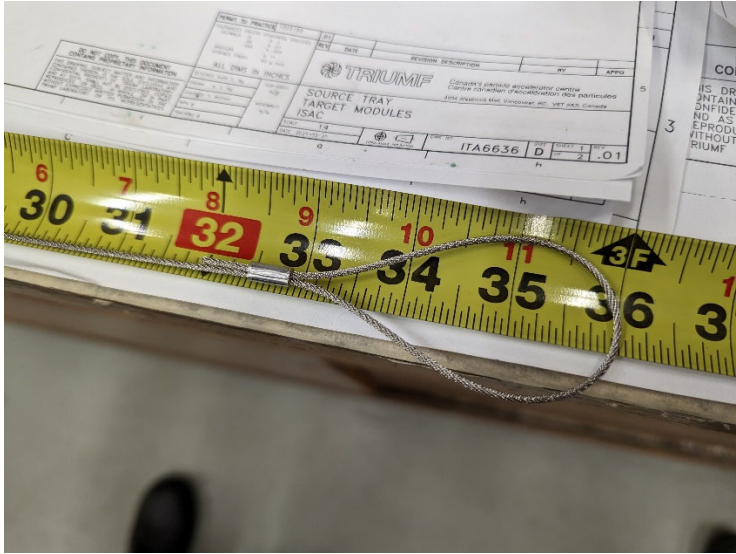
Figure 2: Crimped loop which was added to wire rope (3")

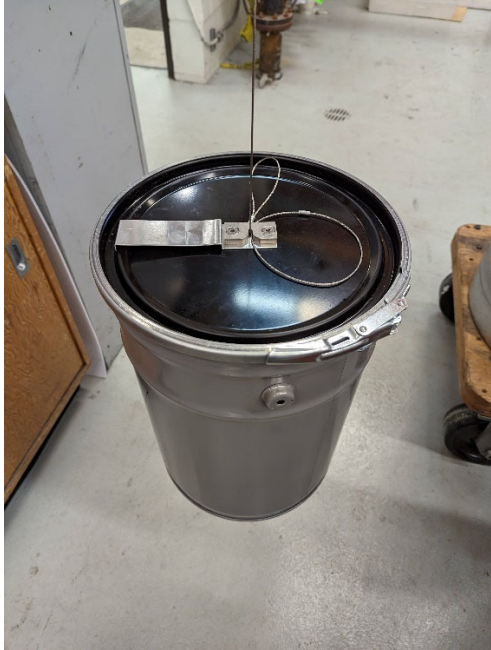
Figure 4: Pail shown suspended by wire rope

3. Hoist the load a sufficient distance off the ground ($> 2''$) to ensure the load is supported by the lifter (i.e. it is not resting on the ground or another surface). See Figures 4 – 7.
4. Leave the load suspended for 2 minutes.
5. Lower the load to the ground.
6. Visually inspect the lifting features for deformation, cracks, or other defects. Note any deficiencies and take photographs (see Figure 7). Complete the test summary table attached to this document.

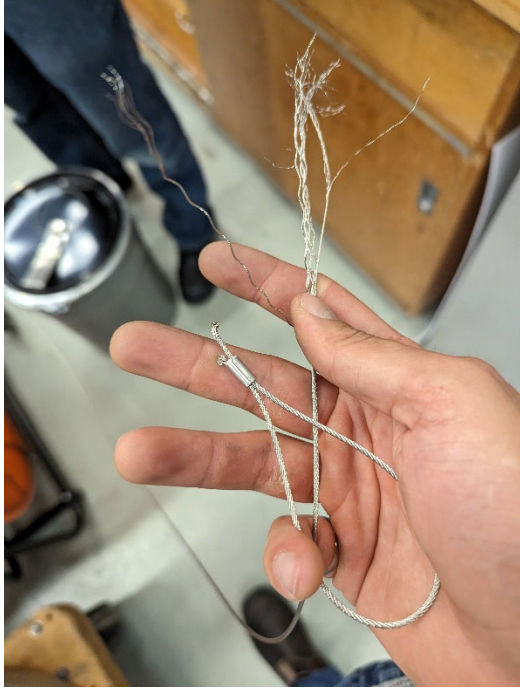
It is worth noting that this wire rope bending observation resulted in some further investigation and a design change for the next revision of the Pail Lifter Device, which is currently underway. It was suspected that this area would be the weakest link in the entire system, so destructive testing was performed on one sample by intentionally lifting up the pail with the full 45 kg load inside and dropping it. The failure point occurred exactly where the sharp 90 degree bend was located as the rope ran around the corner of the attachment block (note: this was not a fresh cable but rather one which already had a kink in it). The failure mechanism was the cable breaking (see Figure 9). While this is not an expected condition to actually occur, the destructive testing was helpful in understanding where the weak point in the design is. Although the design is still satisfactory and meets relevant standards, it is worth the effort to implement a relatively easy design improvement here.

Figure 9: Failure point during intentional destructive testing (beyond what is required for the purposes of this test)

A fillet will be added in place of the sharp 90 degree bend, which will result in less bending of the wire rope. This was tested in a proof-of-concept fashion by using
