T2-MK2 Target Leak Check

March 14, 2013

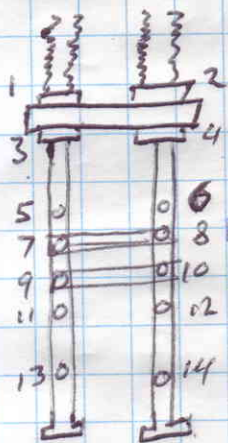
Left Bellows: Up to ~13

Right Bellows: Up to ~17

- 1: N/R
- 3: N/R
- 5: N/R
- 7: N/R
- 9: N/R
- 11: N/R
- 13: N/R

- 2: Up to 18
- 4: N/R
- 6: N/R
- 8: N/R
- 10: Up to 17
- 12: N/R
- 14: N/R

~2s
 Larger ^v general spray in 1+3 area: N/R
 2+4 area: Up to ~50

Repeat spray on right bellows: Up to ~20

Back side of location #2: Up to ~55

Larger (~2s) spray in general area around location #10: Up to ~35
