1AT1 Vacuum Leak Repair (W/P #C2020-1-24-1)

March 3, 2020

SUMMARY

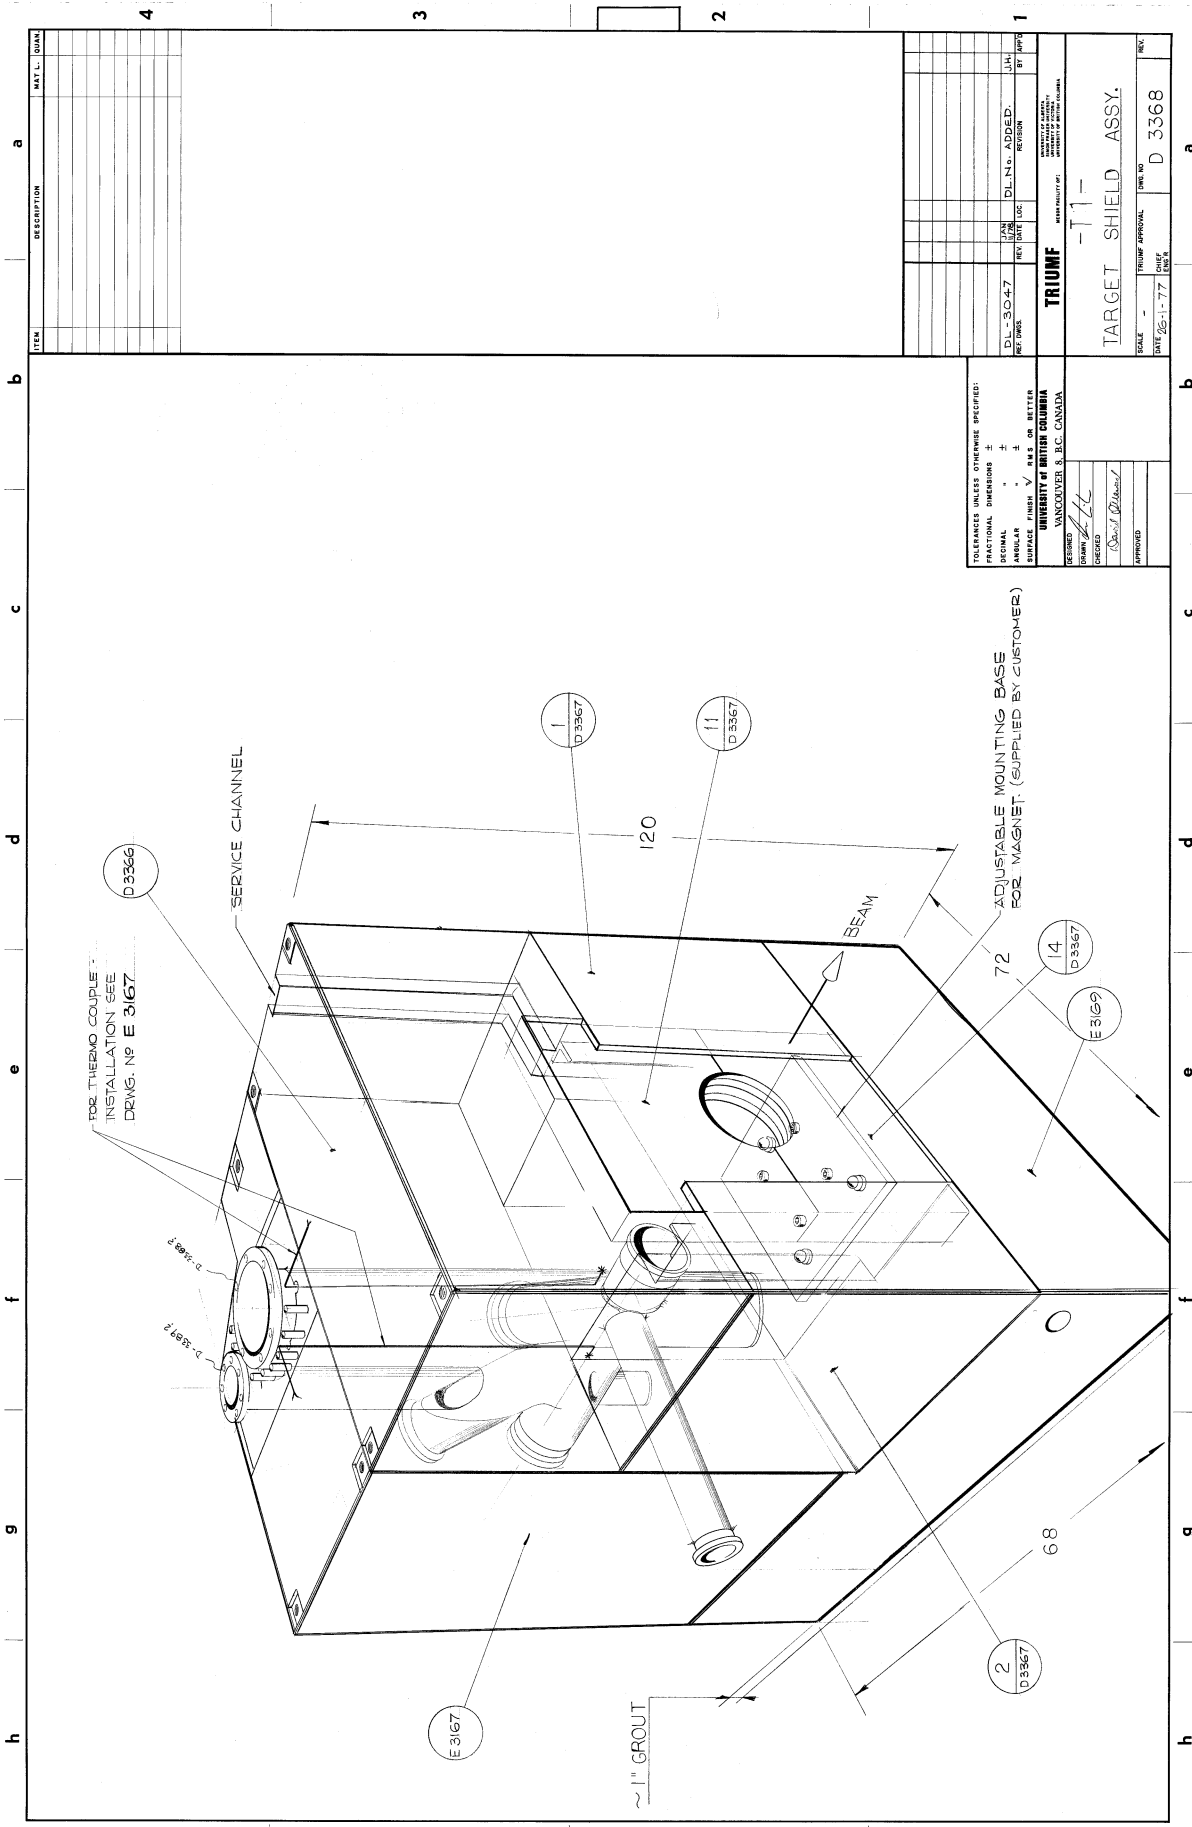
TRIUMF
 TARGET SHIELD ASSY.
 SCALE: AS SHOWN
 DATE: 2011-11-27
 TRUMP APPROVAL: *[Signature]*
 DWG NO: D 3368
 REV:

See TRIUMF Legacy Dwg D-3368 and the enclosed photos.

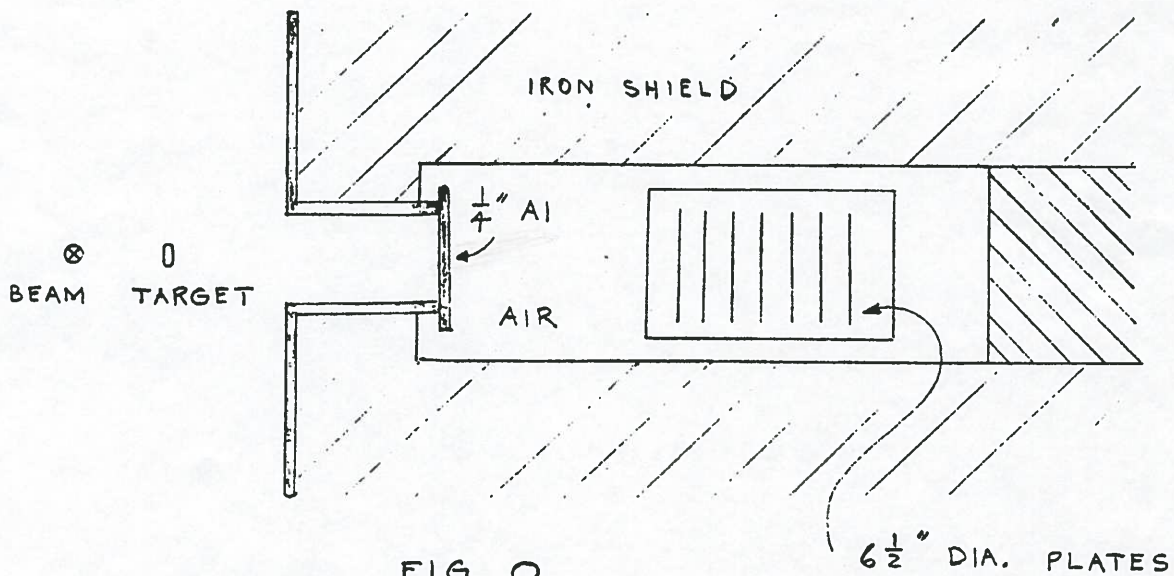
FIG. 0

A multiplate ion chamber with ambient air as the working gas is installed in the Tl target shield and responds to ionizing radiation from the target. (Fig. 0).

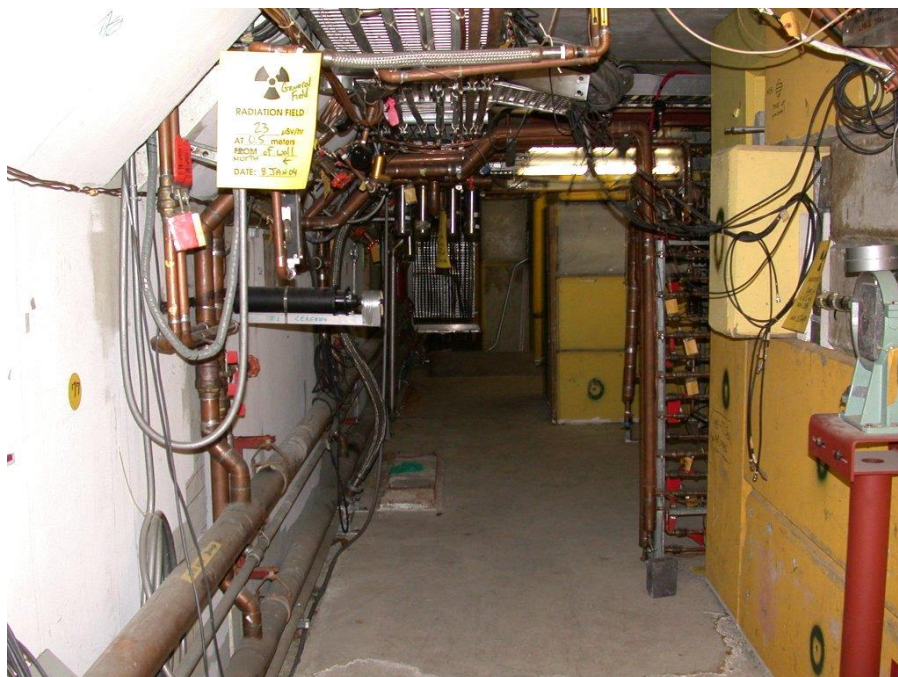
DSCN1642.jpg

Investigation in the 1A Service Tunnel revealed a 4" Maron flange blank-off in a rectangular cavern approx. (12"W x 24"H x 36"L).

1A Service Tunnel

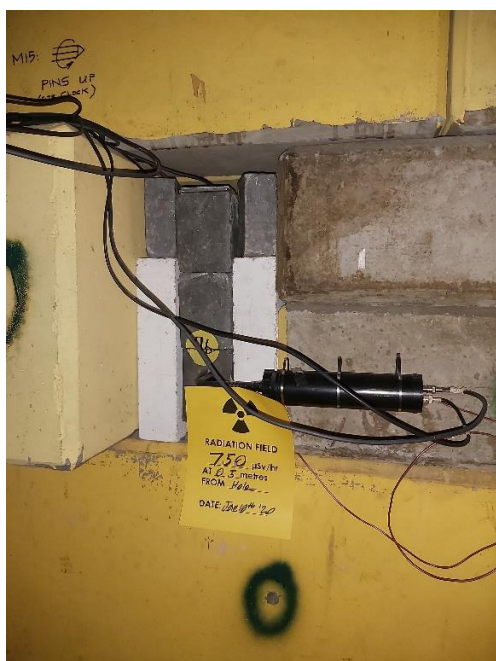
T1 South Vac Port4.jpg

The large vacuum air leak was confirmed at the south port of the T1 monolith vacuum vessel.

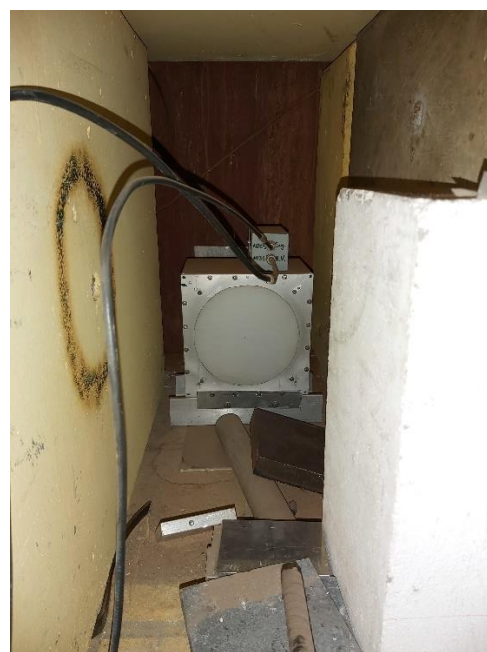
An Ion Chamber box approx. 7.5" Sq. was found in front of the Blank-off flange. It was carefully removed from the Cavern and placed on the tunnel floor after surface swipes were found clean with the RM-14 pancake and 44-2 monitors.

T1 South Vac Port1.jpg T1 Ion Chamber

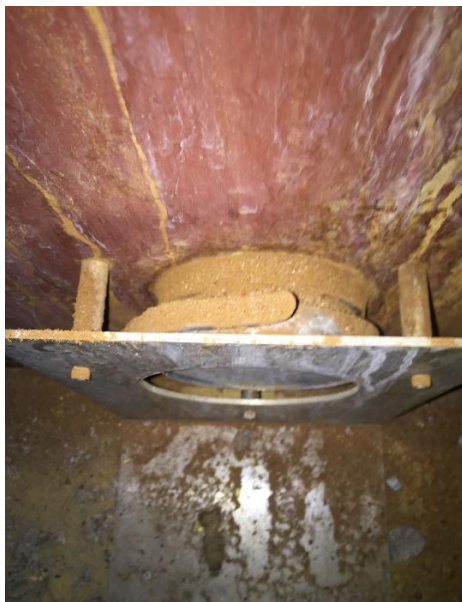
The Blank-off flange was heavily coated with iron rust particles which found 100 c/m on the Ludlum 26-3 Frisker monitor. Rad fields;

- Blank-off port was 7000uSv/Hr OC.
- Cavern opening at 1A Shield blocks was 750uSv/Hr @ 1M away.

IMG_6019.jpg Before repair

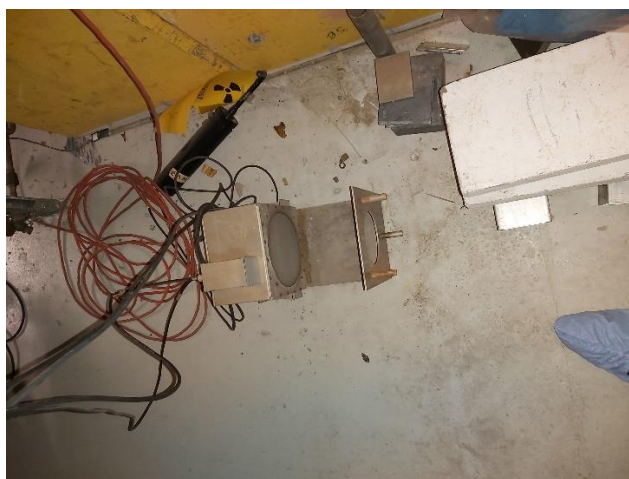
T1 South Vac Port2.jpg T1 Ion Chamber

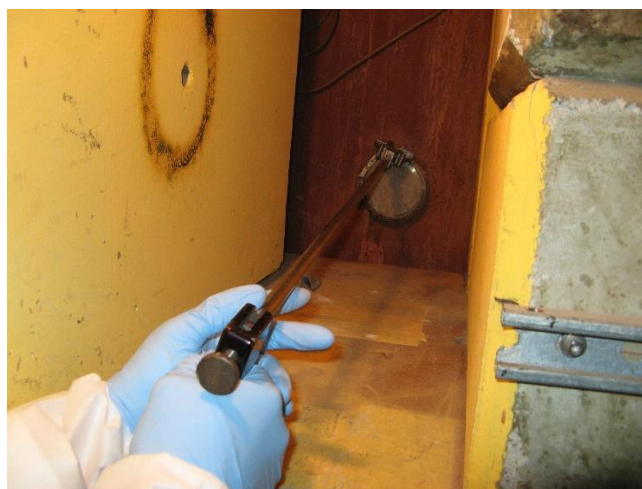
IMG_0434.jpg Removing leaking Blank-off flange

The Blank-off and the Cavern cavity were vacuumed using RH's Nilfisk vacuum cleaner and a 3 Ft. Lg. tongs. The Blank-off with its flange clamp were remotely removed using the tongs.

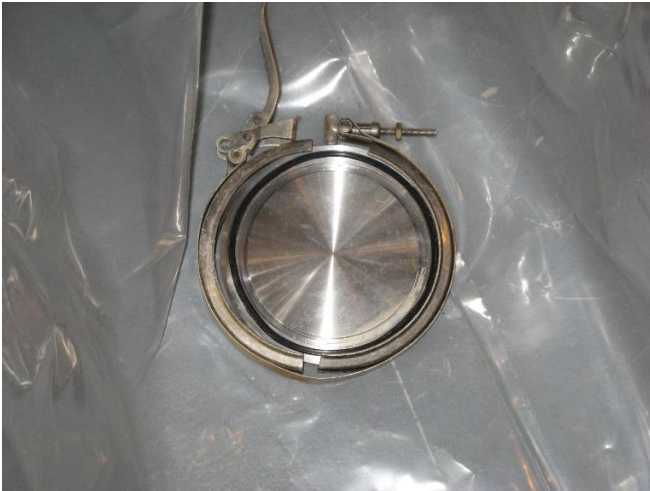
- Alum Blank-off flange was ~4000uSv/Hr, Swipes were ~1000 c/m on Ludlum 26-3 Frisker
- South T1 Port Swipes ~2000 c/m on Ludlum 26-3 Frisker

IMG_0441.jpg Removed Blank-off flange

The south T1 port was remotely cleaned with Wipe-alls moistened with Methanol alcohol using the tongs. About four iterations were needed to complete the flange cleaning.

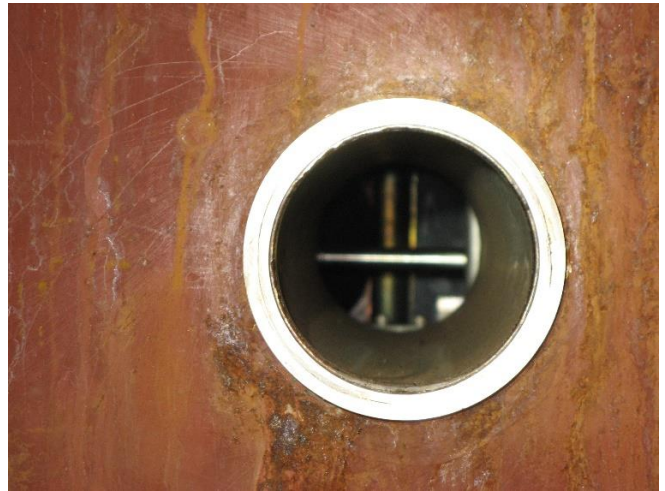
Note: The T1 target was not removed from the B/L with the target in position 0. (raised up from the beam plane)

IMG_0442.jpg T1 Target @ Position #0

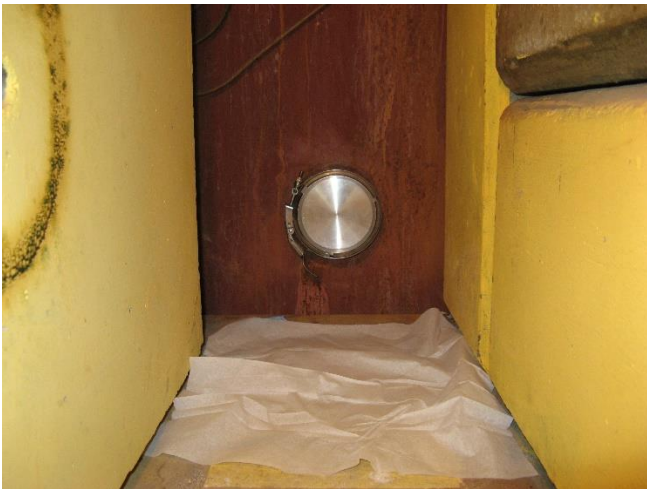
IMG_0449.jpg New Blank-off flange installed

A new Alum blank-off, Buna-N O-ring and Clamp were installed hands on after a DOSE Estimate was filled in. As no Finger TLD's were available, Joe M. from RPG was consulted and approved this work task which took about 12 seconds receiving 0.017 mSv to the worker.

The 1A vacuum was re-established with no leaks detected when sprayed with Helium. The T1 vacuum pressure was quoted to be as good as it was in 2015 from Vacuum group records.
