Product:	F3-VCR-43
Order-No.:	F3-VCR-434
Serial-Nummer:	F3-592
VSE Order-No.	3000-459
Delivery Date	09.06.2009
Customer:	TRIUMF
Customer Order No.	TR179013
Rejection No.:	-
Received Date	31.1.0.2011
Repair Date	02.11. – 03.11.2011
Warranty	No.

Protocol F3 motor: F3-592 after repair

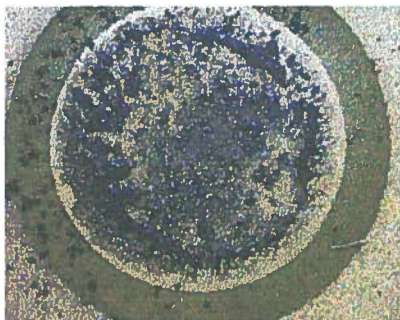
Figure 1: Diaphragm (60x scale)

Valve is early and abruptly tight. No control of leak below 10^{-6} mbar/s possible.

Valve was tested on the leak detector. Tight at position 720, control of leak below 10^{-6} mbar/s not possible.

Valve was disassembled and the valve seat and diaphragm (sealing) was inspected with microscope. See Figure 1.

The diaphragm was cleaned but it could not be used again, because part of the contamination remained. See Figure 2.

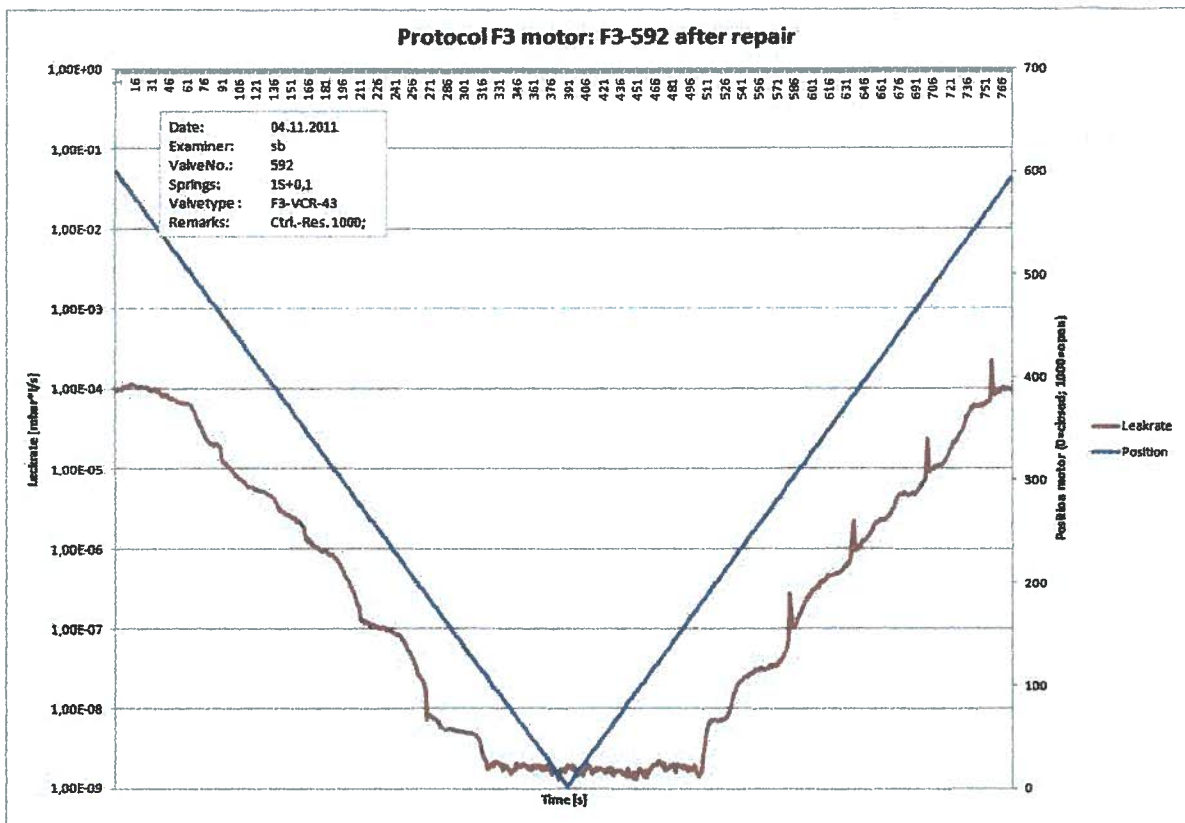
Figure 3: Test protocol after repair

The valve was reassembled with a new diaphragm and a test protocol was made. See Figure 3.

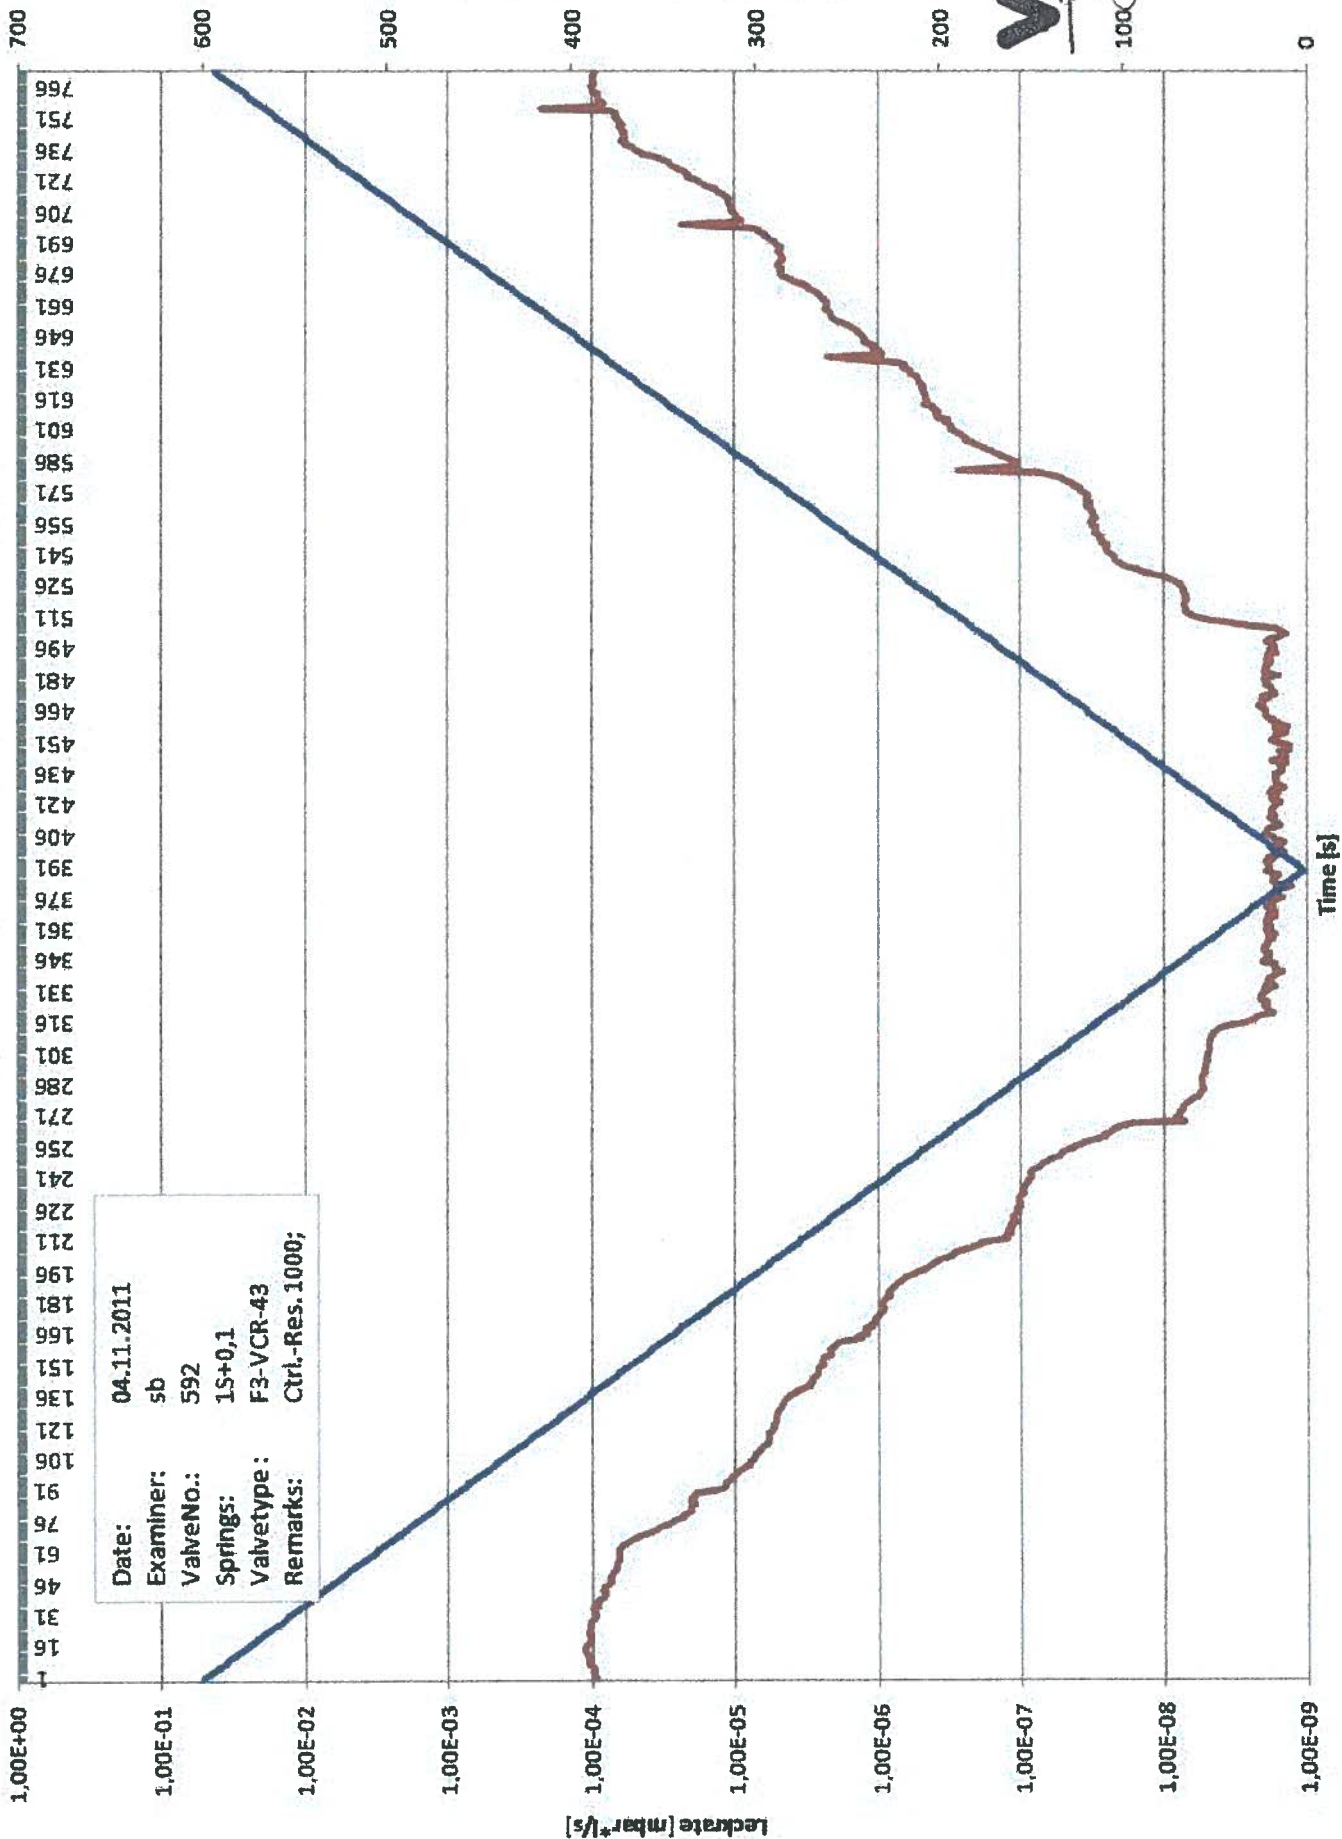
Date: 04.11.2011
 Examiner: sb
 ValveNo.: 592
 Springs: 1S+0,1
 Valvetype: F3-VCR-43
 Remarks: Ctrl.-Res. 1000;

Leakrate
 Position
