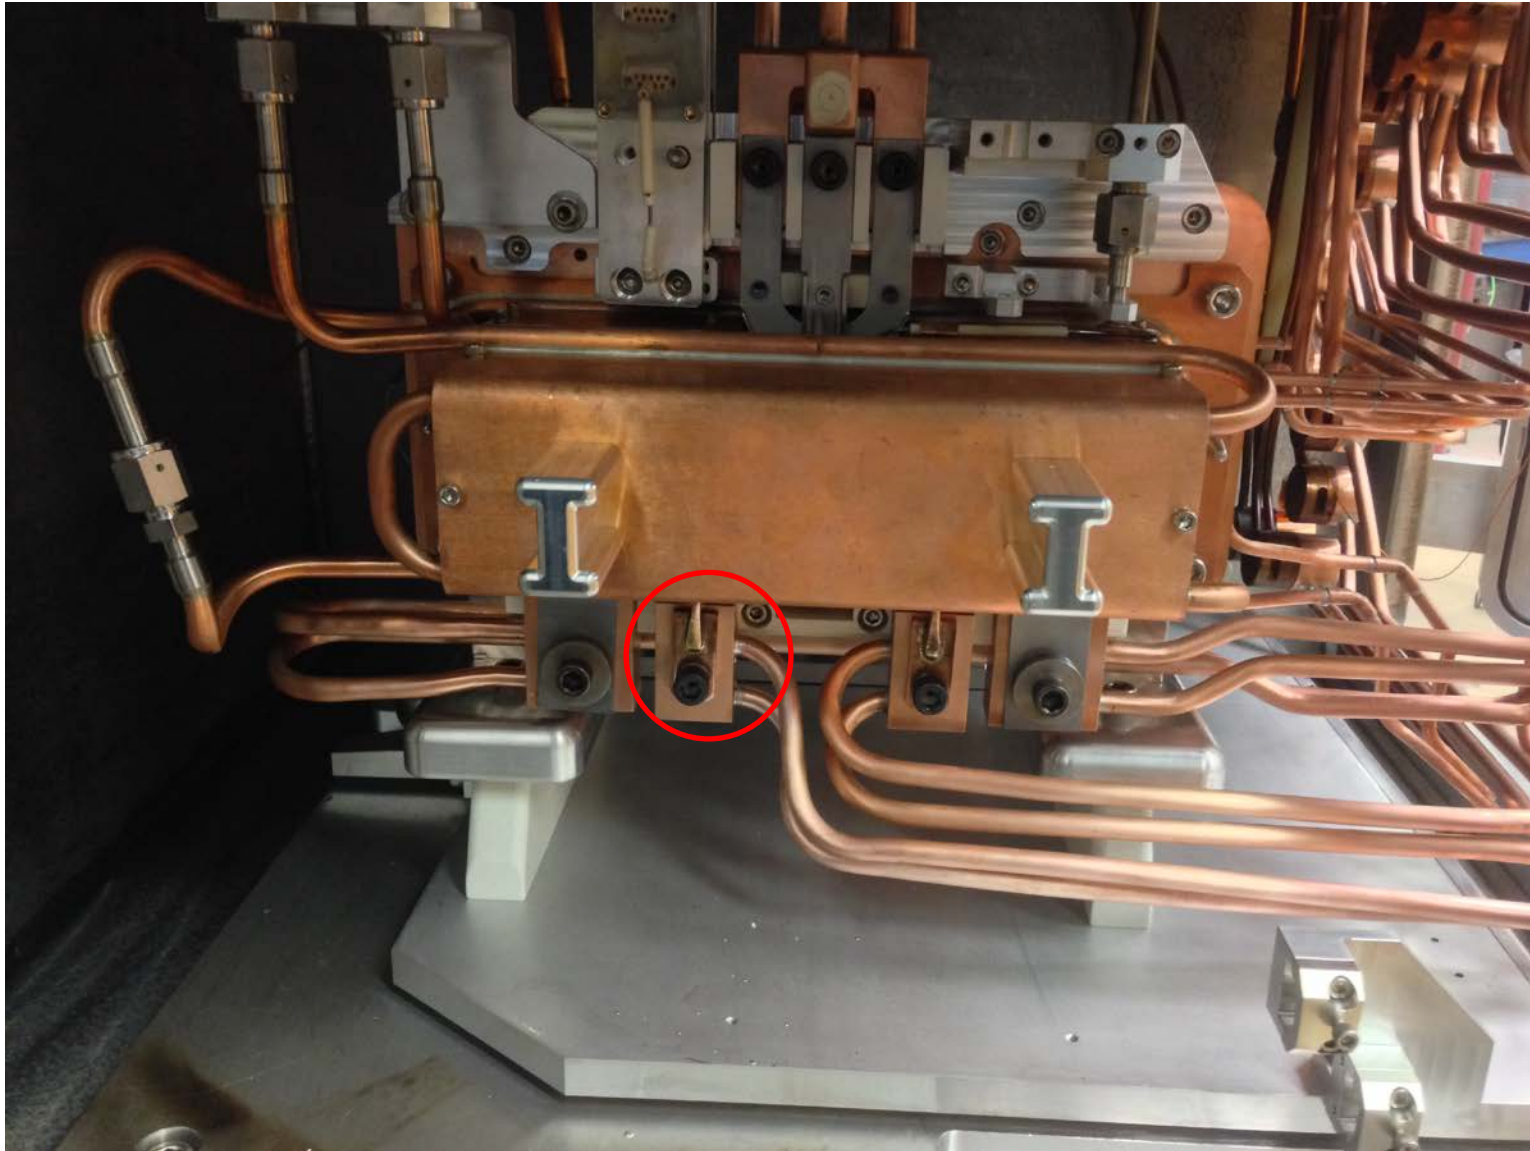
Figure 1: FEBIAD test target on TM2 Source Tray. Left coil connector circled.

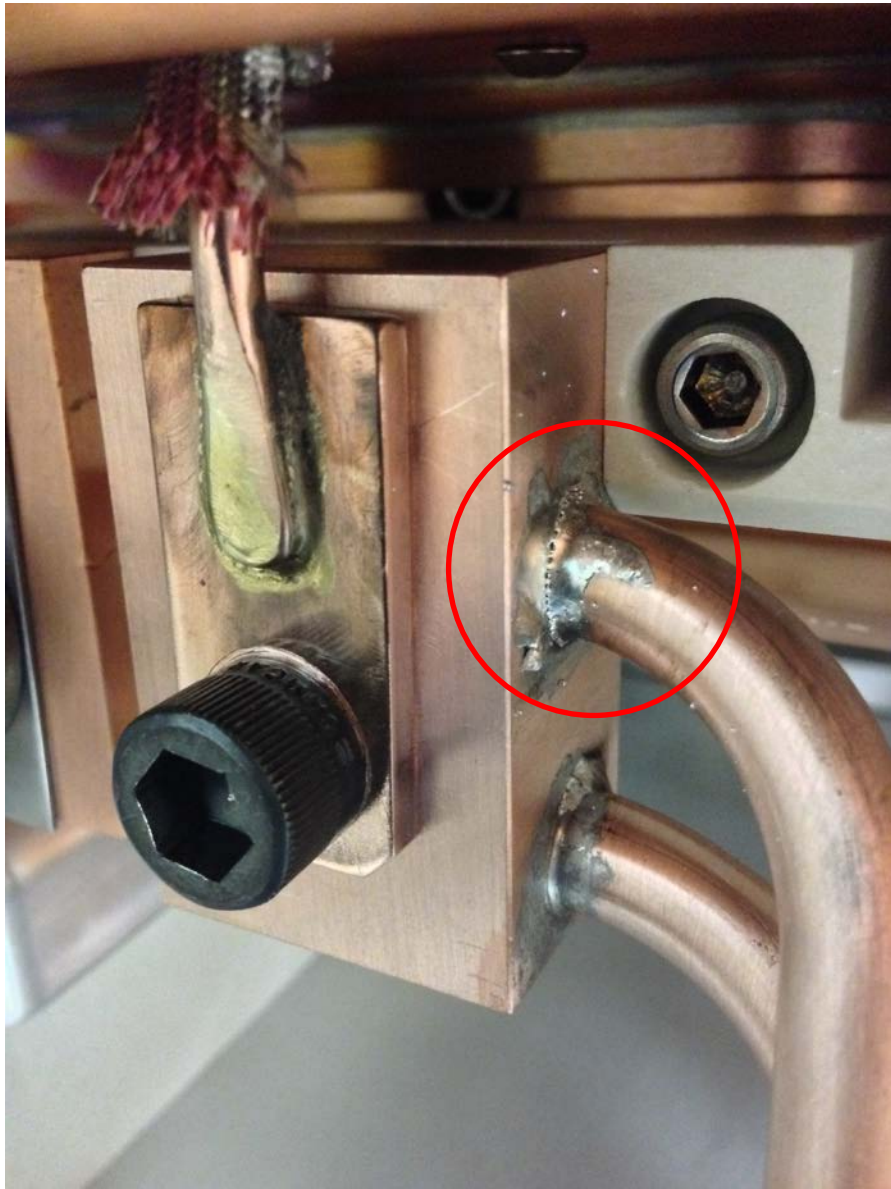
Figure 2: Close up of the solder site on the left coil line. Coil connected. Leak site circled.

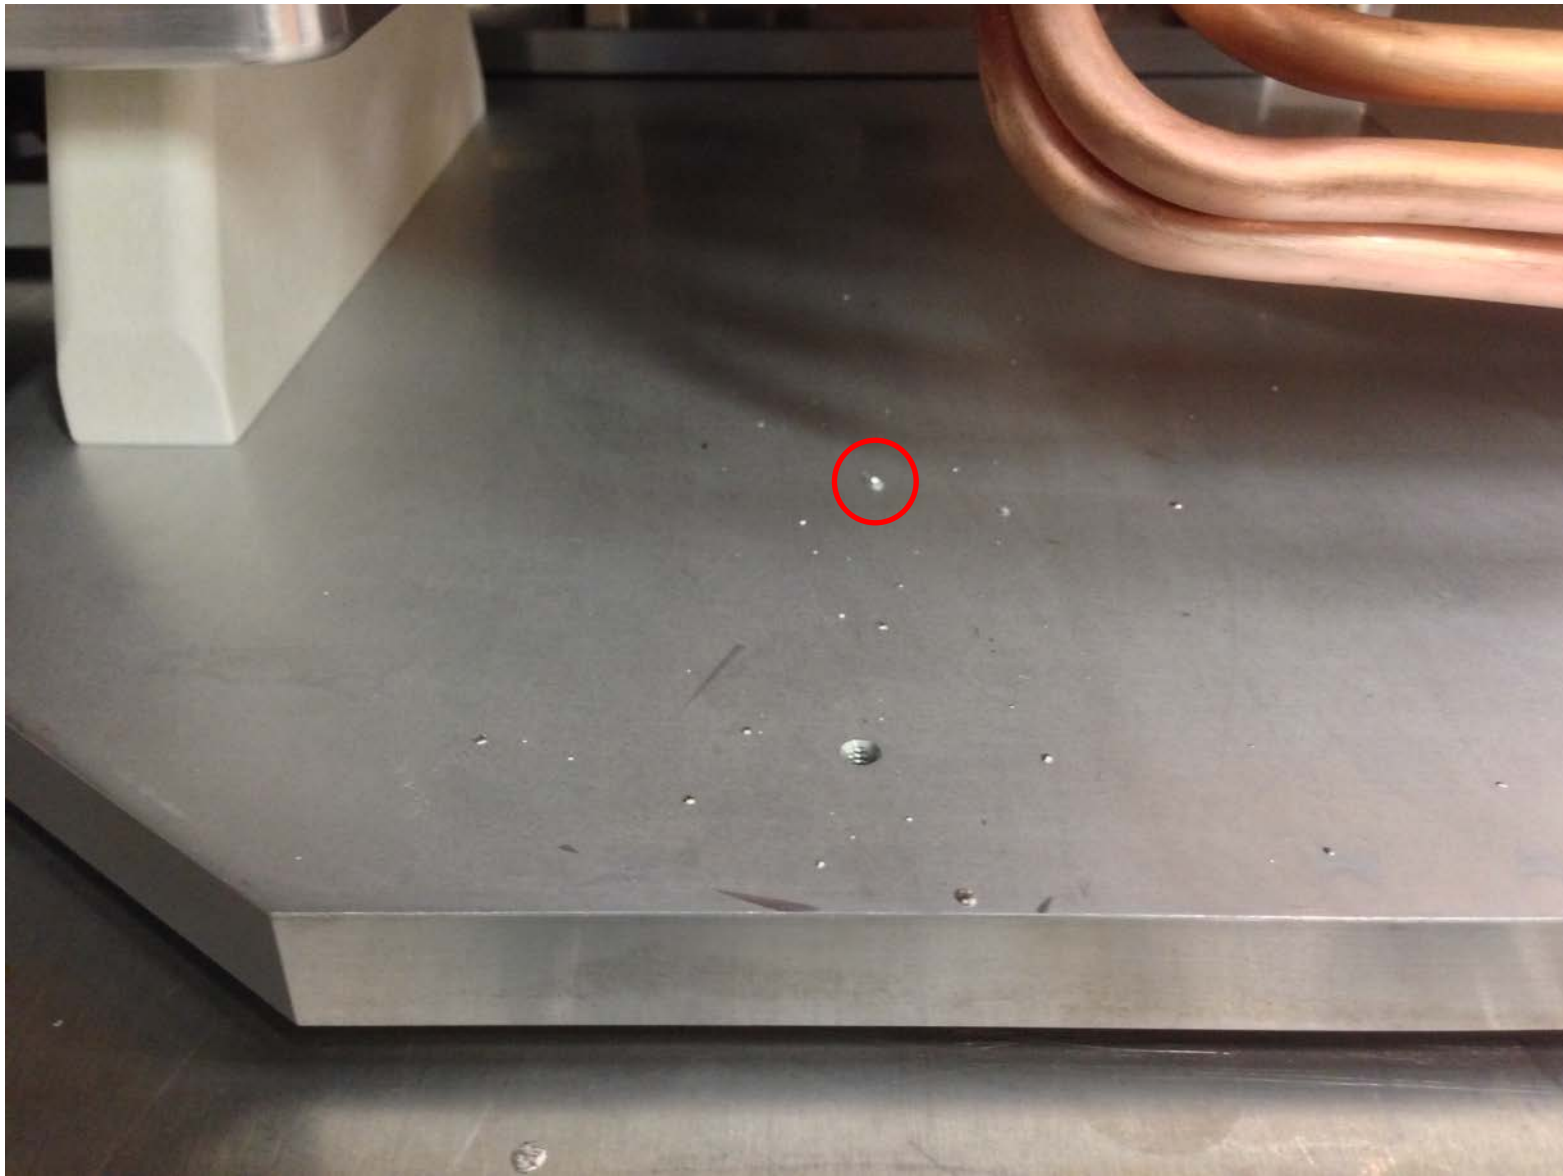
Figure 3: Solder splash marks on the Source Tray base plate
