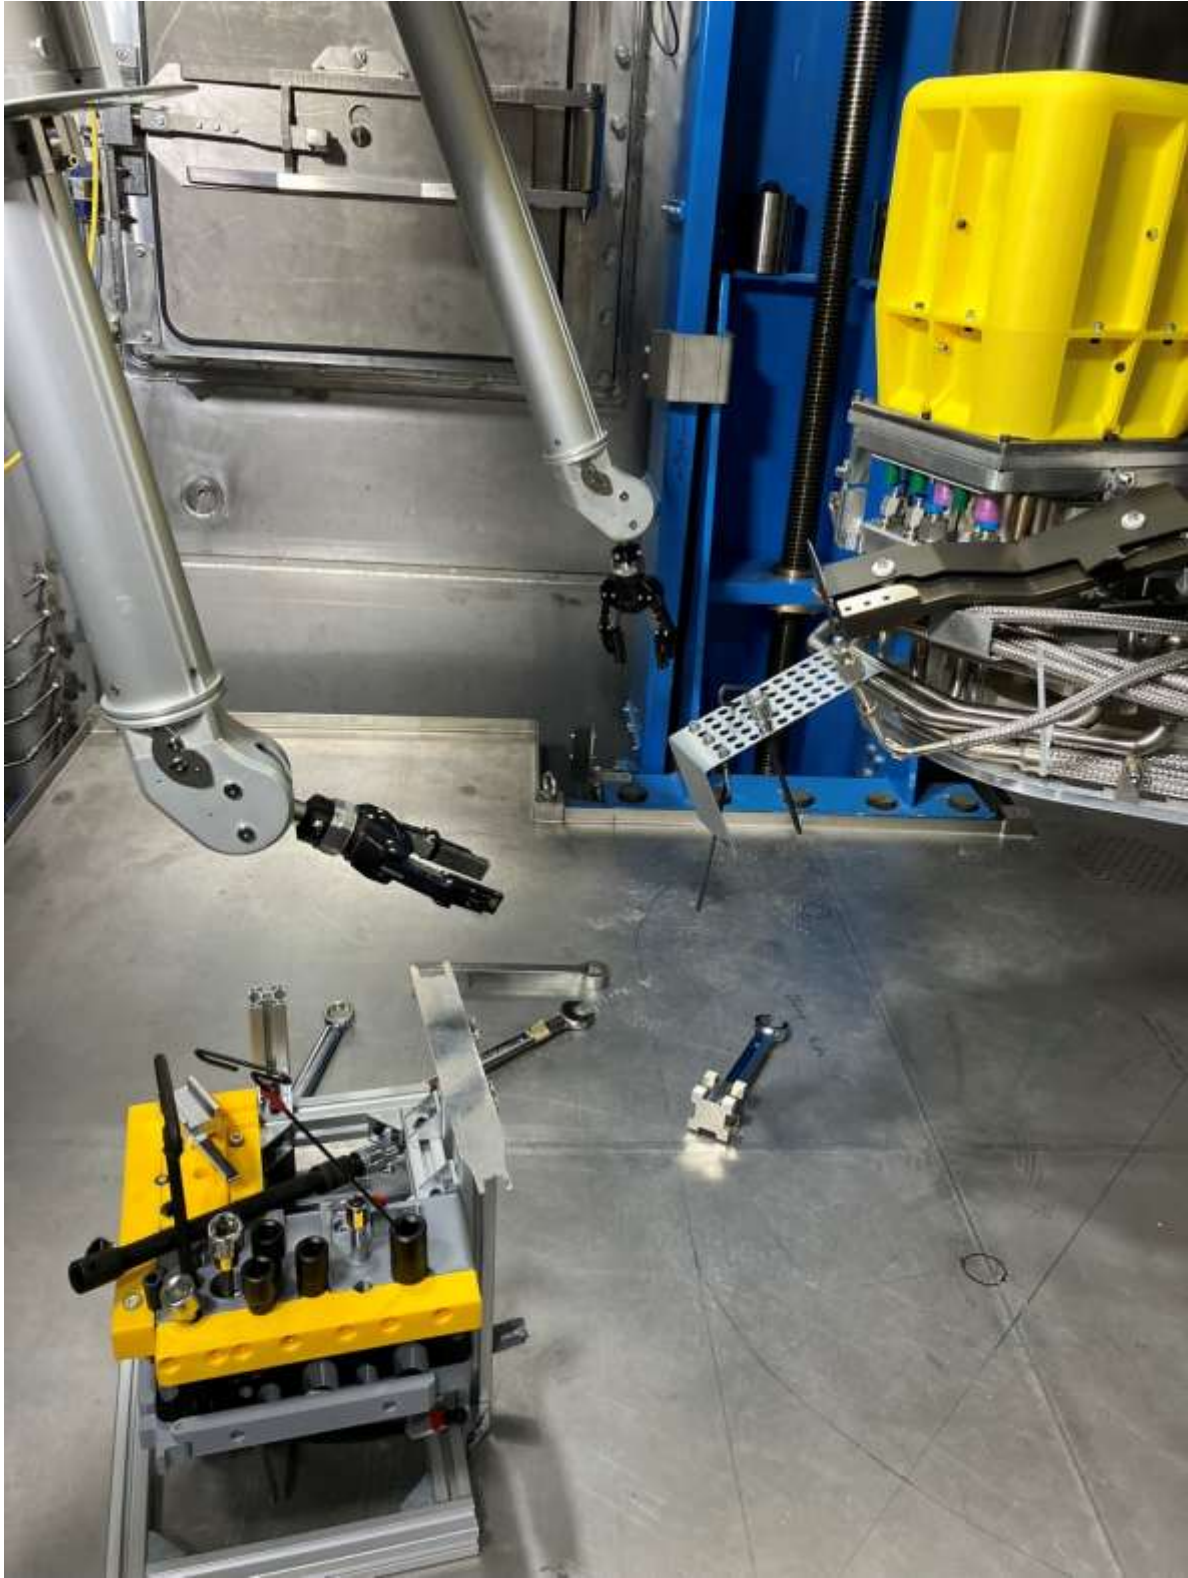
'makeshift' tool tray setup to return the busbar, camera battery died but busbar was successfully returned

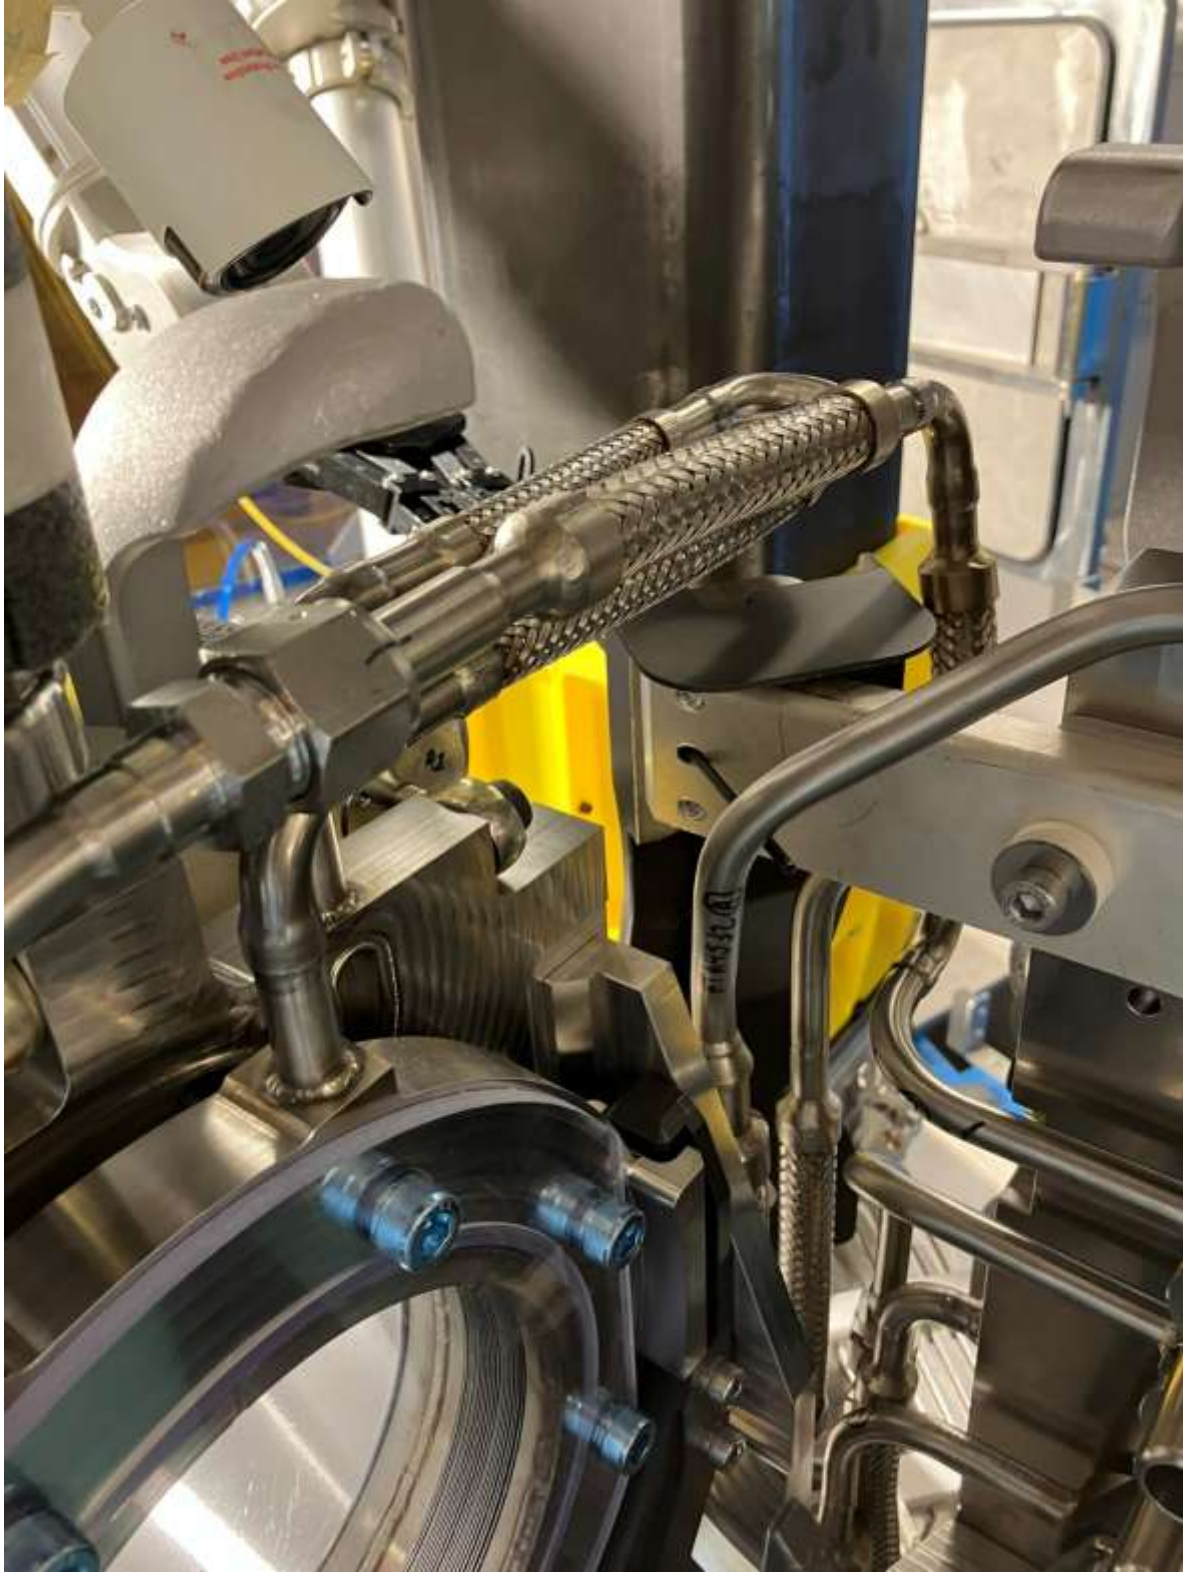
'Pinning' a screw hole on busbar.
