2017 Jul 10 T2 Solenoid Valve Replacement

CYCLOTRON Fault 10119
Summary: T2 target cooling system flow lost To Group: Targets Issued by:
Robin Swanson
Priority: immediate response
Preventive Request: 0
Details:
At 19:17 T2 target cooling system flow on the Cu-ALCW side of the heat
exchanger went to zero. Confirmed that target system had in fact lost flow
to heat exchanger when water package temps began to rise.

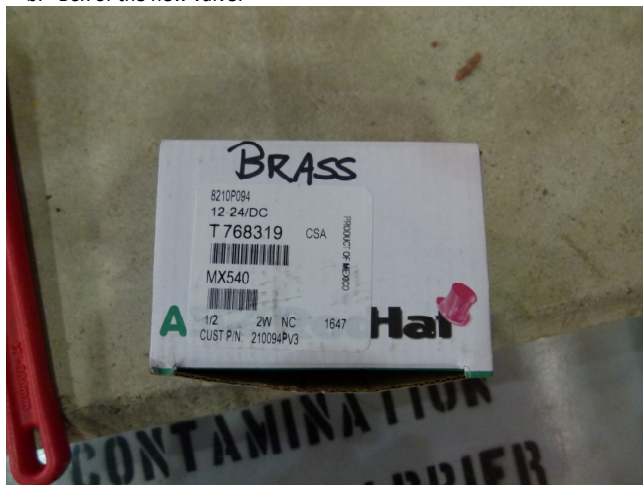
- b. Box of the new valve:

- a. Disconnecting old valve some black debris fell into drain pan, unsure if debris was already there or not.
- b. Connected new valve to multipin, had Controls (Tony) remote fire it, works, confirmed by Doug.
- c. MDV removed fittings from failed valve, taped pipe joints, reattached swagelok couplings to valve.

- d. Valve replaced on to water package.
 - e. Total job time replacing valve proper, est 30 mins.
9. Once valve connected, had ops restart water system.
- a. Heard solenoid fire, ops reported low flow but then back to normal after 5-10 minutes, likely from the heat exchanger being drained from removing the valve. MDV heard cavitation, but went away. Visually checked for leaks at the joints, none were seen. Pressure may not have been high enough to spot slow leaks at the joints however.
 - b. Flow meter was showing normal flow, Doug and Ops ok to re cover blocks
 - c. Doses: MDV .04 mSv, Doug P. .007mSv , KCN .019 mSv; 0.066 mSv Total, does not include plant group uncovering blocks.
10. Work done by 15:15.
11. Post mortem:
- a. Valve has failed about two times in the same way in the last year.
