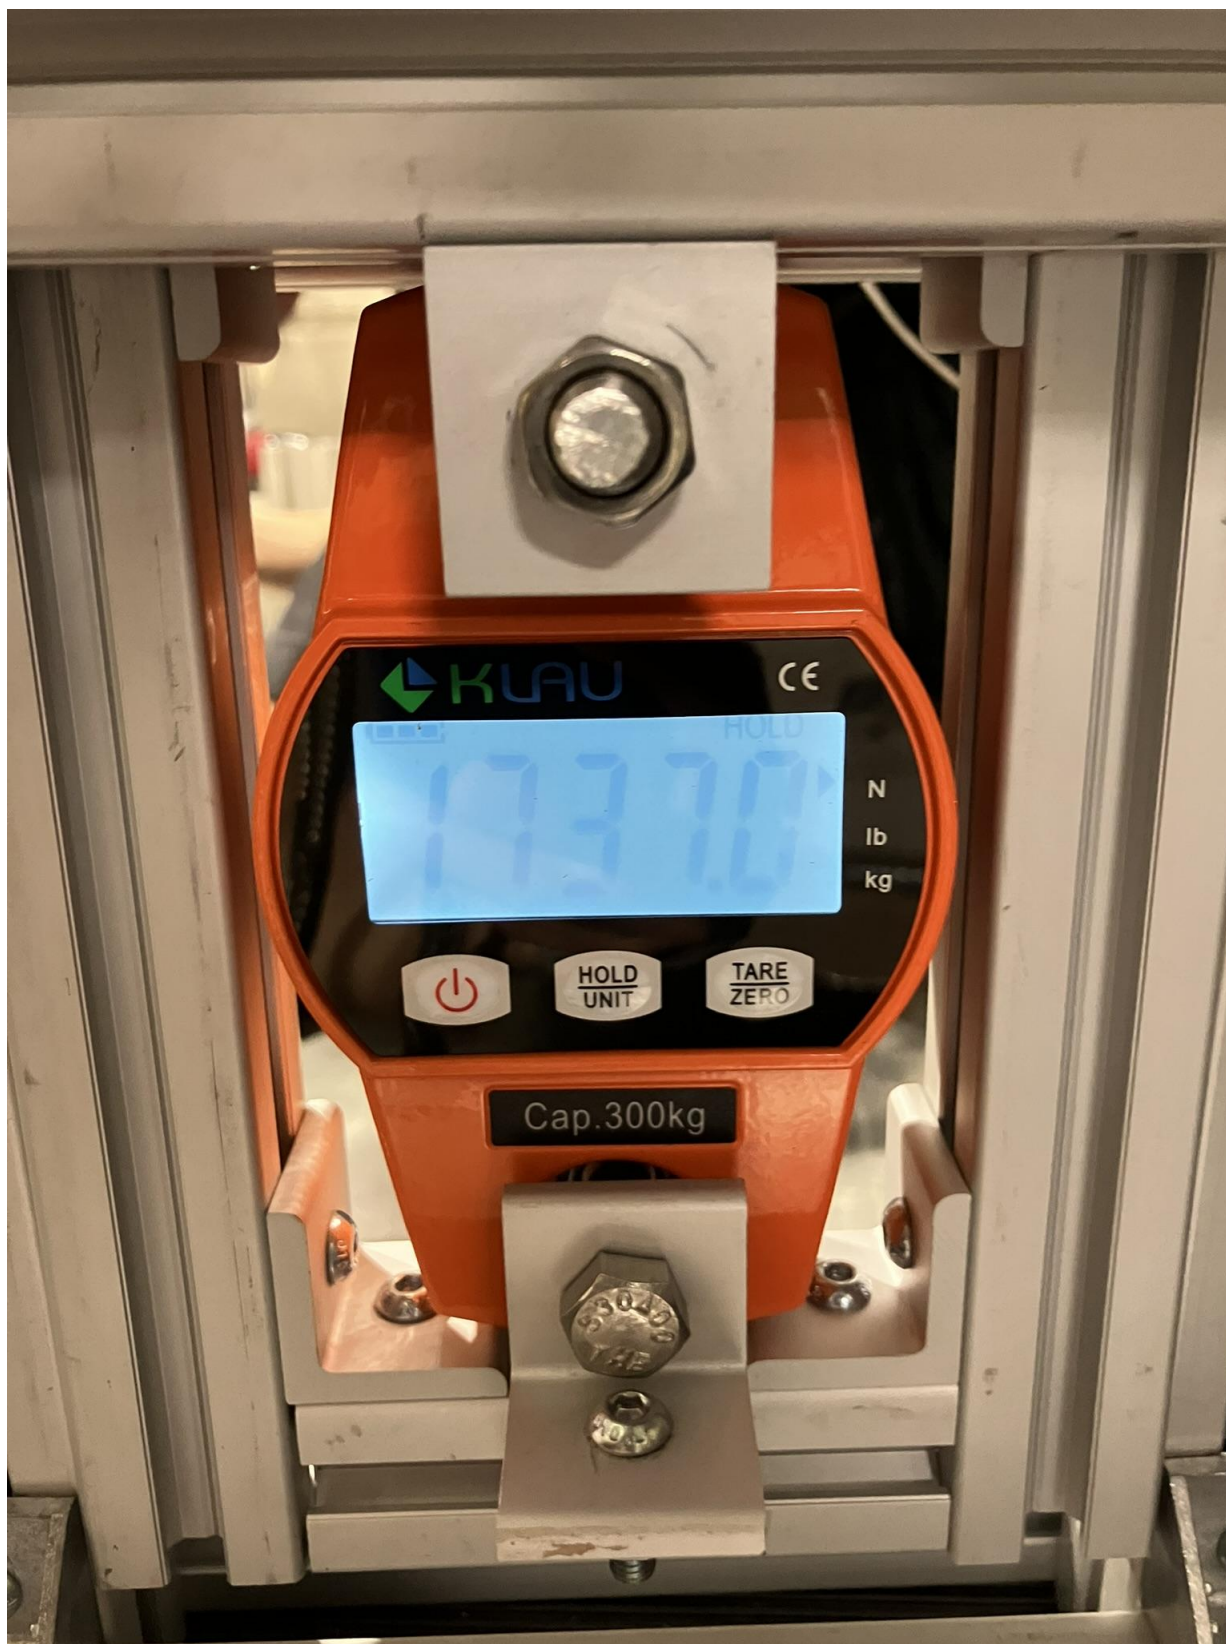
Peak force measured during coupling was ~1700N.

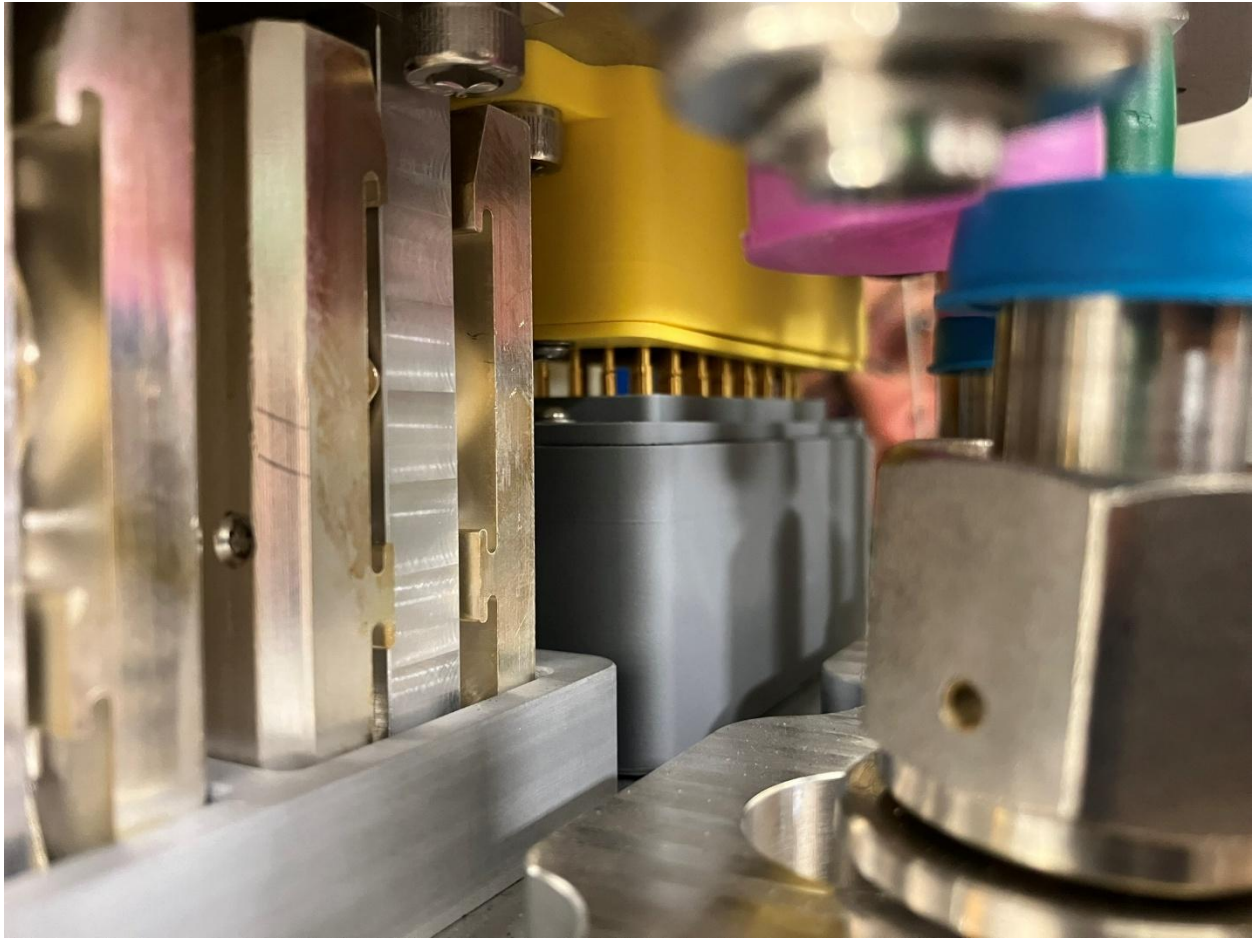
All pins on 48 pin connector coupled together without issue when the service tray was raised.

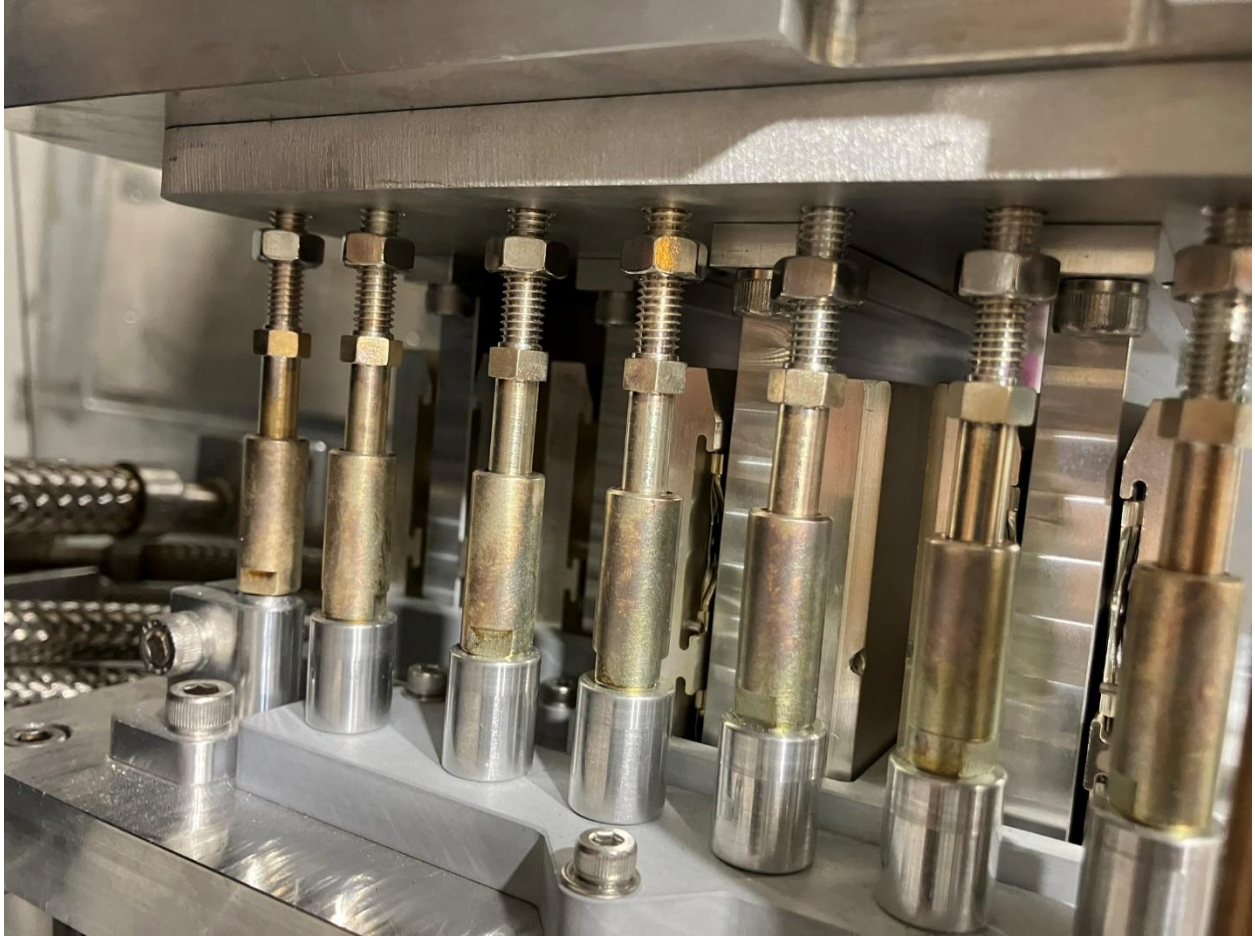
All pins self-guide into the sockets.
