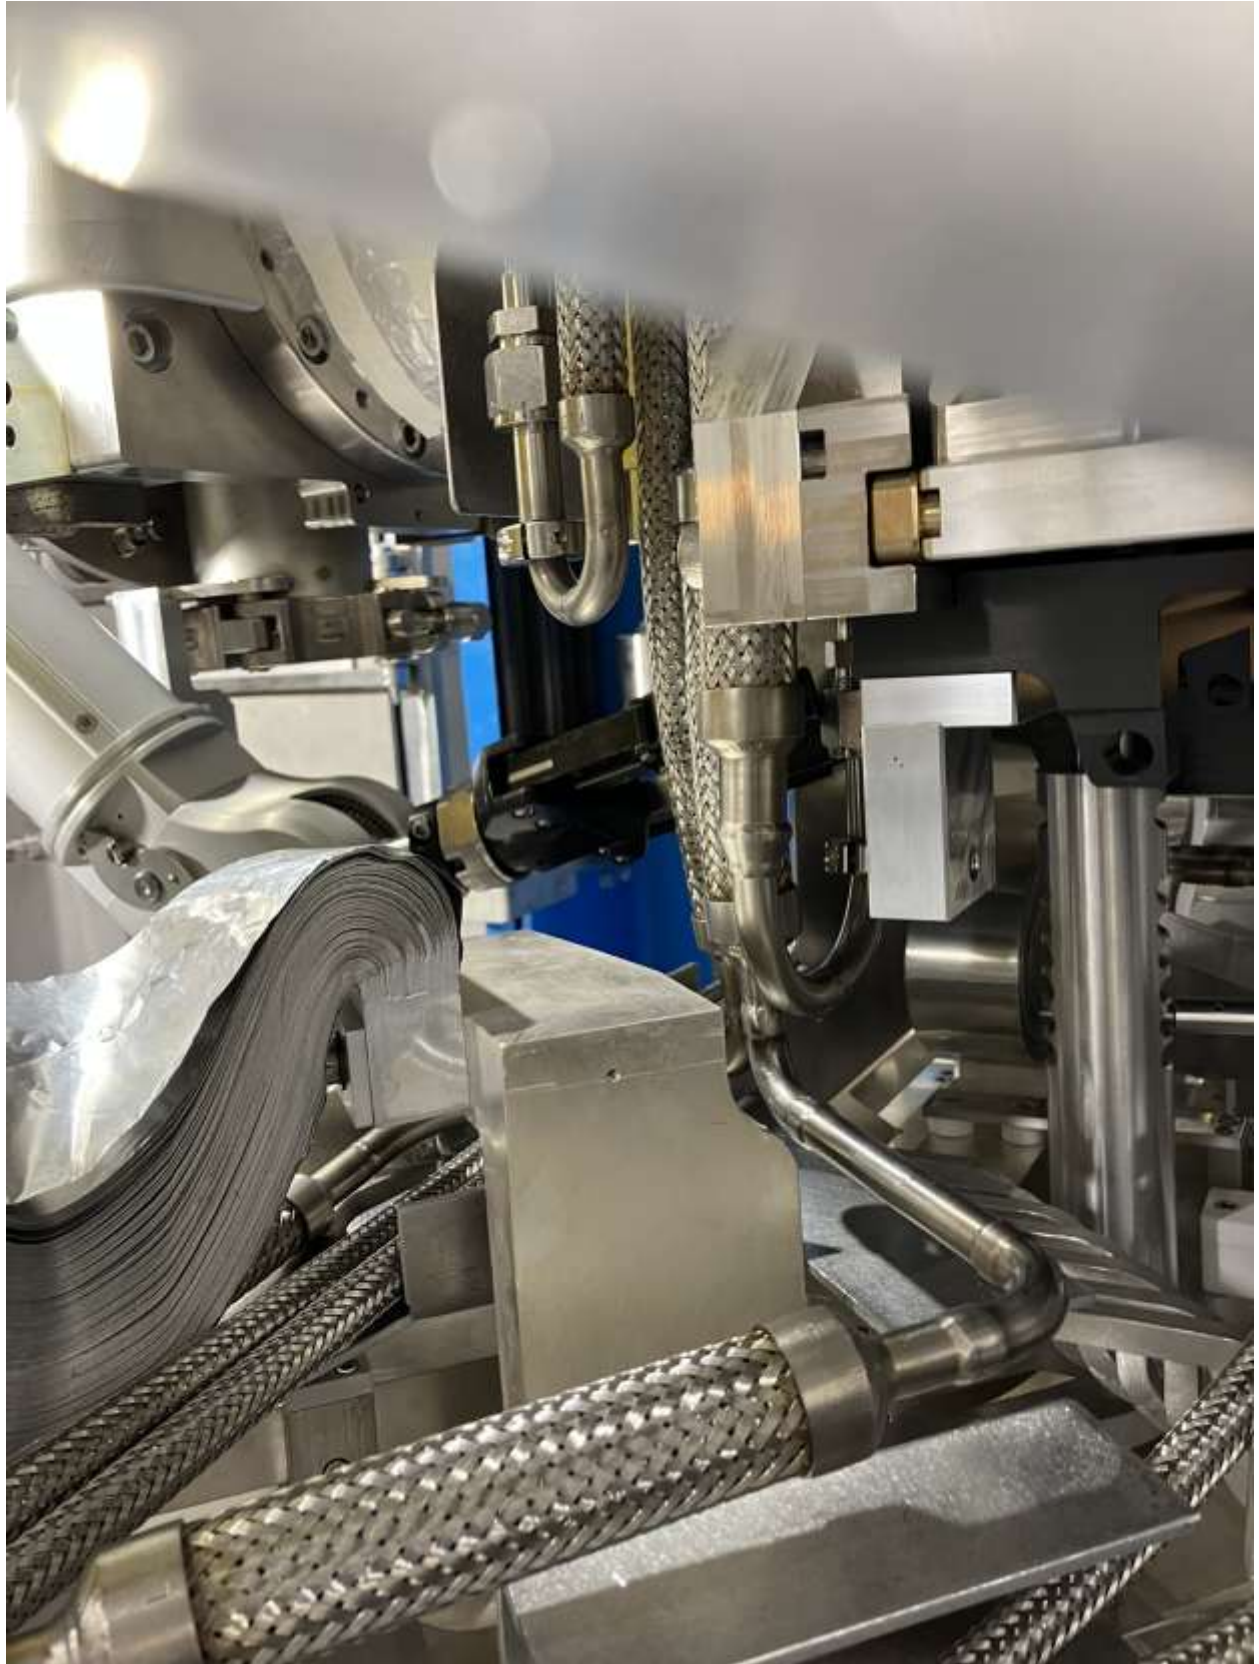
Illustration of how 'deep' the VCR joint on the top most water line is, as viewed from the hot cell window.

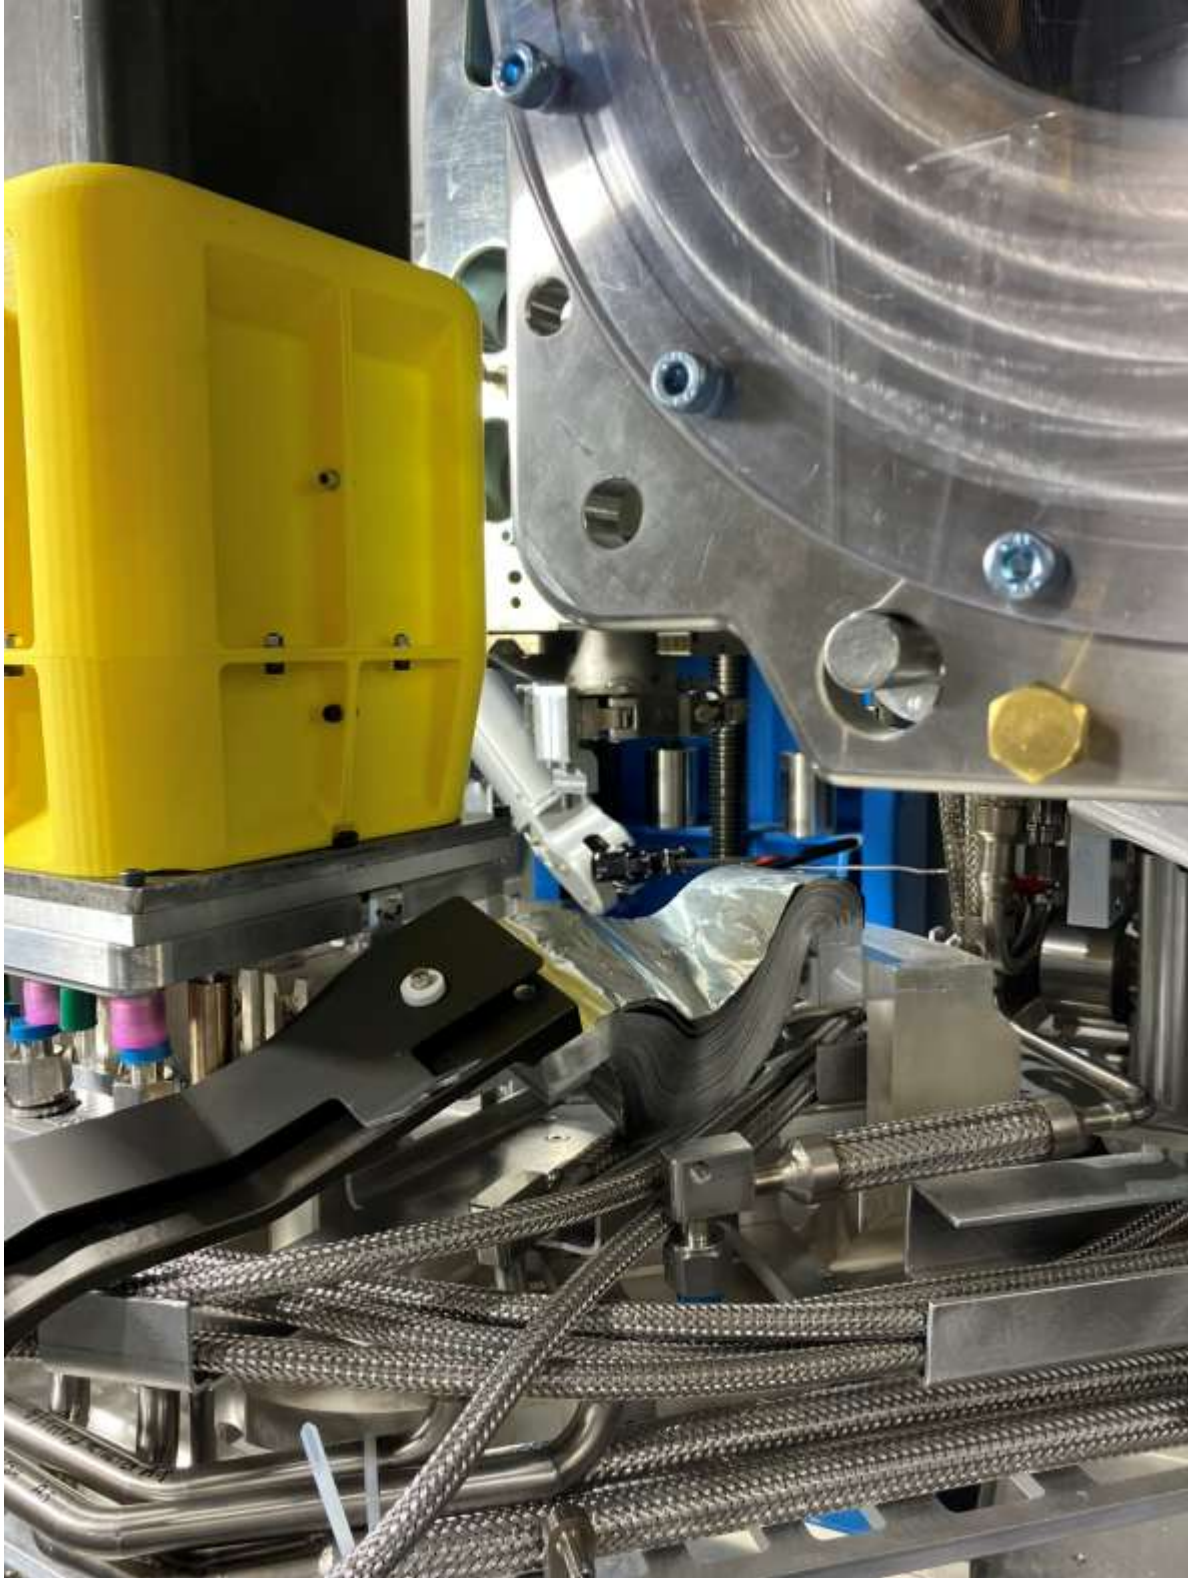
Changing position of hook access.

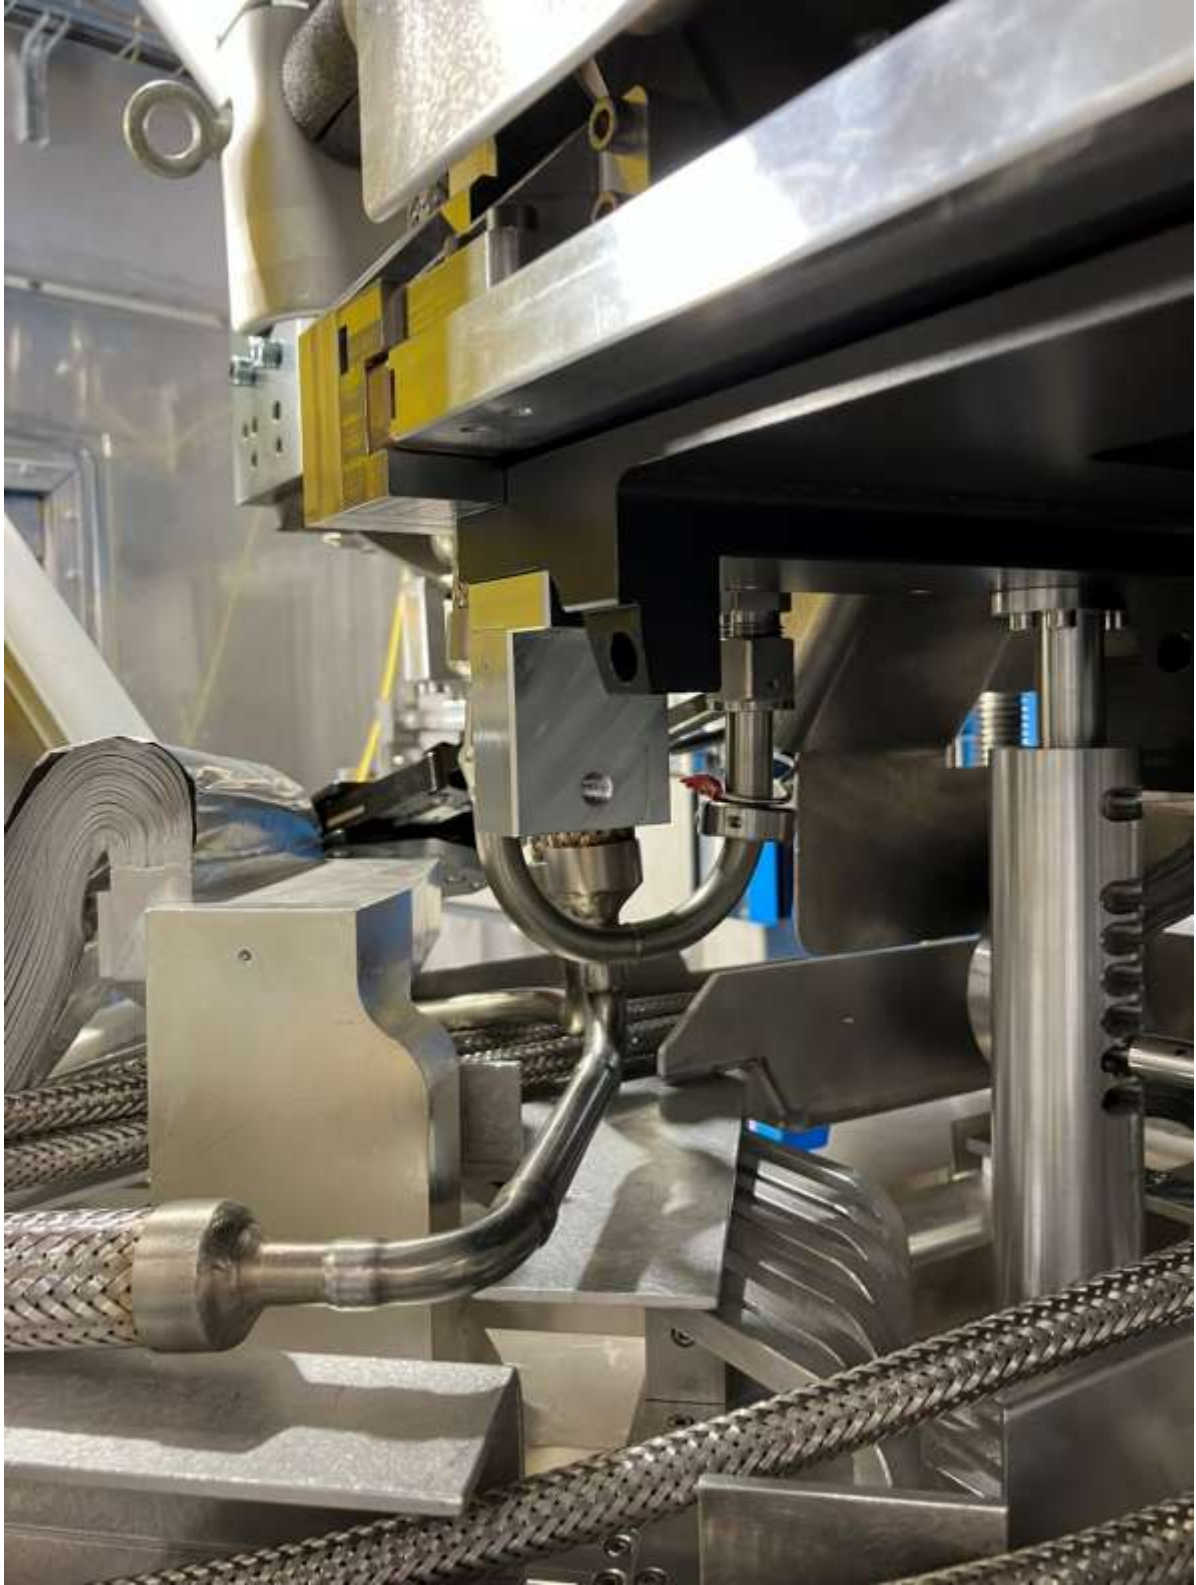
Nut successfully restarted.
